STATE OF ILLINOIS
DEPARTMENT OF TRANSPORTATION

CONTRACT NO. 66584

WEST ABUTMENT
US 136 OVER BRANCH OF SALT CREEK
FAP ROUTE 315 - SECTION 102X-BR-2
McLEAN COUNTY
STATION 616+99.00
STRUCTURE NO. 057-0185

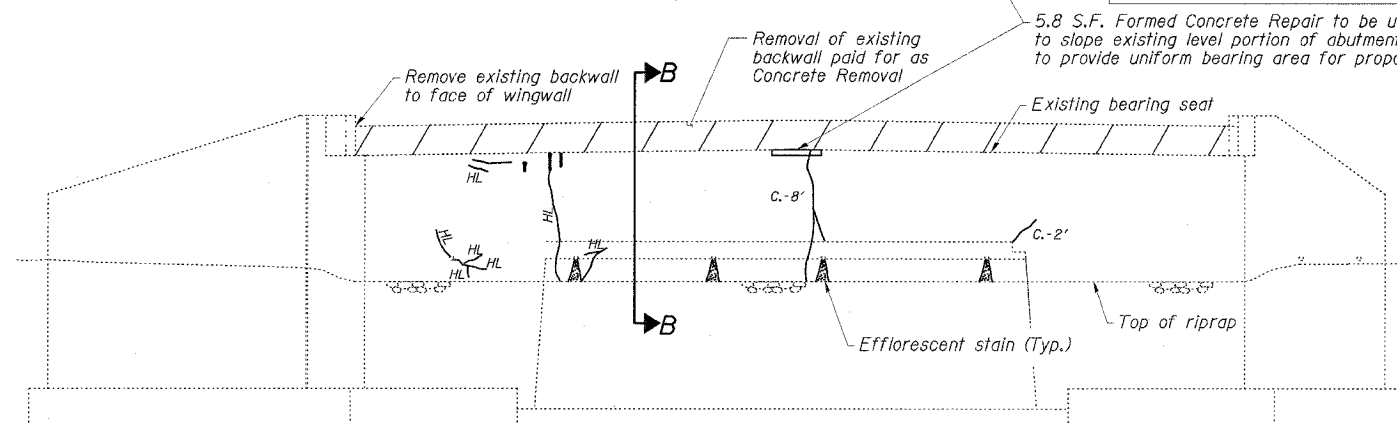
ELEVATION
Abutment and Wingwall Repairs

NOTE: ABUTMENT CRACK REPAIR LENGTHS AND FORMED CONCRETE REPAIR AREAS ARE ESTIMATED FROM 11-15-01 SURVEY WORK. ACTUAL LOCATIONS AND QUANTITIES OF REPAIRS SHALL BE SHOWN BY THE ENGINEER ON THE AS-BUILT PLANS FOR THIS SECTION.
