STATE OF ILLINOIS
DEPARTMENT OF TRANSPORTATION

ROUTE NO.	SECTION	COUNTY	TOTAL SHEETS	SHEET NO.
FAP 315	*	McLEAN	44	26
STA.	TO STA.			
FED. ROAD DIST. NO.	ILLINOIS	FED. AID PROJECT-		
*102X-BR-2	DWG. NO. 14 OF 17			
CONTRACT NO. 66584

PIER 2
US 136 OVER BRANCH OF SALT CREEK
FAP ROUTE 315 - SECTION 102X-BR-2
McLEAN COUNTY
STATION 616+99.00
STRUCTURE NO. 057-0185

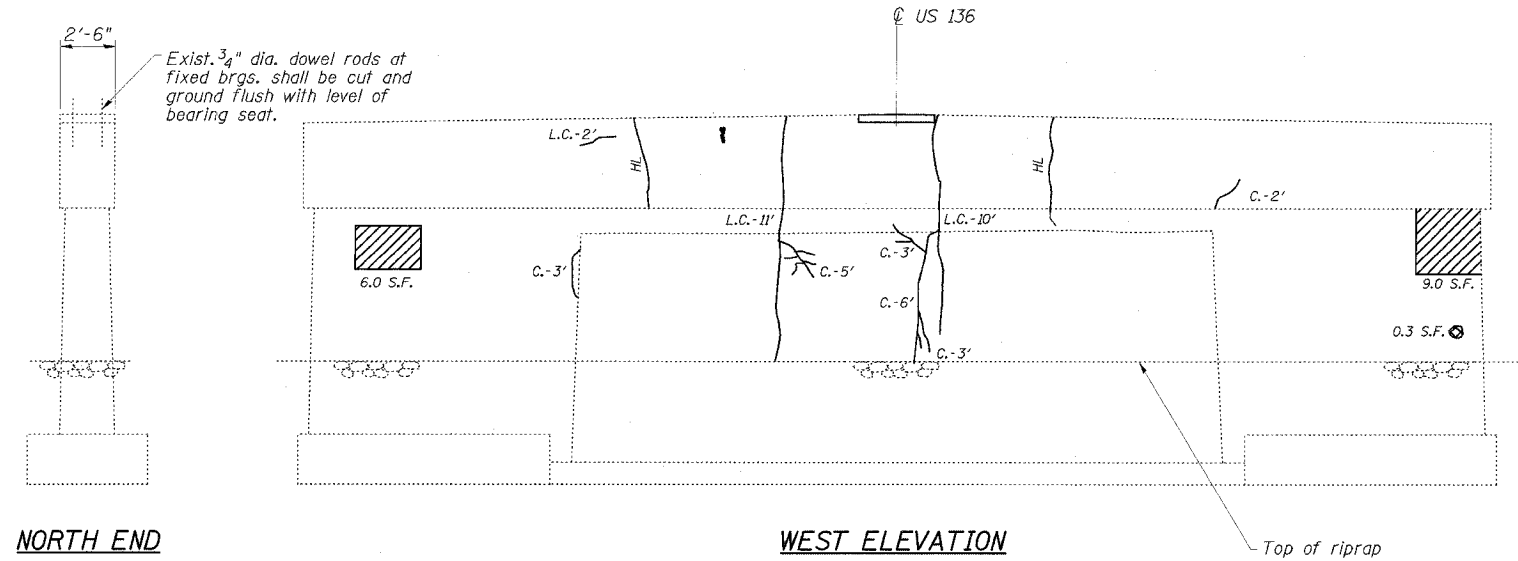
WEST ELEVATION

Efflorescent stain (Typ.)

EXISTING BEARING SEAT TO BE INSPECTED BY THE ENGINEER AFTER DECK BEAM REMOVAL. DETERIORATED CONCRETE AREAS SHALL BE REPAIRED (ESTIMATED 15 S.F. ADDITIONAL FORMED CONCRETE REPAIR DEPTH < 5") AND CRACKS SHALL BE SEALED (ESTIMATED 20' ADDITIONAL EPOXY CRACK SEALING) IF FOUND.

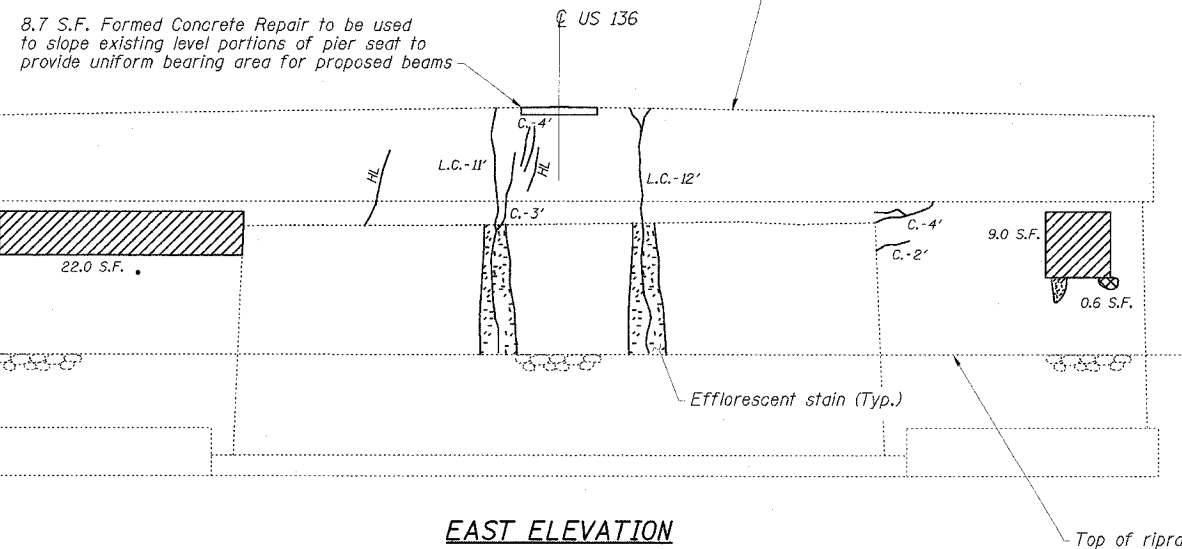
EAST ELEVATION

8.7 S.F. Formed Concrete Repair to be used to slope existing level portions of pier seat to provide uniform bearing area for proposed beams
