ROUTE NO.	SECTION	COUNTY	TOTAL SHEETS	SHEET NO.
FAP 697	17BR	FORD	40	25
STA.	TO STA.			
FED. ROAD DIST. NO.		FED. AID PROJECT		
DWG. NO. 12 OF 15

CONTRACT NO. 66604

PIER 1
IL 9 OVER BIG FOUR DITCH
FAP ROUTE 697 - SECTION 17BR
FORD COUNTY
STATION 923+87.00
STRUCTURE NO. 027-0068

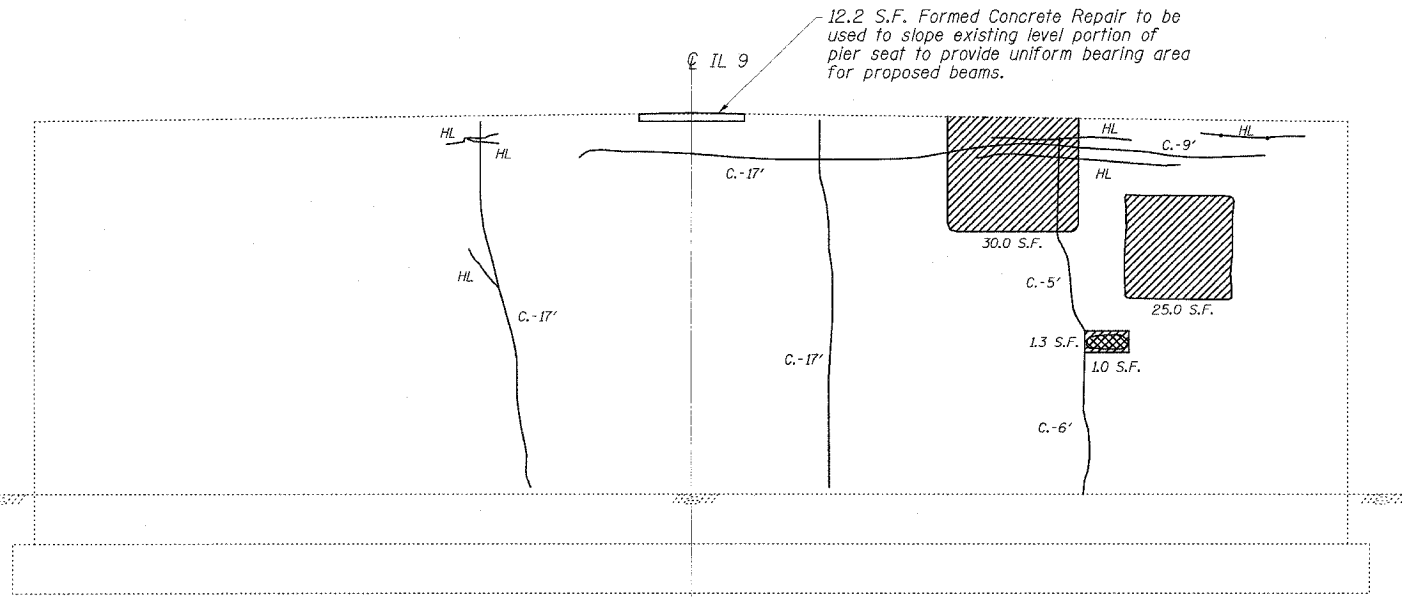
EAST ELEVATION

Exist. 3/4" dia. dowel rods at fixed brgs. shall be cut and ground flush with level of bearing seat.

12.2 S.F. Formed Concrete Repair to be used to slope existing level portion of pier seat to provide uniform bearing area for proposed beams.
