TRUSS SPANS - STRINGER REPAIR SCHEDULE

TRUSS SPANS  
STRINGER REPAIR SCHEDULE  
F.A.U.S. Rte. 9811 (U.S. 60 & 62)  
S.B.I. 150 SECTION 138D-BR  
ALEXANDER CO., IL. MISSISSIPPI CO., MO  
STATION 28 + 13.08

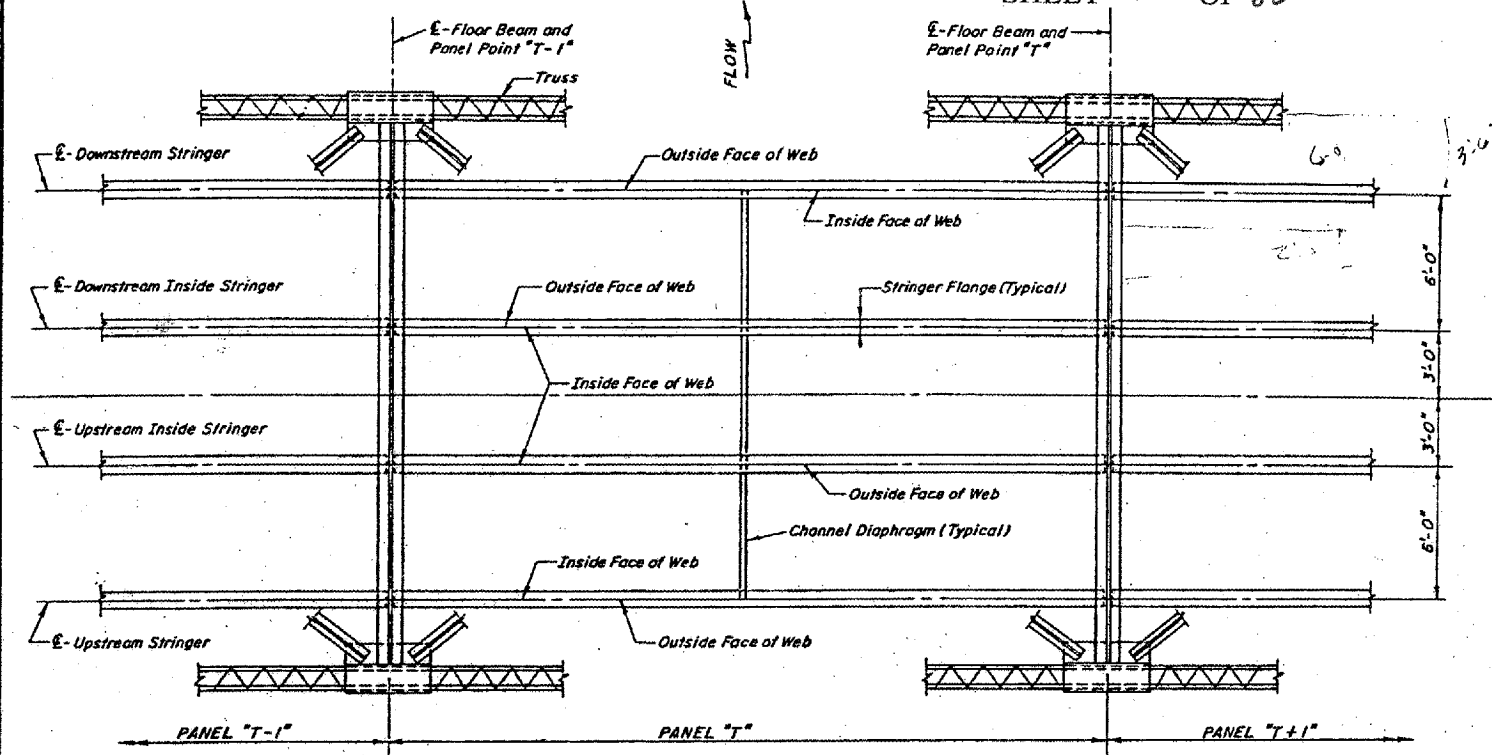
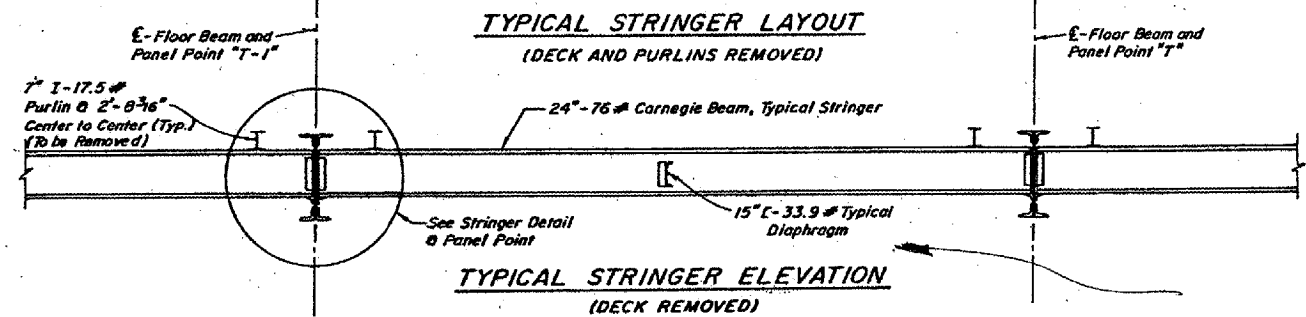
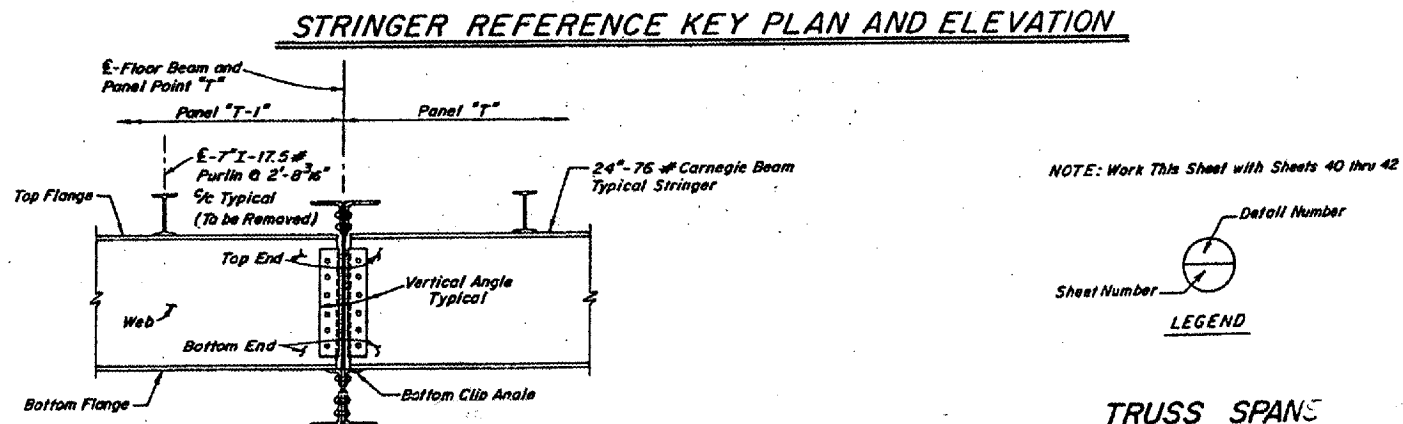
STRINGER DETAIL AT P. BRIDGE NO. 1  
(TYPICAL EXCEPT AT SLIP STRINGERS A) STRUCTURE 002-0005  
FOR INFORMATION ONLY

PANEL PT. NO.	PANEL NUMBER	STRINGER LOCATION				REMARKS
		UPSTREAM	DOWNSTREAM	UPSTREAM-INSIDE	DOWNSTREAM-INSIDE	
96	96	Outside face of the web has thin area near the bottom end, the bottom clip angle is rusted. See detail (15/40) and Use A=18", B=9", n=5, n1=2	The bottom clip angle is rusted. See detail (15/40) for repair.	The bottom clip angle is rusted. See detail (15/40) for repair.	The bottom clip angle is rusted. See detail (15/40) for repair.	
96	97	Inside face of the web has thin area near the bottom end, the bottom clip angle is rusted. See details (15/40) and Use A=39", B=9", n=12, n1=2	Inside face of the web has thin area near the bottom end. See Note "I" This Sheet	Outside face of the web has thin area near the bottom end, the bottom clip angle is rusted. See details (15/40) and Use A=60", B=9", n=19, n1=2	The bottom clip angle is rusted. See detail (15/40) for repair.	Downstream: The bottom clip angle is rusted. See detail (15/40) for repair.

97	97	The bottom clip angle is rusted. See detail (15/40) for repair.	The bottom clip angle is rusted. See detail (15/40) for repair.			
97	98	The bottom clip angle is rusted. See detail (15/40) for repair.				
98	98	The bottom clip angle is rusted. See detail (15/40) for repair.	Inside face of the web has a hole near the bottom end, the bottom clip angle is rusted. See detail (15/40) and below for repair.	The bottom clip angle is rusted. See detail (15/40) for repair.	The bottom clip angle is rusted. See detail (15/40) for repair.	
98	98		Outside face of the web has thin area near the top and bottom ends and a hole near the bottom end. See detail (20/40) for repair. Use A=12", n=3			
98	99	The bottom clip angle is rusted. See detail (15/40) for repair.	Inside face of the web has thin area near the bottom end, the bottom clip angle is rusted. See details (15/40) and (22/41) Use A=24", B=9", n=7, n1=2	The bottom clip angle is rusted. See detail (15/40) for repair.	Outside face of the web has thin area near the bottom end, the bottom clip angle is rusted. See detail (15/40) and below for repair.	Inside face of the web has thin area near the bottom end. See detail (23/41) for repair. Use A=54", B=9", n=17, n1=2

99	99	The bottom clip angle is rusted. See detail (15/40) for repair.	The bottom clip angle is rusted. See detail (15/40) for repair.	The bottom clip angle is rusted. See detail (15/40) for repair.	The bottom clip angle is rusted. See detail (15/40) for repair.	
100	100	The bottom clip angle is rusted. See detail (15/40) for repair.	Outside face of the web has thin area near the bottom end, the bottom clip angle is rusted. See details (15/40) and (22/41) Use A=18", B=9", n=5, n1=2	The bottom clip angle is rusted. See detail (15/40) for repair.	The bottom clip angle is rusted. See detail (15/40) for repair.	
100	100		Outside face of the web has thin area near the top end. See Note "I" This Sheet			
100	101	Outside face of the web has thin area and a hole near the bottom end, the bottom clip angle is rusted. See details (15/40) and (23/41) Use A=24", B=9", n=7, n1=2	Inside face of the web has thin area and holes near the bottom end, the bottom clip angle is rusted. See details (15/40) and (23/41) Use A=36", B=9", n=11, n1=2	Outside face of the web has thin area and a hole near the bottom end, the bottom clip angle is rusted. See details (15/40) and (23/41) Use A=30", B=9", n=9, n1=2	The bottom clip angle is rusted. See detail (15/40) for repair.

101	101	The bottom clip angle is rusted. See detail (15/40) for repair.	The bottom clip angle is rusted. See detail (15/40) for repair.	The bottom clip angle is rusted. See detail (15/40) for repair.		
101	102		The bottom clip angle is rusted. See detail (15/40) for repair.

NOTE:  
1. Contractor to clean the thin area and remove all rust, foreign material and all old paint down to the bare metal.
