STATE OF ILLINOIS  
DEPARTMENT OF TRANSPORTATION

CONTRACT 98939  
U.S. RTE. 60 & U.S. RTE. 62  
(138D-BR) P-1  
ALEXANDER COUNTY  
SHEET 55 OF 85 LEAVE

BRIDGE NO. 1  
STRUCTURE 002-0005  
FOR INFORMATION ONLY

MISCELLANEOUS REPAIR SCHEDULE  
F.A.U.S. Rte. 9811 (U.S. 60 & 62)  
S.B.I. 150 SECTION 138 D-BR  
ALEXANDER CO., IL. MISSISSIPPI CO., MO.  
STATION 28 + 13.08

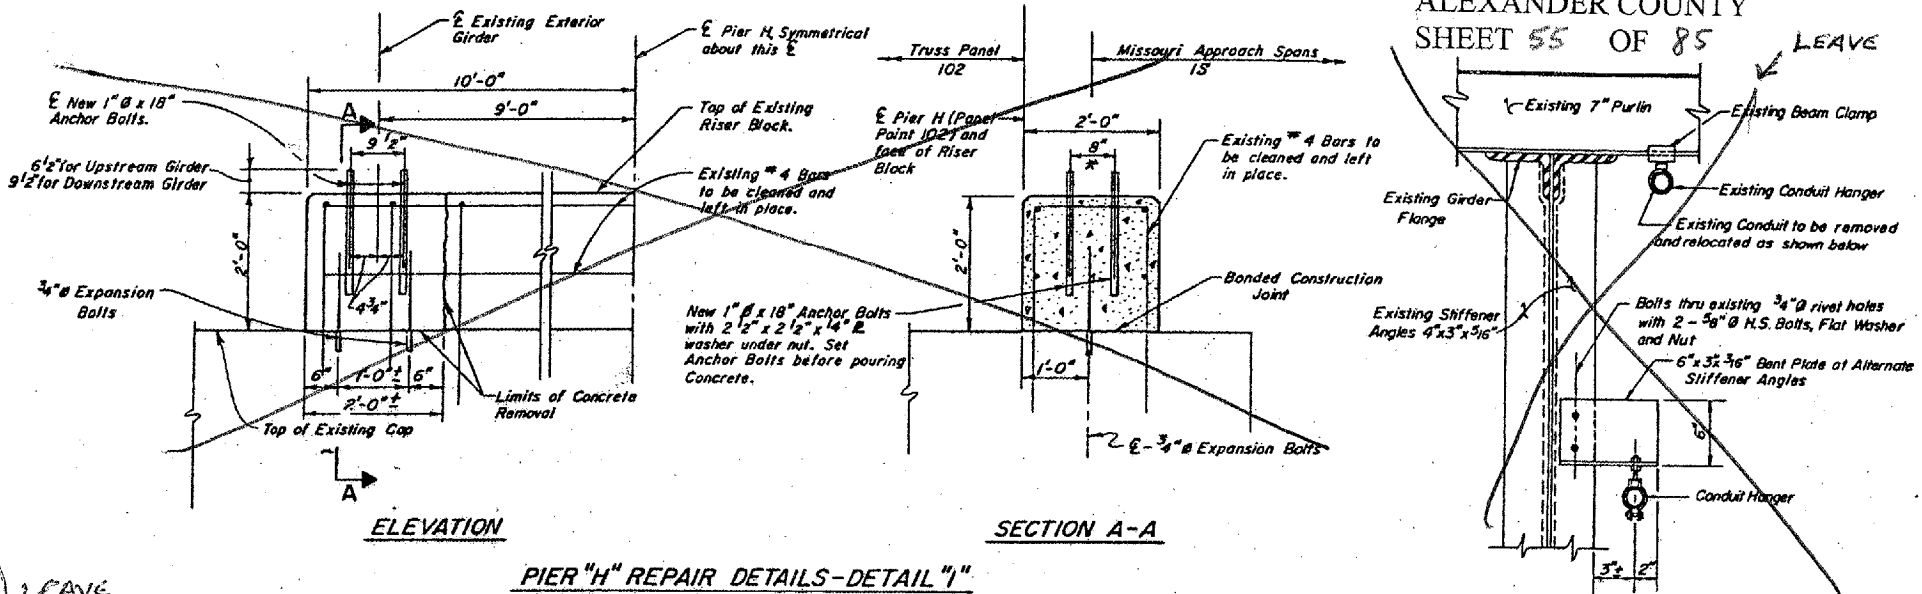
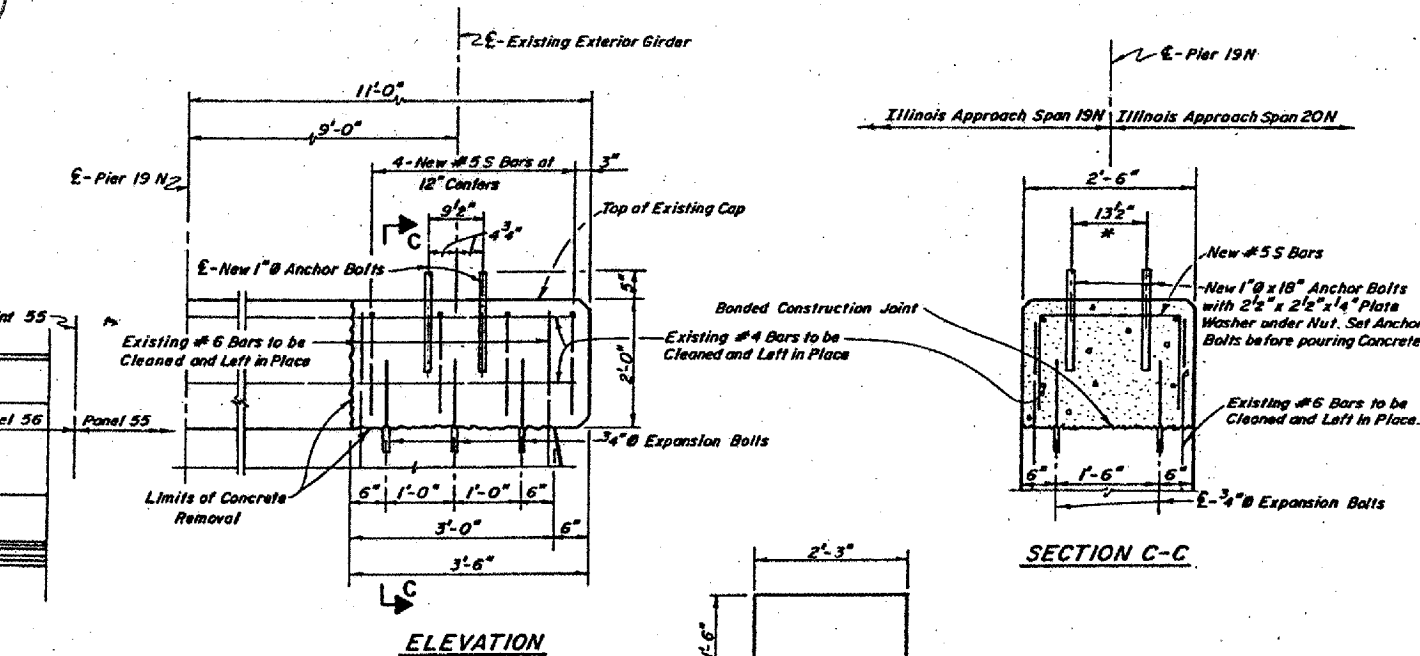
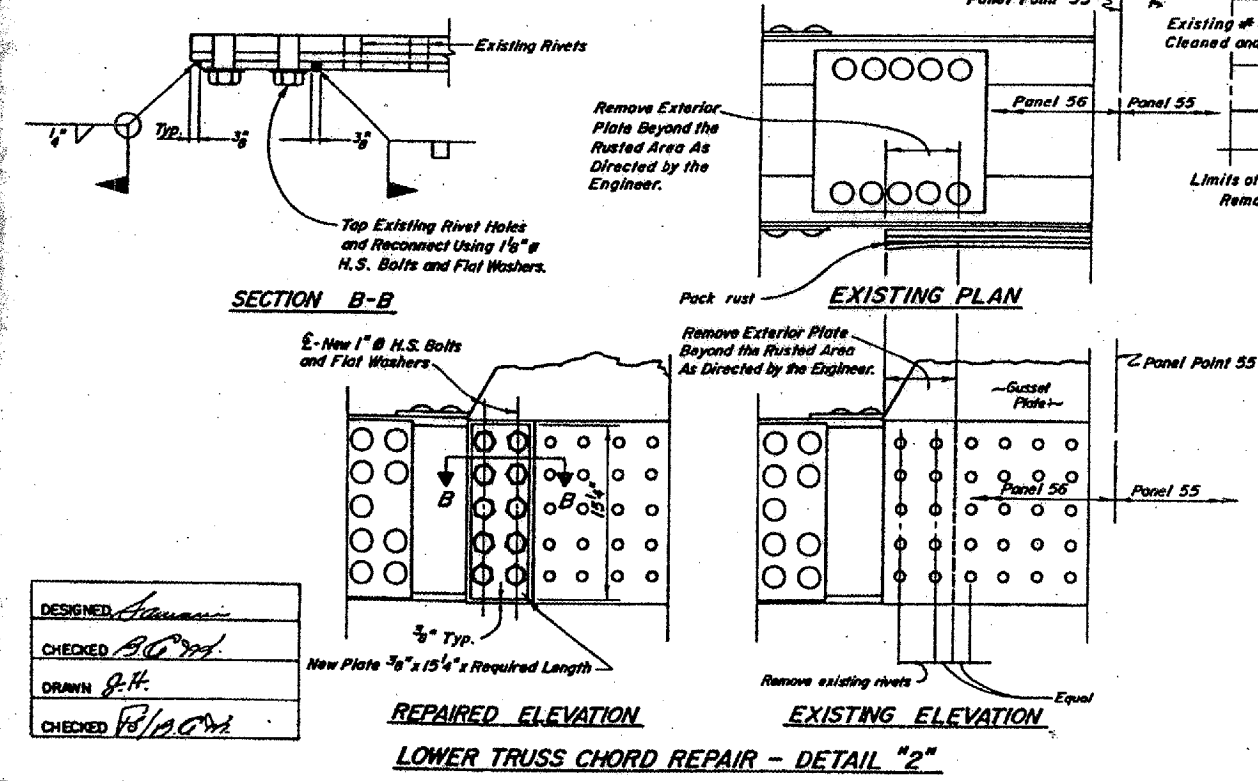
* MISCELLANEOUS REPAIR SCHEDULE			
SPAN NO. OR PANEL NO.	PIER NO. OR PANEL POINT NO.	DESCRIPTION	REPAIR REQUIREMENTS
15	H	The West and East ends of Concrete Bearing Block for the approach spans are leaching and spalling.	See Detail "1", This Sheet.
1	O	The Electrical Conduit is loose from the North Abutment to Panel Point No. 1.	Reconnect as directed by the Engineer.
24	23	The 2 1/2" Ø Pin of the upstream lower slip chord connection does not have adequate clearance from the edge of 25" x 7 1/2" slot.	Increase the length of slot to the South by 1 1/2".
56	55	Slip Connection at the Upstream side has pack rust between the two outside splice plates.	See Detail "2", This Sheet.
	19N	The West End of the Pier Cap is badly deteriorated.	See Detail "3", This Sheet.
		Conduit Hangers for Navigational Lighting are Broken or Missing.	Provide and Install New Hangers as directed by the Engineer.
		Electrical Conduit is hanging from west end of Existing Purlins. (Note Purlins are being removed.)	Remove and Relocate Existing Conduit. See Detail "4", This Sheet. II. Approach only.

\* May Change - Position Anchor Bolts at Center of Existing 3" Slots of the Expansion Girder End at 50' E.
