CONTRACT 98939
U.S. RTE. 60 & U.S. RTE. 62
(138D-BR) P-1
ALEXANDER COUNTY
SHEET 81 OF 85

BRIDGE NO. 1
STRUCTURE 002-0005
FOR INFORMATION ONLY

BRIDGE REPAIRS
OLD CAIRO BRIDGE OVER MISSISSIPPI RIVER
FAS RTE. 944 (US 60 & 62)
SEC. (138D-BR)I-5
ALEXANDER COUNTY
SN 002-0005

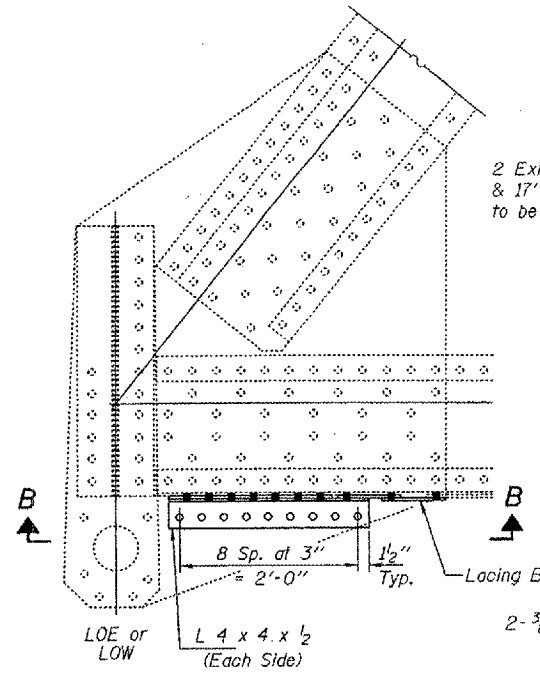
ELEVATION LOWER CHORD REPAIR

REPAIR 6

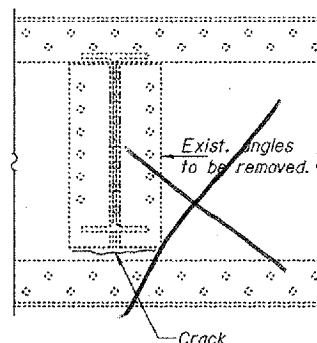
ELEVATION (Existing)

REPAIR 9

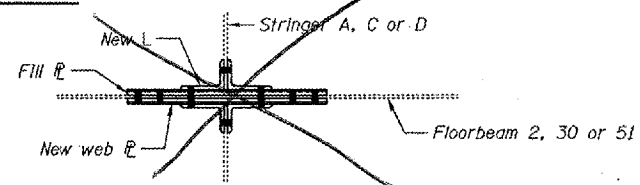
SECTION F-F

Floorbeam 2, Stringer D
Floorbeam 30, Stringer C
Floorbeam 51, Stringer A
