Existing Structures: S.N. 016-1000 and S.N. 016-1001.

DECK SLAB REPAIRS
1ST AVE. (IL. 171) OVER 47th STREET
COOK COUNTY
STATION 104+82.77
STRUCTURE NO. 016-1000 (S.B.)
& STRUCTURE NO. 016-1001 (N.B.)

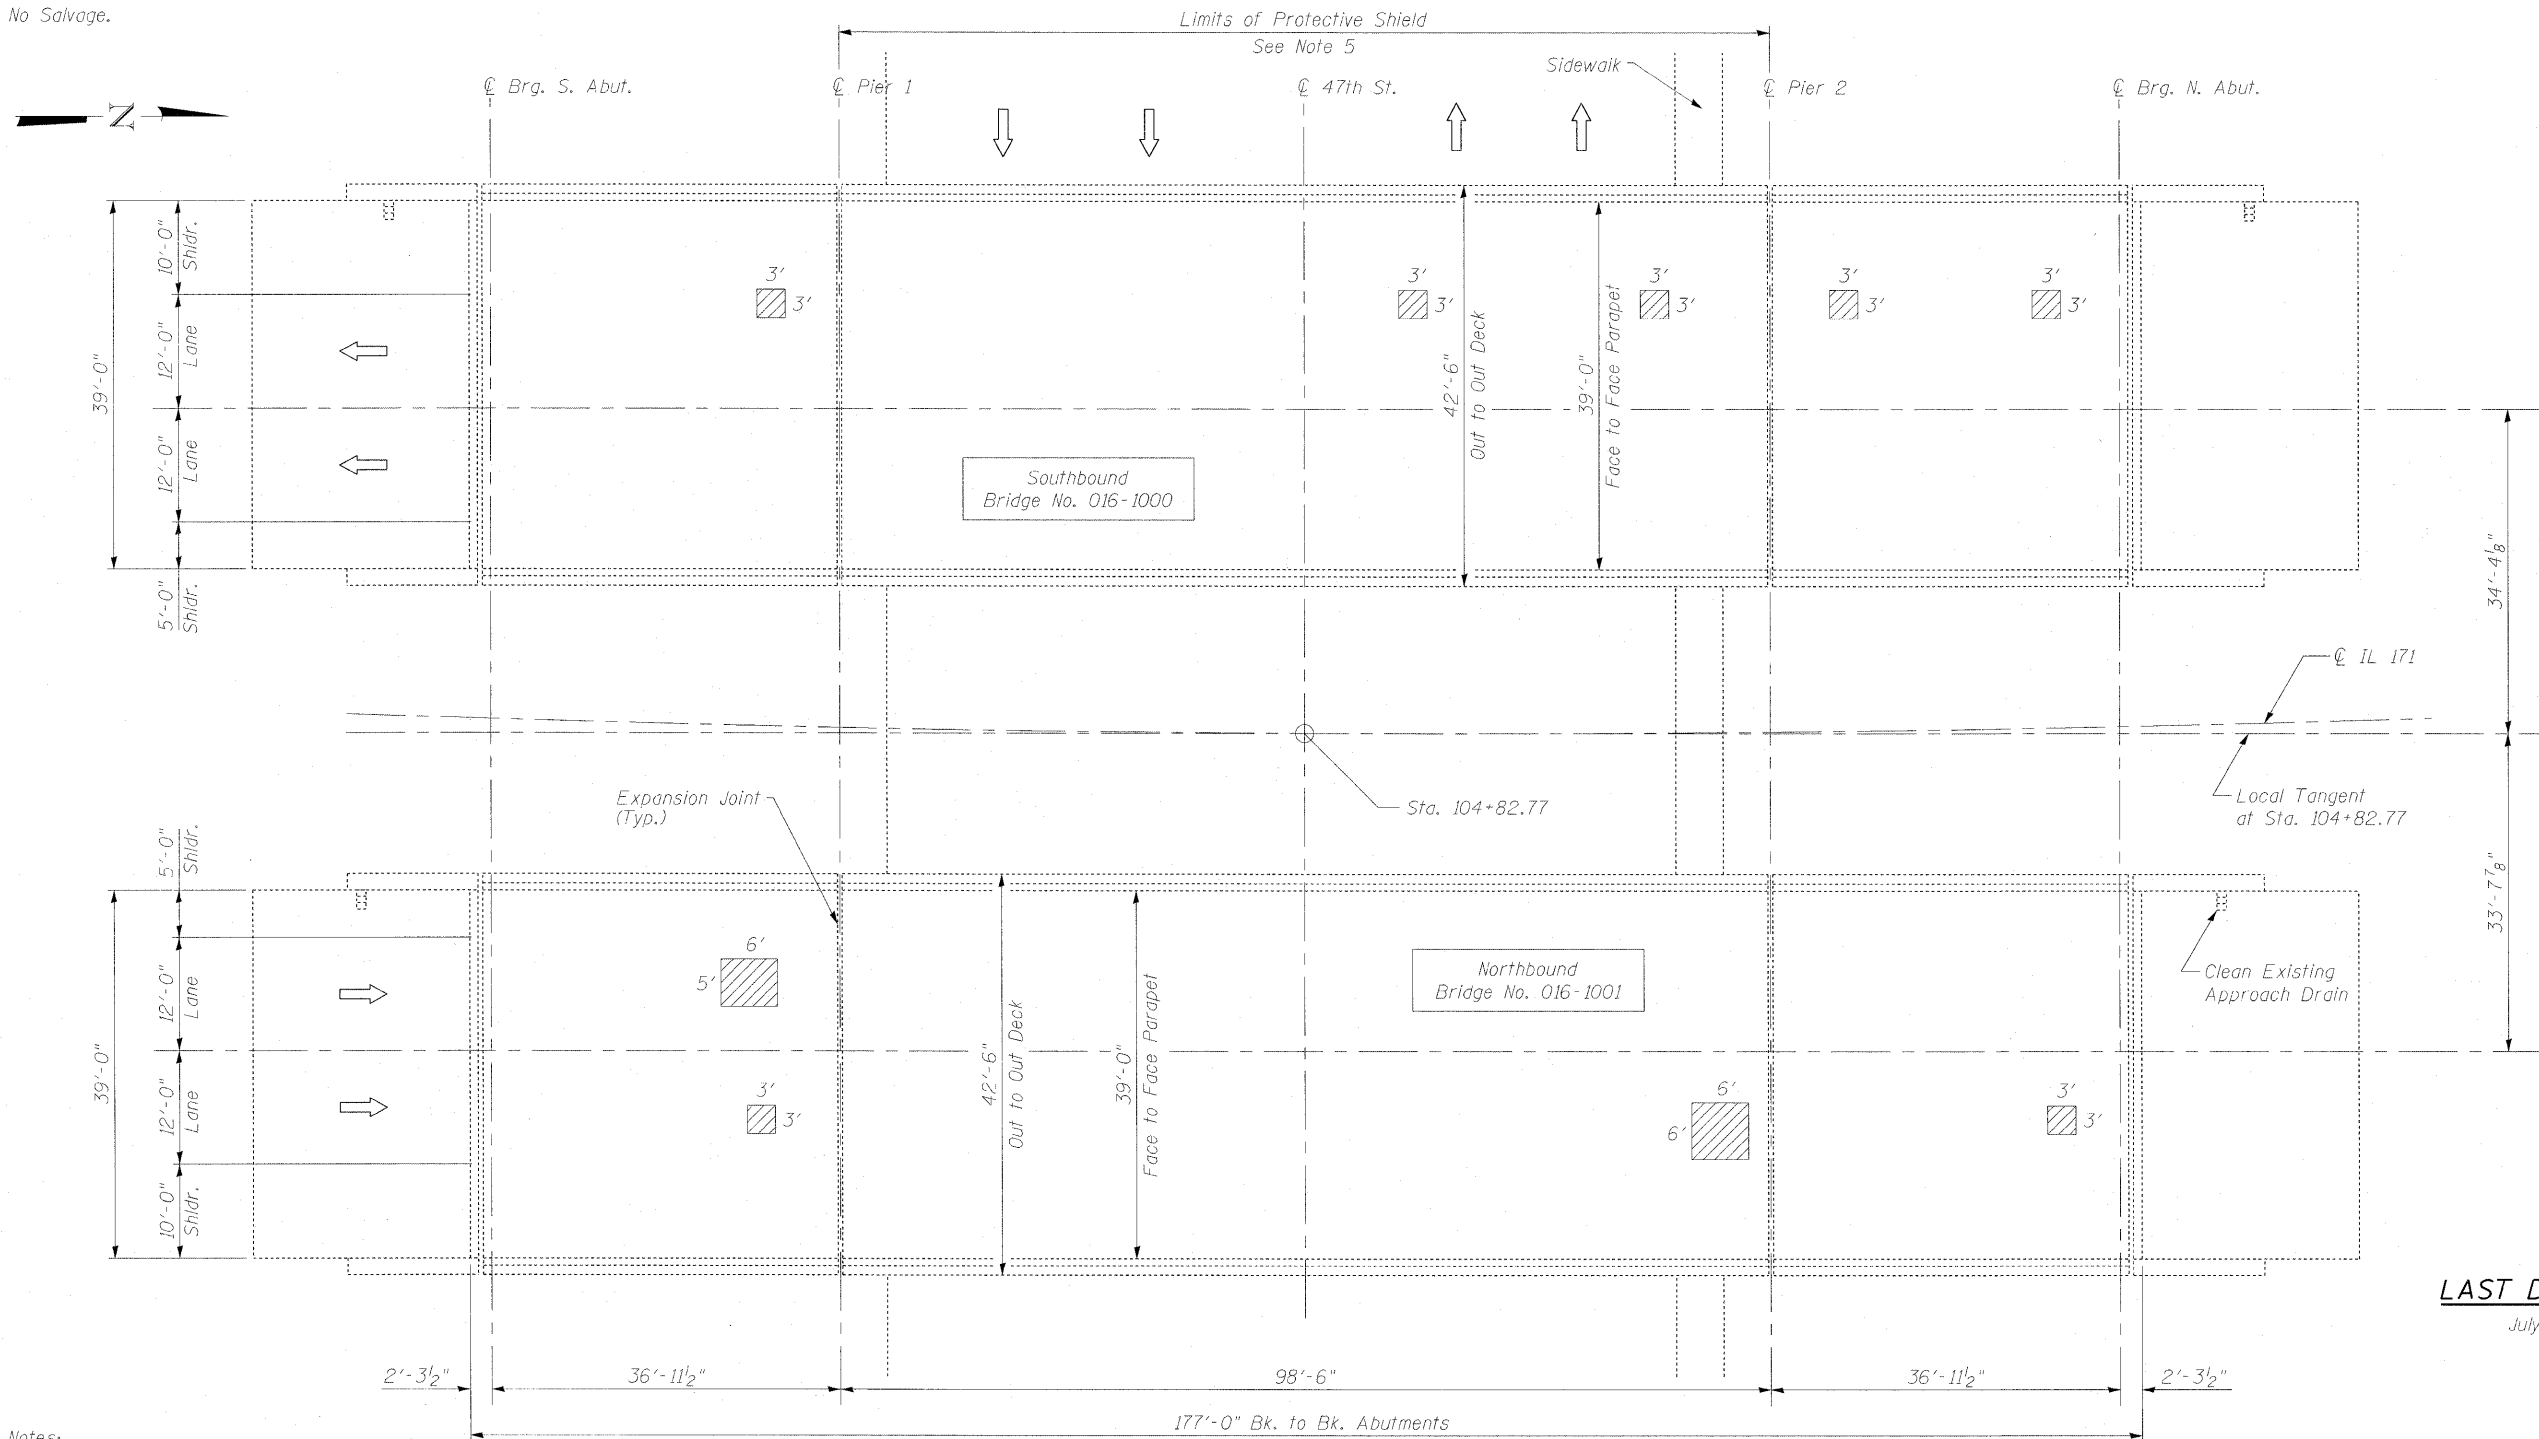
PLAN

LAST DELAMINATION SURVEY

July, 2011 (Provided by IDOT)

ITEM	UNIT	QUANTITY
Deck Slab Repair (Partial)	Sq. Yd.	14.4
Drainage Structures to be Cleaned	Each	1
Protective Shield	Sq. Yd.	772
