**EXISTING CONDITION OF INSPECTION WALKWAY**

**PROPOSED REHABILITATION OF INSPECTION WALKWAY**

DESIGNED - Marcus K. Christensen	EXAMINED - <i>Jaime F. Joffe</i> ACTING ENGINEER OF STRUCTURAL SERVICES	DATE - NOVEMBER 23, 2011	<b>STATE OF ILLINOIS DEPARTMENT OF TRANSPORTATION</b>	<b>INSPECTION WALKWAY REPAIR DETAILS SN 081-0106</b>	F.A.I. RTE. 280	SECTION (81-1B)M-2	COUNTY ROCK ISLAND	TOTAL SHEETS 30	SHEET NO. 24
CHECKED - Irvin J. Lopez	PASSED - <i>Carl P. ...</i> ACTING ENGINEER OF BRIDGES AND STRUCTURES	REVISED			CONTRACT NO. 64F22				
DRAWN - Kyle M. Steffen	REVISED	SHEET NO. 8 OF 14 SHEETS							
CHECKED - MKC IJL	ILLINOIS FED. AID PROJECT

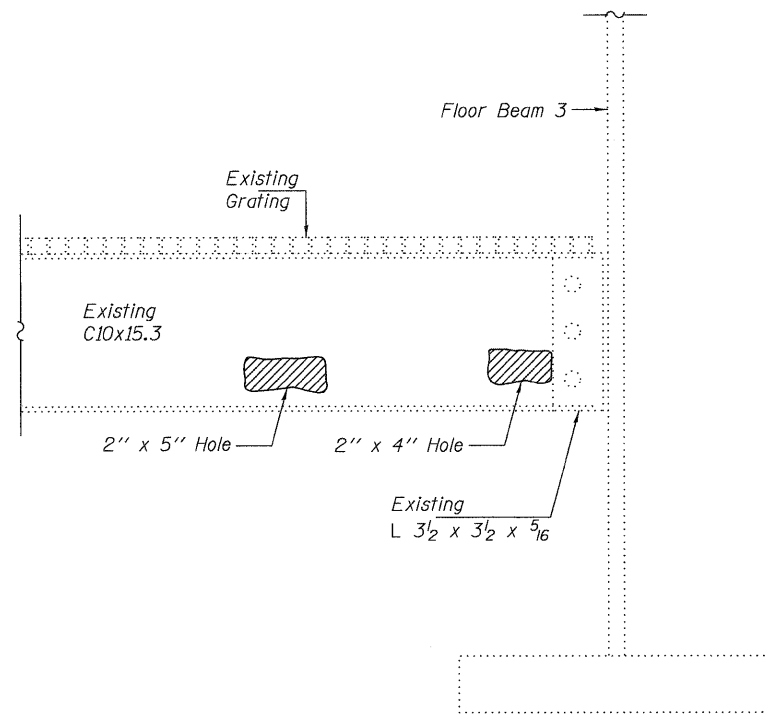
(Span 14, Between Floor Beam 2 & Floor Beam 3)
