ILLINOIS
CONTRACT NO. 66365
Sheet 13 of 18

Inspection Date: 5-19-04

PIER 1 REPAIR DETAILS

U.S. RTE. 45/52 OVER
SOUTH BRANCH ROCK CREEK
F.A.P. RTE. 330 - SECTION 16BR
KANKAKEE COUNTY
STA. 356+17.50 - STR. NO. 046-0047

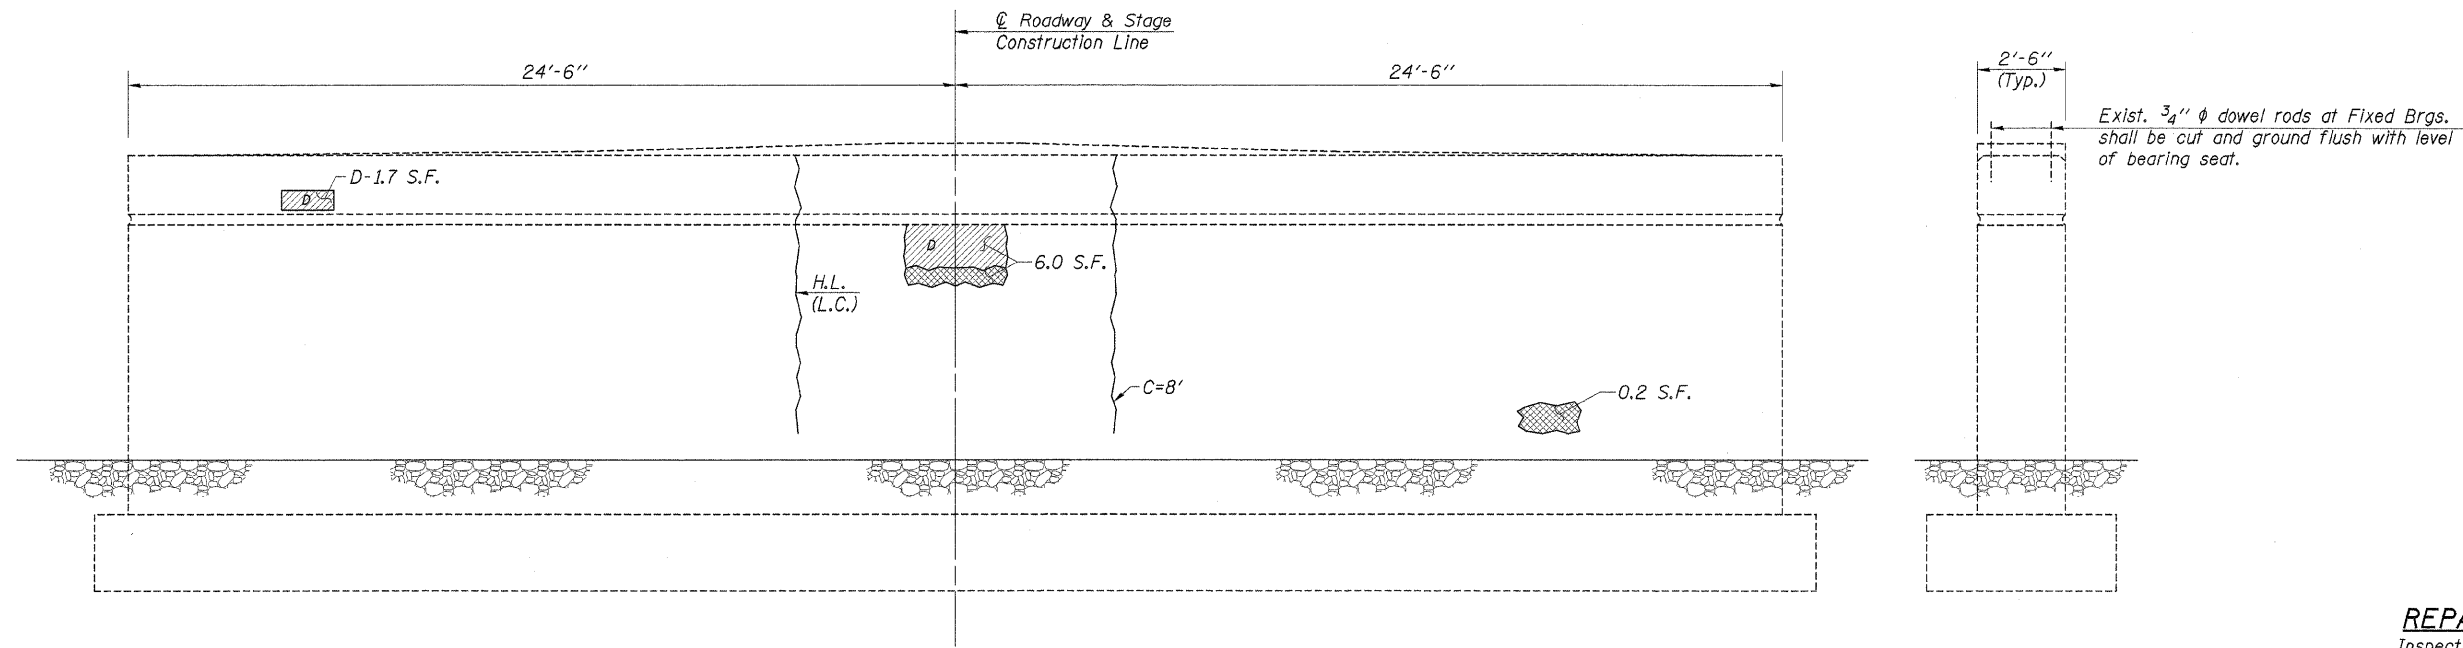
SOUTH ELEVATION - PIER 1

NOTE: PIER 1 CRACK REPAIR LENGTHS AND F.C.R. AREAS ARE ESTIMATED FROM 5-19-04 SURVEY WORK. ACTUAL LOCATIONS AND QUANTITIES OF REPAIRS SHALL BE SHOWN BY THE ENGINEER ON AS-BUILT PLANS FOR THIS SECTION.

EXISTING BEARING SEAT TO BE INSPECTED BY THE ENGINEER AFTER DECK BEAM REMOVAL. DETERIORATED CONCRETE AREAS SHALL BE REPAIRED (FORMED CONCRETE REPAIR DEPTH ≤ 5") AND CRACKS SHALL BE SEALED (EPOXY CRACK SEALING) IF FOUND.
