STATE OF ILLINOIS
DEPARTMENT OF TRANSPORTATION

BEAM STRAIGHTENING DETAILS
SN 016-1153 (W.B.)
SHEET NO. 2 OF 2 SHEETS

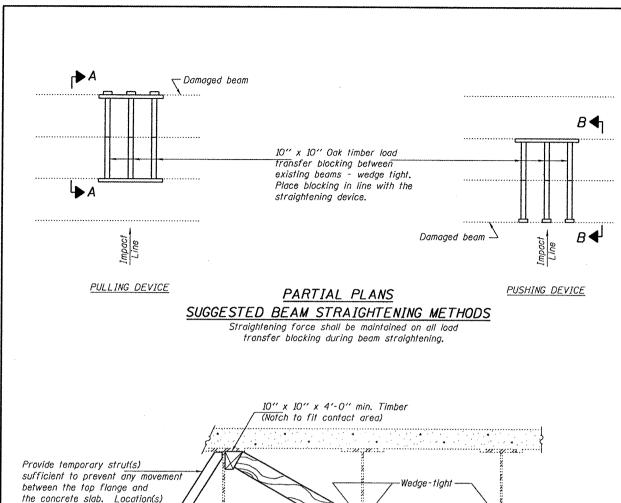
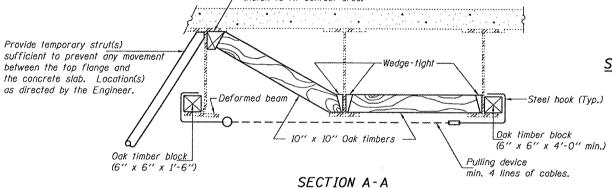
EXISTING DEFORMATION TO BE STRAIGHTENED

(Looking East)
(Approximate max. deflections)
Deflected length of beam to be
straightened is approximately 2'-0".

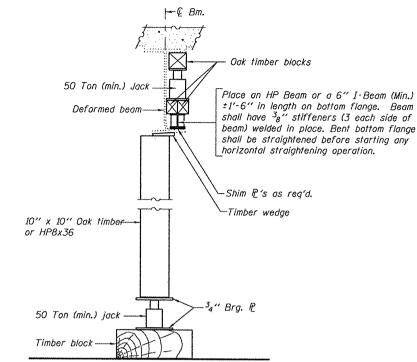
SUGGESTED VERTICAL STRAIGHTENING DETAIL

(To correct flange rotation.)

Grind existing nicks, gouges and shallow cracks in the damaged beams as detailed. Ground surfaces shall be inspected for cracks using magnetic particle testing prior to initiating any beam straightening operations. Any cracks that cannot be removed by grinding approximately '4" deep shall be identified and reported to the Bureau of Bridges and Structures for further disposition. Ground surfaces shall be spot cleaned and painted with an aluminum epoxy mastic primer followed by a finish coat to match the color of the existing beam. Cost of grinding, testing and spot painting included with Beam Straightening.

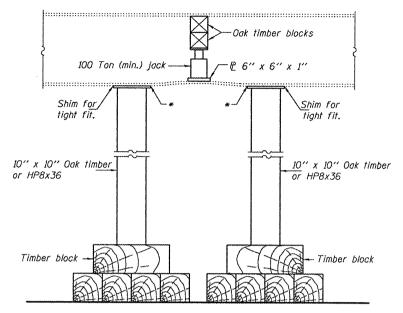
SUGGESTED VERTICAL STRAIGHTENING DETAIL

(To correct localized vertical flange deformations.)

* Edge of plate shall line up with edge of deformation.

Braces and jack assembly shall be placed on same side of web.

Bent bottom flange shall be straightened before starting any horizontal straightening operations.
