Table 1. Asbestos Homogeneous Areas Summary  
 IDOT - Asbestos Abatement Survey  
 WO # 44  
 331A East Ford St., Harrisburg, Illinois

30291391.01 - IDOT / Asbestos Surveys WO #44  
Job No. R-99-005-73  
Route IL13 (FAP 331) Parcel 9015698  
331A East Ford St.  
Harrisburg, Saline County, Illinois  
**ASBESTOS ABATEMENT SURVEY**

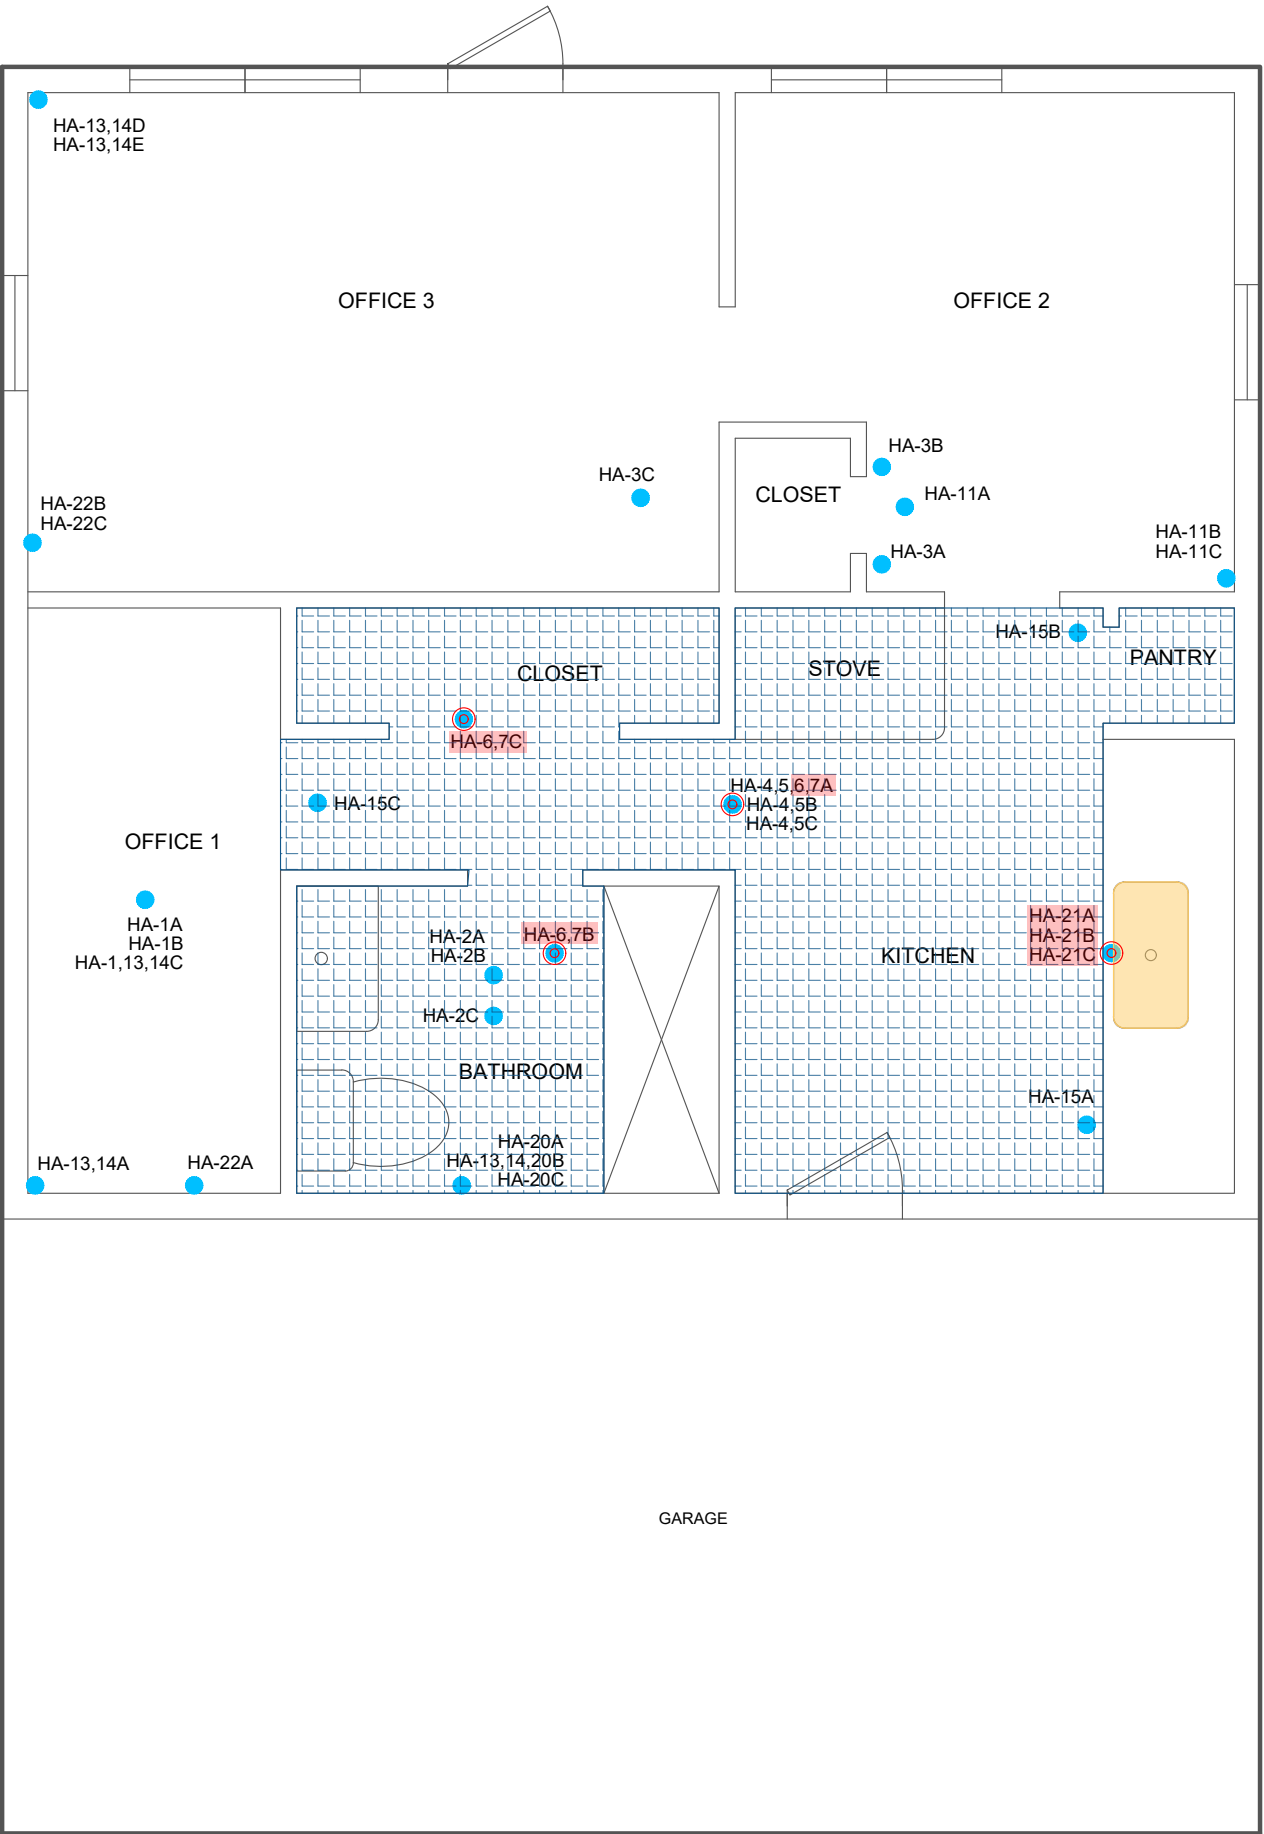
| <b>ASBESTOS CONTAINING MATERIAL<br/>LOCATIONS - FIRST FLOOR</b> | |

| HA No. | Material Description | Material Location | Sample Number | Condition | Friability | Asbestos Content | Estimated Quantity | Unit | Notes |
|---|---|---|---|---|---|---|---|---|---|
| 6 | Beige and Brown Linoleum | Kitchen, Bathroom, Closet | 6A, 6B, 6C | Good | Non-Friable | Chrysotile 15-20% | 200 | SF | Under HA-4 in the kitchen |
| 7 | Clear Adhesive associated with HA-6 | Kitchen, Bathroom, Closet | 7A, 7B, 7C | Good | Non-Friable | Chrysotile 1-5% | 200 | SF | Under HA-4 in the kitchen |

| HA No. | Material Description | Material Location | Sample Number | Condition | Friability | Asbestos Content | Estimated Quantity | Unit | Notes |
|---|---|---|---|---|---|---|---|---|---|
| 21 | <b>Black Sink Undercoating</b> | <b>Kitchen</b> | <b>21A, 21B, 21C</b> | <b>Good</b> | <b>Non-Friable</b> | <b>Chrysotile 1-5%</b> | <b>4</b> | <b>SF</b> | |

- LEGEND**
- ASBESTOS SAMPLE
  - ⊙ POSITIVE SAMPLE
  - HA-6: Beige & Brown Linoleum  
HA-7: Clear Adhesive Assoc. w/ HA-6
  - HA-21: Black Sink Undercoating

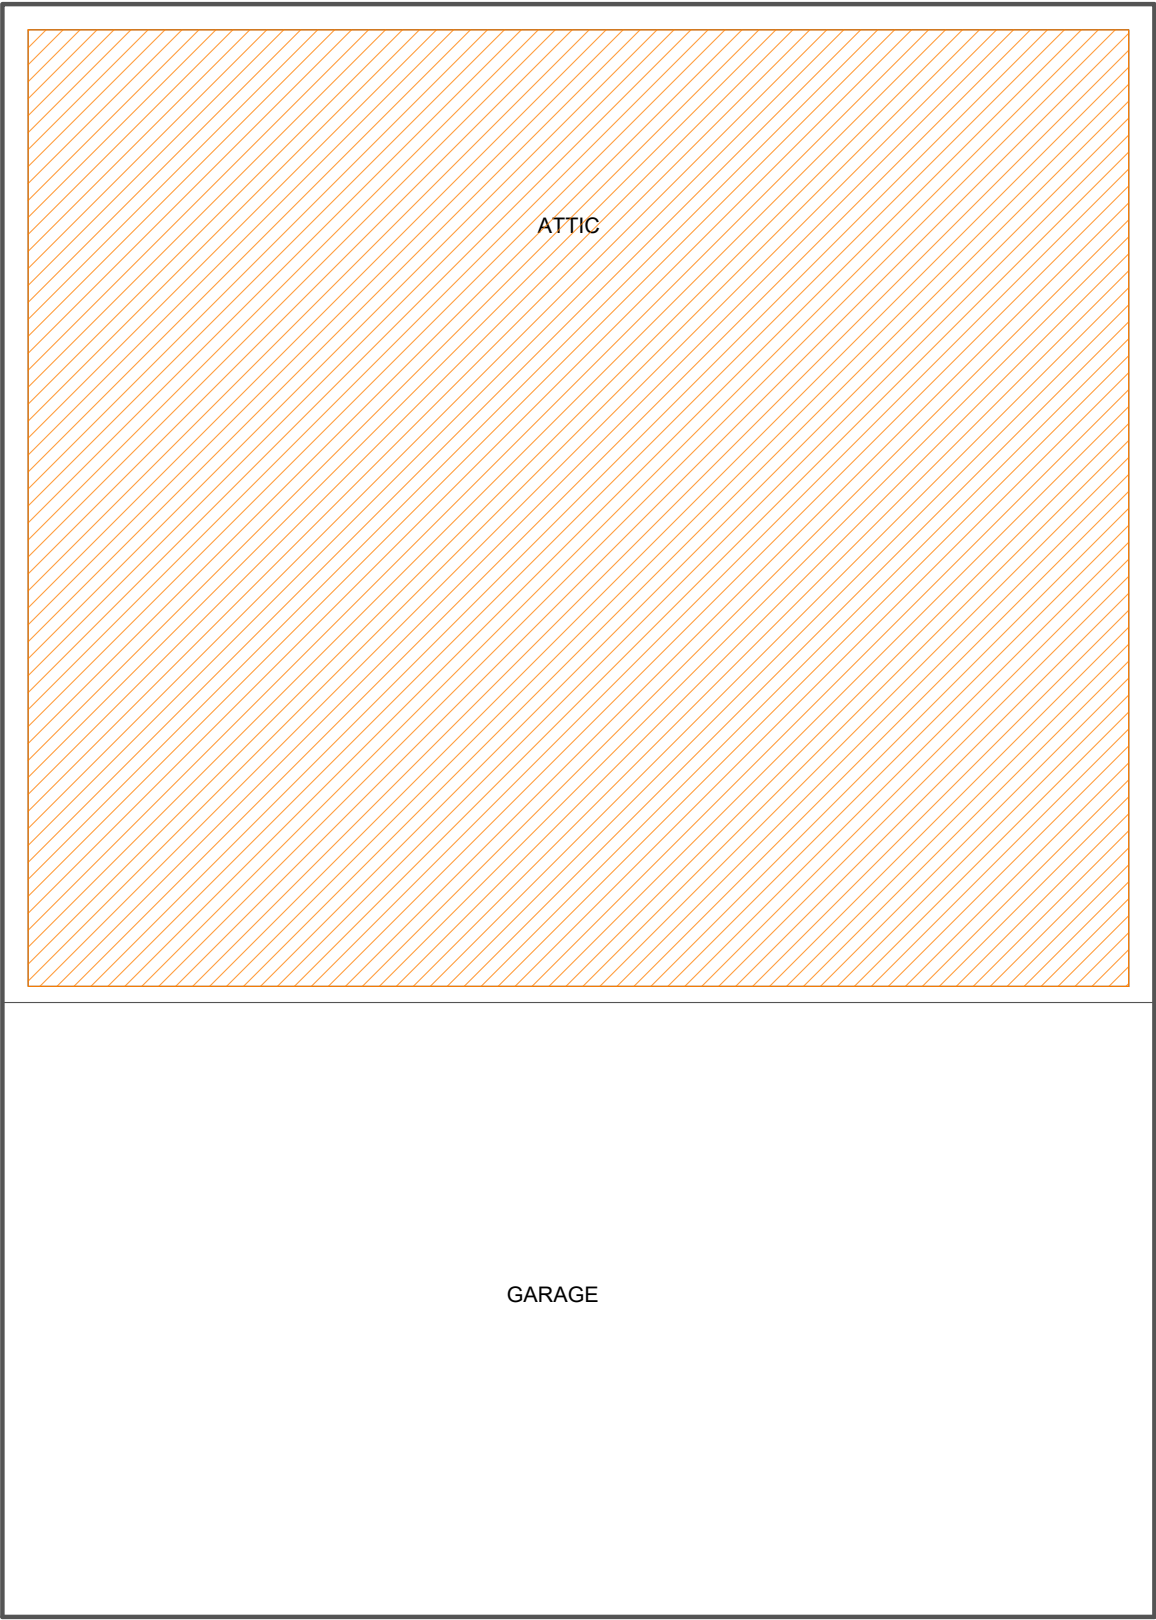
| <b>ASBESTOS CONTAINING MATERIAL<br/>LOCATIONS - ATTIC</b> | |

| HA No. | Material Description | Material Location | Sample Number | Condition | Friability | Asbestos Content | Estimated Quantity | Unit | Notes |
|---|---|---|---|---|---|---|---|---|---|
| 12 | Brown and Tan Vermiculite | Attic | 12A, 12B, 12C | Good | Friable | Assumed ACM | 480 | CF | |

- LEGEND**
- ASBESTOS SAMPLE
  - ⊙ POSITIVE SAMPLE
  - ▨ HA-12: Brown & Tan Vermiculite (Not Sampled - Assumed ACM)
