PIER END OF BEAM STRUCTURAL STEEL REPAIR DETAIL

**STRUCTURAL STEEL
STRUCTURE NO. 005-3006**

PROJECT NUMBER: 08.0204.130 DATE: 11/10/09

C.H.	SECTION	COUNTY	TOTAL SHEETS	SHEET NO.
3A	05-00065-00-BR	BROWN	24	18
FED. ROAD DIST. NO.			ILLINOIS FED. AID PROJECT ARA 1583(103)	
CONTRACT NO. 93509

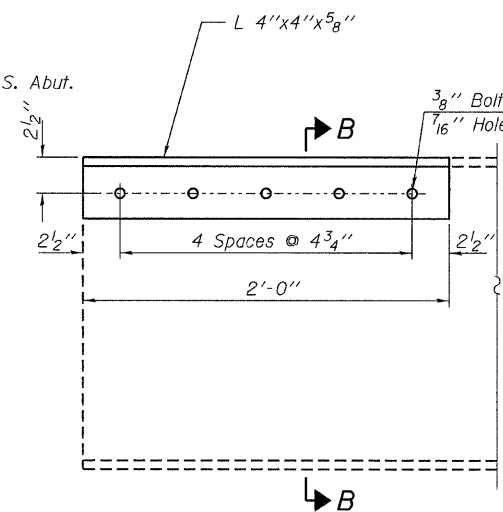
* Top Flange to be removed and repaired if engineer determines the overall thickness of the flange is less than 1/2" for a length of 6" at the pier end.

32 angles required @ 16 end of beam repairs = 1,030 lbs
