**TIMBER BEAM REPAIR DETAILS**

**PIER 3 DETAILS**

**GLEN CARBON HERITAGE BIKE TRAIL OVER JUDY BRANCH MADISON COUNTY STATION 108+17.70 STRUCTURE NO. 1**

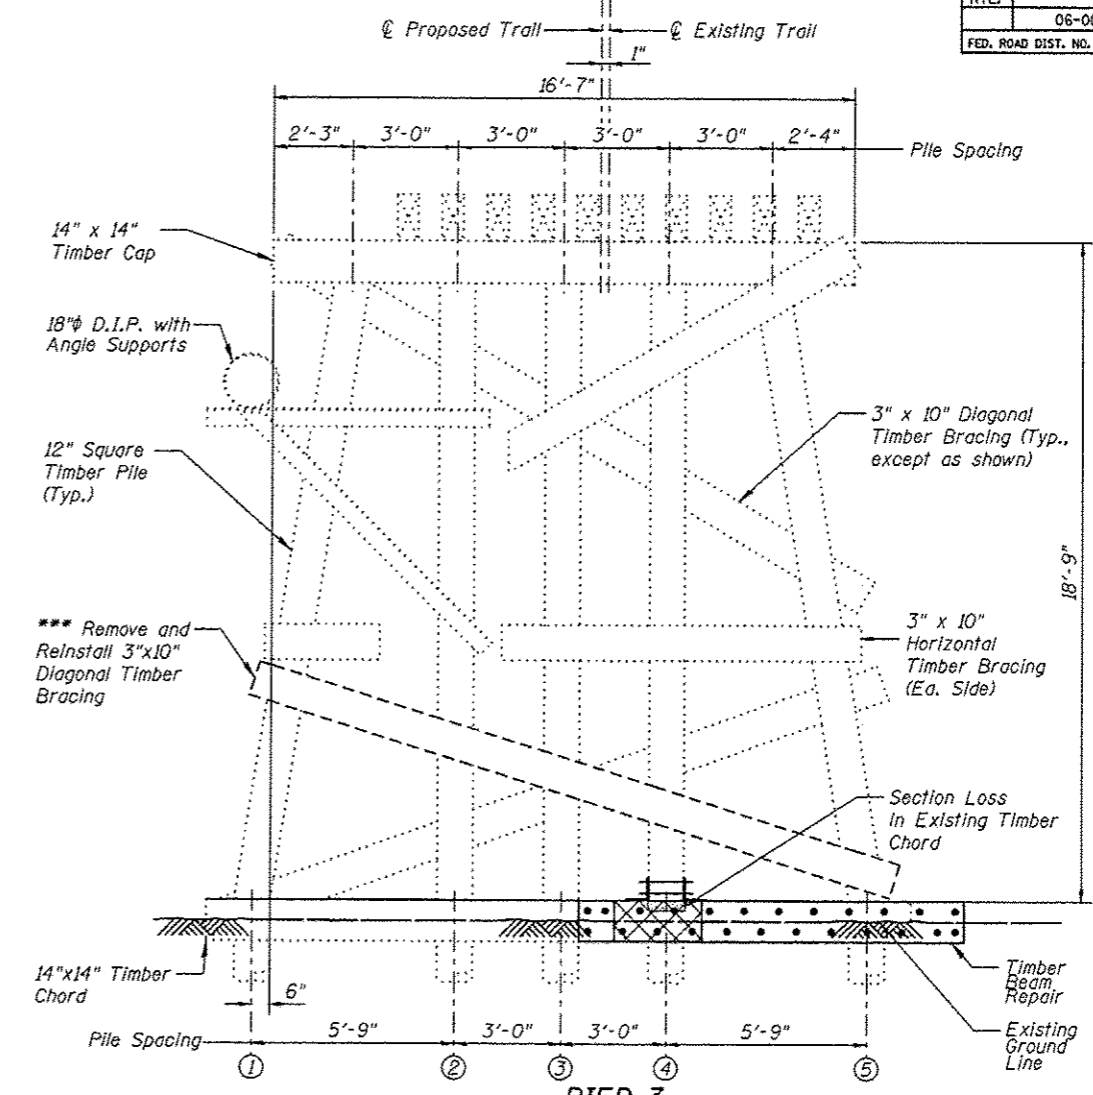
**PIER 3 (Looking East)**  
**PIER 3 BILL OF MATERIAL**

**Legend**  
 Area of Deterioration  
 Split

**Note:**  
 All dimensions are approximate. Bolts, nuts and washers for the Timber Beam Repair shall be hot-dipped galvanized.  
 \* Cross Hatched area indicates removal of damaged 2'-6" length of Existing Timber Chord. Replace the removed section with new 14"x14"x2'-6" Timber Chord.  
 \*\* Replacement of removed section with new 14"x14"x2'-6" Timber Chord.  
 \*\*\* The 3"x10" Existing Diagonal Timber Bracing shall be removed and reinstalled to clear Timber Beam Repair. Existing bolts, nuts, and washers to be removed, cleaned and reinstalled. Cost of removing and relocating the existing timber bracing shall be included with Timber Beam Repair.
