**CONCRETE ENCASEMENT DETAILS**

<p>Juneau Associates, Inc. P.C. CONSULTING ENGINEERS AND LAND SURVEYORS 2100 State Street, P.O. Box 1325 Madison, WI 53703 Phone: (608) 261-1100 Fax: (608) 261-0911</p>		<p>GLEN CARBON HERITAGE BIKE TRAIL OVER AN UNNAMED CREEK MADISON COUNTY STATION 387+75.21 STRUCTURE NO. 11</p>									
<p>REVISIONS</p> <table border="1"> <thead> <tr> <th>NO.</th> <th>DATE</th> <th>BY</th> <th>REMARKS</th> </tr> </thead> <tbody> <tr> <td> </td> <td> </td> <td> </td> <td> </td> </tr> </tbody> </table>		NO.	DATE	BY	REMARKS					<p>SCALE: NOT TO SCALE, FOLLOW DIMENSIONS</p>	
NO.	DATE	BY	REMARKS								
<p>DGN NAME:</p>		<p>DSN BY: DB</p>	<p>DATE: 10/18/12</p>								
<p>NO. DATE BY REMARKS</p>		<p>DWN BY: EER</p>	<p>DATE: 10/18/12</p>								
<p> </p>		<p>CHK'D: WWH</p>	<p>DATE: 10/18/12</p>								
<p> </p>		<p>JOB NO. E064403</p>	<p>DGN. NO.</p>								
<p> </p>		<p>SHEET</p>	<p>234</p>								
<p> </p>		<p>OF 819 SHTS</p>	<p> </p>

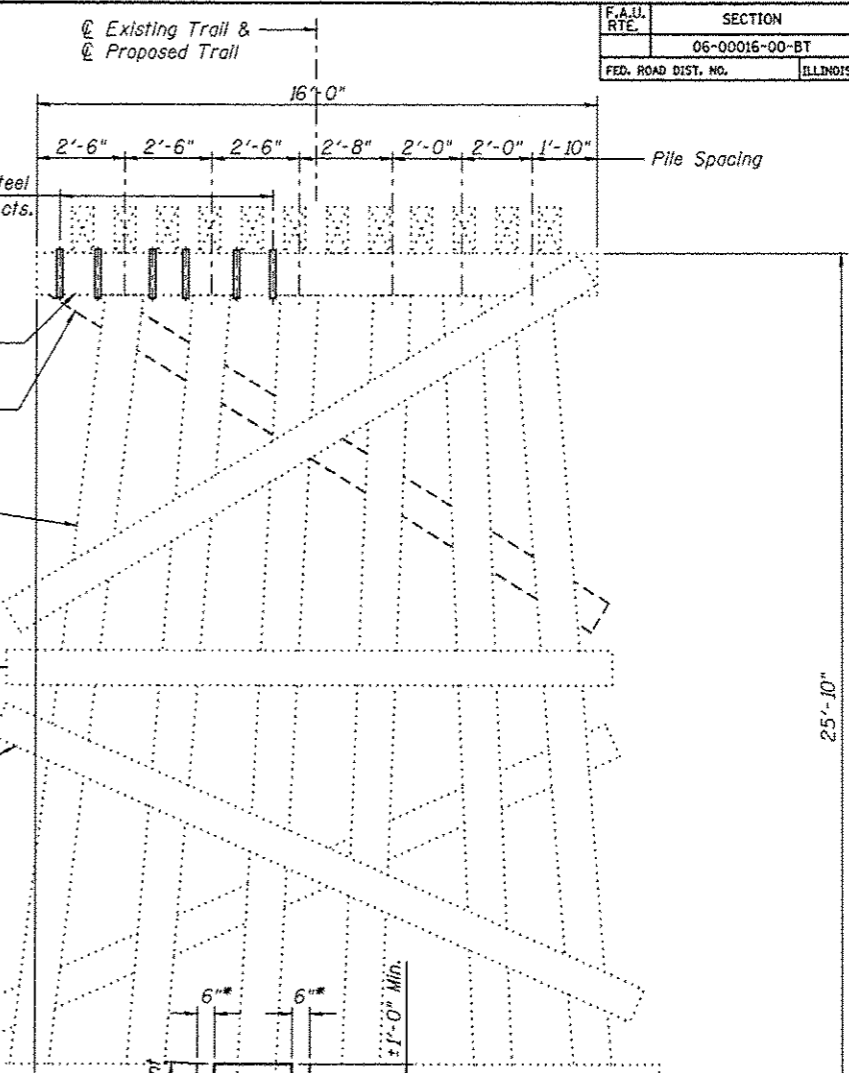
**PIER 3**  
(Looking East)

Concrete Encasement shall extend above and below the damaged area of the pile a minimum of 1'-0".

Item	Unit	Quantity
Concrete Encasement	Cu Yd	0.5
Stainless Steel Bands	Foot	28

\* Existing timber bracing that interferes with the Concrete Encasement shall be removed a max distance of 6" beyond the face of the pile encasement. Cost included with Concrete Encasement.
