Contract Number: 62956

PARTIAL PLANS
SUGGESTED BEAM STRAIGHTENING METHODS

BEAM STRAIGHTENING DETAILS

F.A.I. RT. 90/94
COOK COUNTY
SN 016-0478

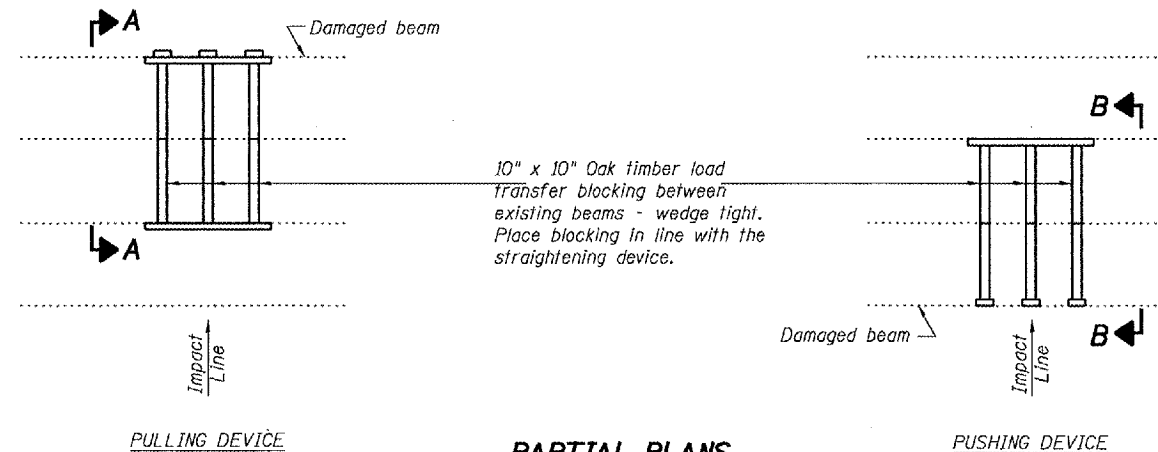
EXISTING DEFORMATION TO BE STRAIGHTENED

(Looking West)
(Approximate max. deflections)
Deflected length of beam to be straightened is approximately 7'-6".

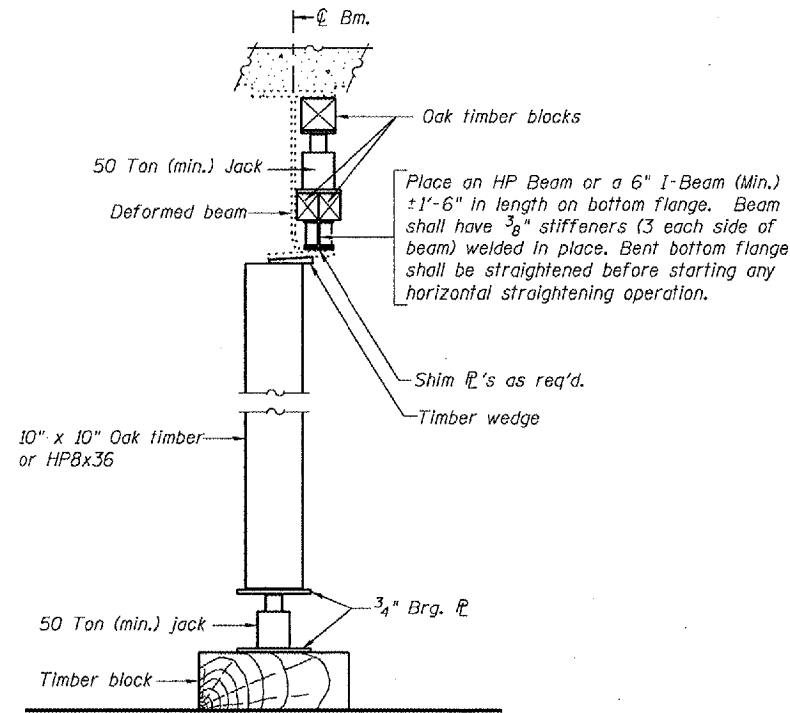
SUGGESTED VERTICAL STRAIGHTENING DETAIL
(To correct flange rotation.)

Straightening force shall be maintained on all load transfer blocking during beam straightening.

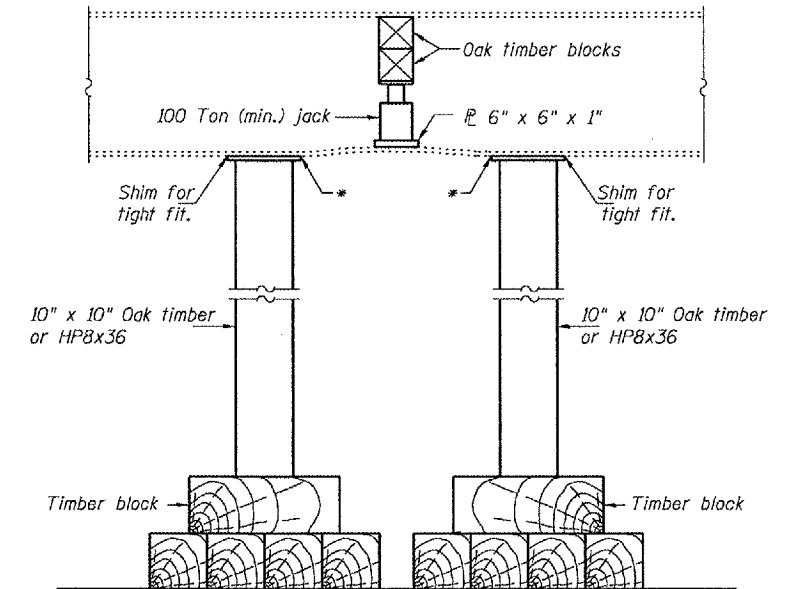
SUGGESTED VERTICAL STRAIGHTENING DETAIL
(To correct localized vertical flange deformations.)

* Edge of plate shall line up with edge of deformation.

Note:
Braces and jack assembly shall be placed on same side of web.
Bent bottom flange shall be straightened before starting any horizontal straightening operations.
