ROUTE NO.	SECTION	COUNTY	TOTAL SHEETS	SHEET NO.
FAP 68	101BR	LIVINGSTON	47	26
STA.	TO STA.			
	ILLINOIS		FED. AID PROJECT-	
DWG. NO. 12 OF 17

SOUTH ABUTMENT
IL 23 OVER PRAIRIE CREEK
FAP ROUTE 68 - SECTION 101BR
LIVINGSTON COUNTY
STATION 280+55.00
STRUCTURE NO. 053-0153

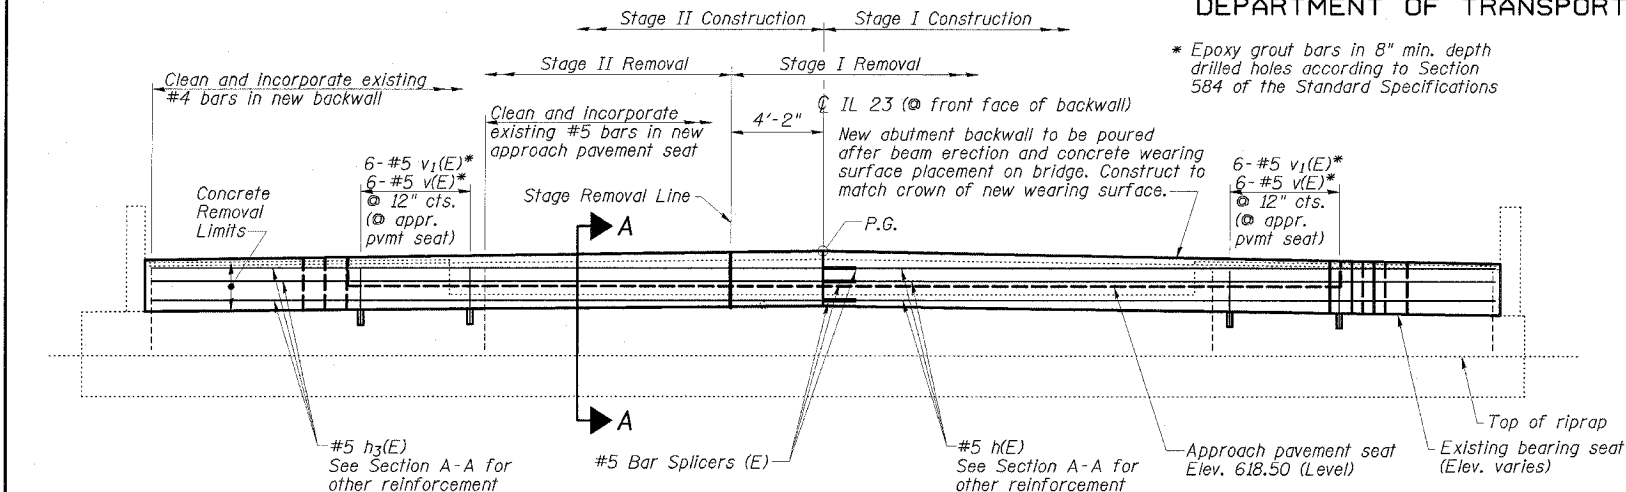
ELEVATION
Backwall Repairs

NOTE: ABUTMENT CRACK REPAIR LENGTHS AND FORMED CONCRETE REPAIR AREAS ARE ESTIMATED FROM 3-31-05 SURVEY WORK. ACTUAL LOCATIONS AND QUANTITIES OF REPAIRS SHALL BE SHOWN BY THE ENGINEER ON THE AS-BUILT PLANS FOR THIS SECTION.
