STATE OF ILLINOIS
DEPARTMENT OF TRANSPORTATION

ABUTMENT REPAIRS
WESTBOUND FAI-80 OVER HICKORY CREEK
STRUCTURE NO. 099-0063

SHEET NO. S-4 OF 8 SHEETS

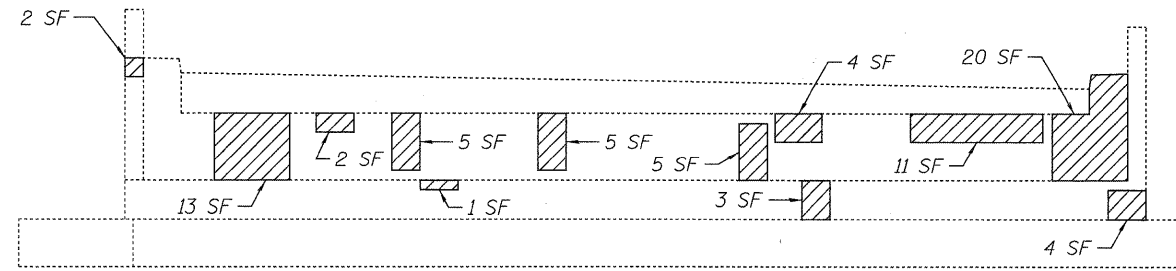
ELEVATION - NORTHWEST ABUTMENT
Looking West

ELEVATION - SOUTH WINGWALL
Outside Face

ELEVATION - NORTH WINGWALL
Outside Face

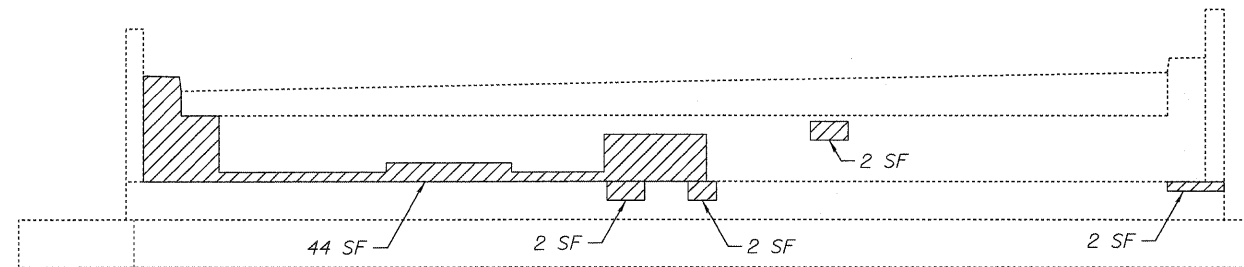
ELEVATION - NORTHEAST ABUTMENT
Looking East

ELEVATION - NORTH WINGWALL
Outside Face

ELEVATION - SOUTH WINGWALL
Outside Face
