**EROSION REPAIR AT VAULTED ABUTS.**  
SN 050-0180  
FAP ROUTE 68 (IL 23)  
OVER ILLINOIS RIVER  
SECTION (12R)-2  
LASALLE COUNTY  
STA. 805+45

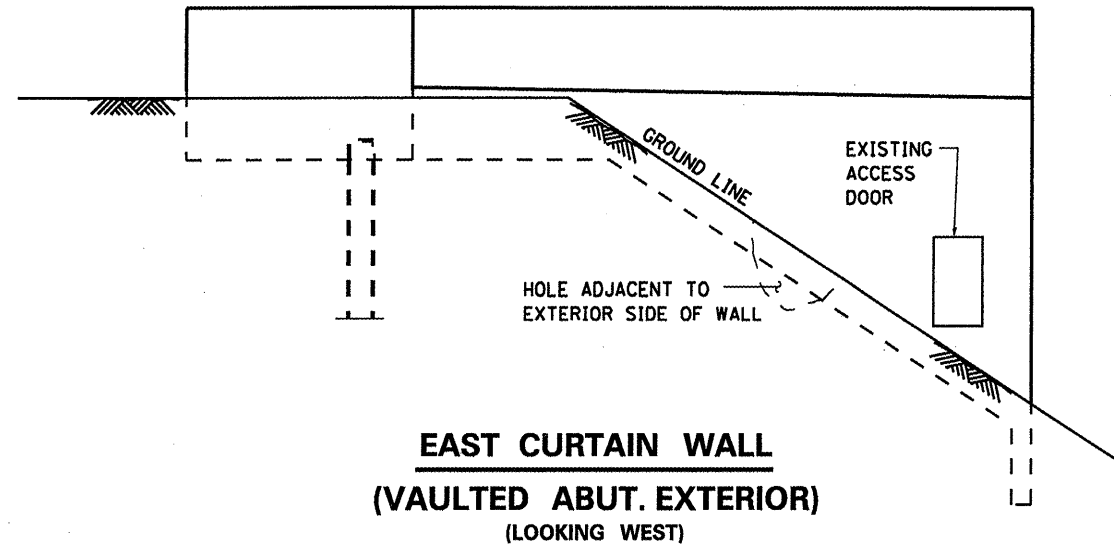
- 1) FILL INTERIOR (OF VAULT) VOIDS/EROSION WASHOUTS ADJACENT TO THE EAST CURTAIN WALL WITH CONTROLLED LOW-STRENGTH MATERIAL.
- 2) FILL EXTERIOR HOLE WITH APPROVED EMBANKMENT MATERIAL. REQUIRED EMBANKMENT MATERIAL SHALL BE INCLUDED IN THE COST OF CONTROLLED LOW-STRENGTH MATERIAL.
