**TABLE OF REPAIRS**

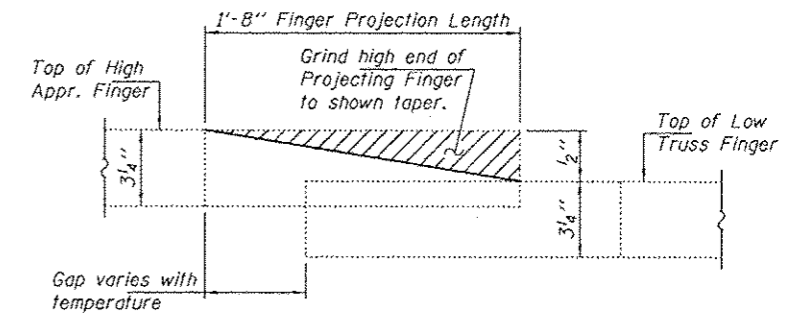
**FINGER PLATE GRINDING DETAIL**

Typical at  $\pm 90$  Fingers / 30' width  
(Cost included with Structural Steel Removal)

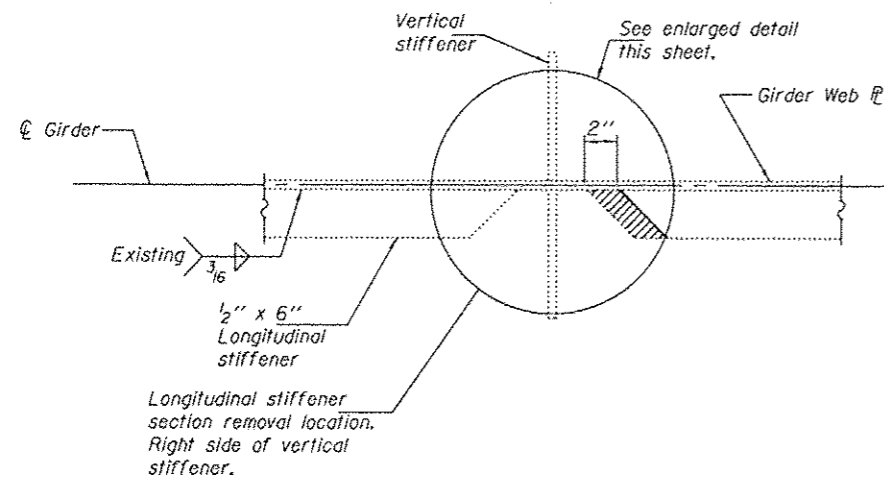
**ITEM 107 REPAIR DETAIL**

Hatched area indicates section removal.  
(Showing 1 location)
