*2004-108 BR Contract No. 62853

PLAN OF CONCRETE DECK BEAM REPAIRS
TOP VIEW

CONCRETE DECK BEAM REPAIRS
EAST FRONTAGE ROAD OVER PALATINE ROAD
FAP 305/PALATINE ROAD
SECTION 2004-108 BR
COOK COUNTY
STA. 0+88.85
STRUCTURE NO. 016-2529

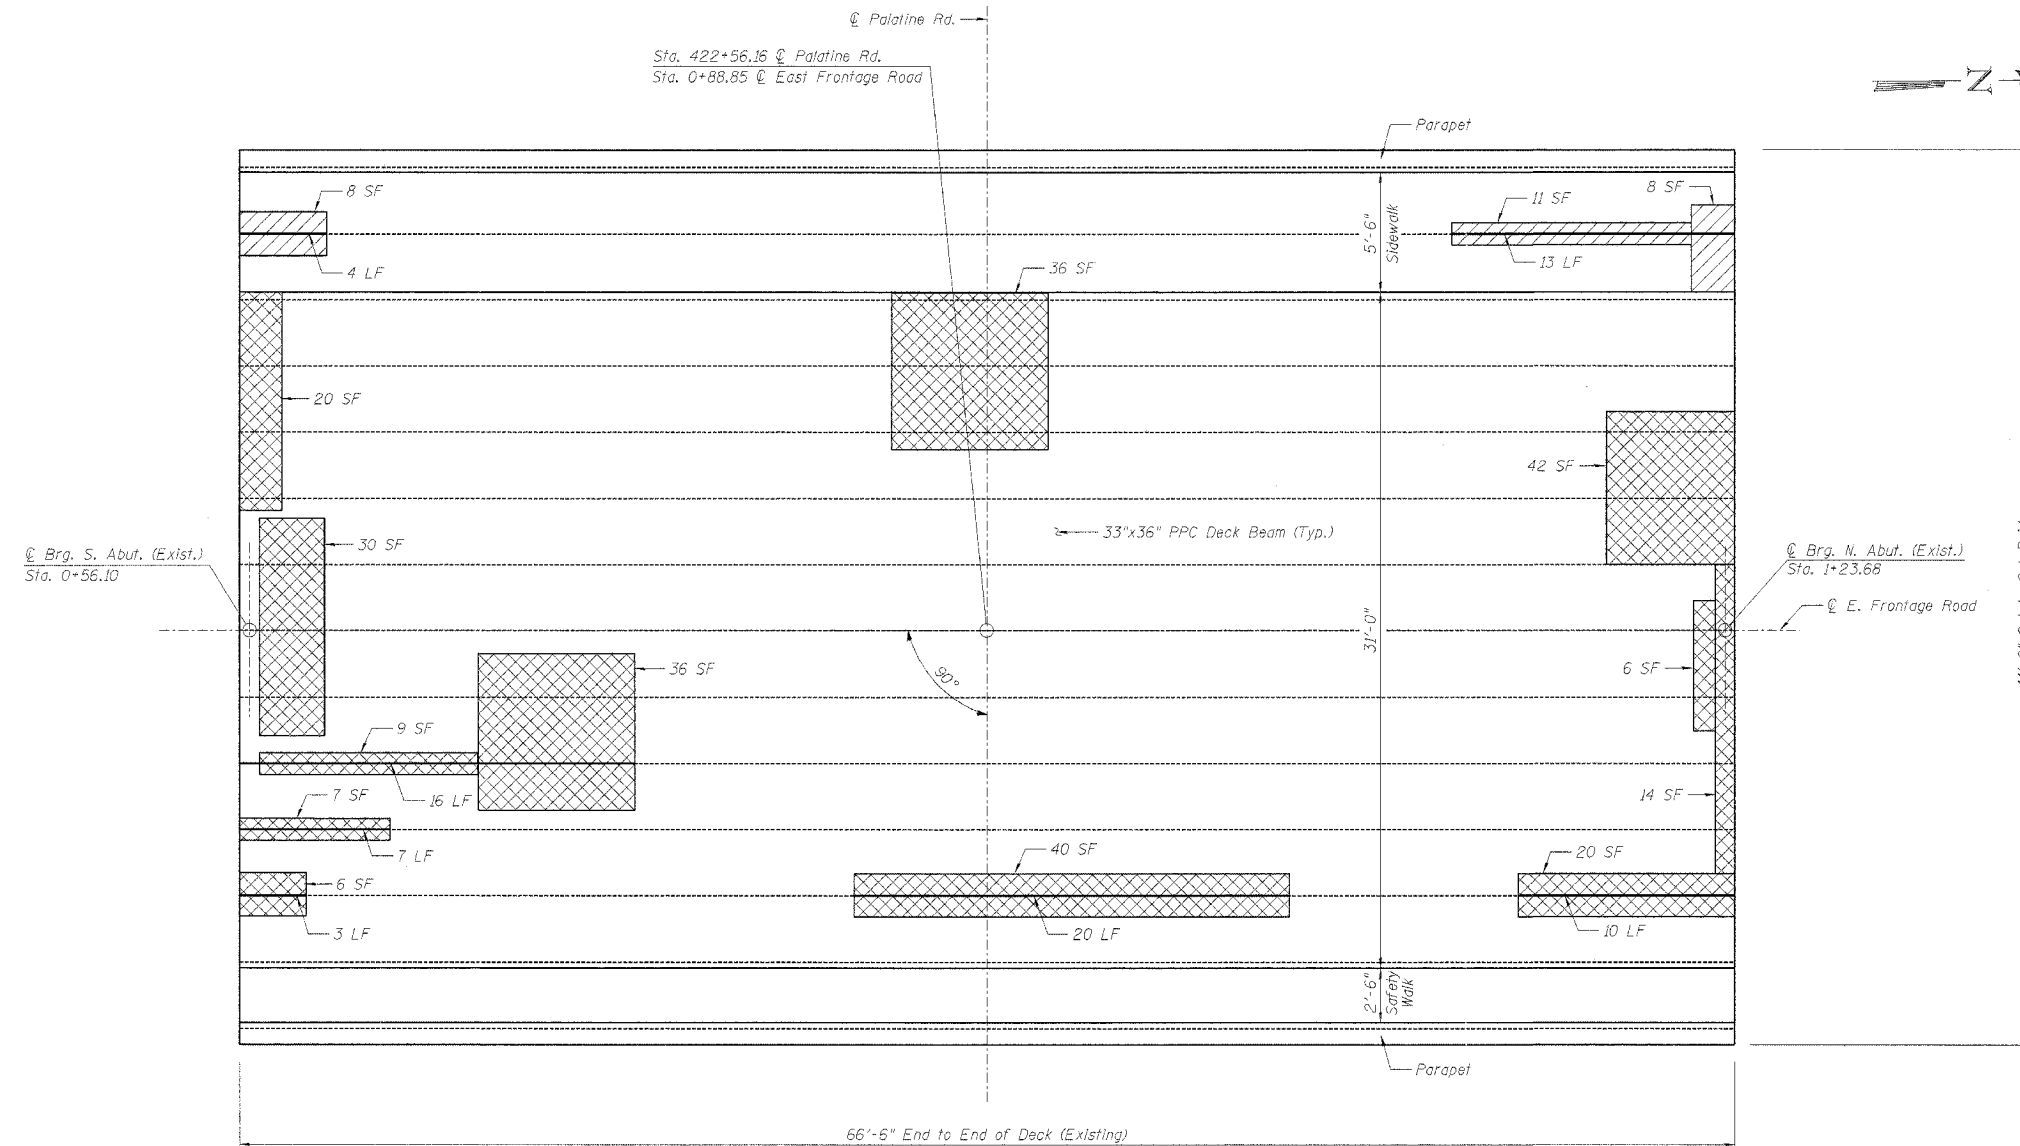
- Surveyed Area Showing Possible Delamination of Top of Beam
- Surveyed Sidewalk Area Requiring Full Depth Repair
- Surveyed Length of Keyway Repair

Repair areas shown are the surveyed areas of deterioration. The actual area to be repaired shall be as directed by the Engineer.

Contractor must exercise extreme care while doing sidewalk repairs so as not to damage the PPC Deck Beams.

Surveyed areas that show possible delamination should be investigated after removal of the bituminous overlay. Any areas with delamination extending to the top mat of reinforcement on the beam shall be cleaned of any loose concrete and filled back up with the concrete overlay. Any area where the damage extends below the top mat of reinforcement on the beam shall be brought to the attention of the Bureau of Bridges and Structures for further disposition. Work included in the cost of "Concrete Wearing Surface."
