STATE OF ILLINOIS
 DEPARTMENT OF TRANSPORTATION

REPAIR DETAILS
 SN 010-0146

F.A.I. RTE.	SECTION	COUNTY	TOTAL SHEETS	SHEET NO.
72	410-TIMBIBOR,BJR	CHAMPAIGN	14	8
CONTRACT NO. 70865			ILLINOIS FED. AID PROJECT

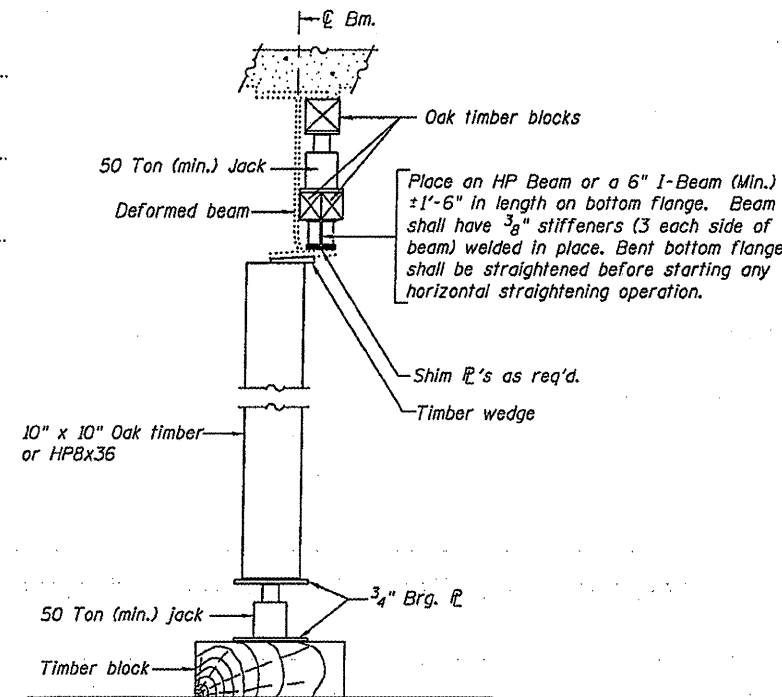
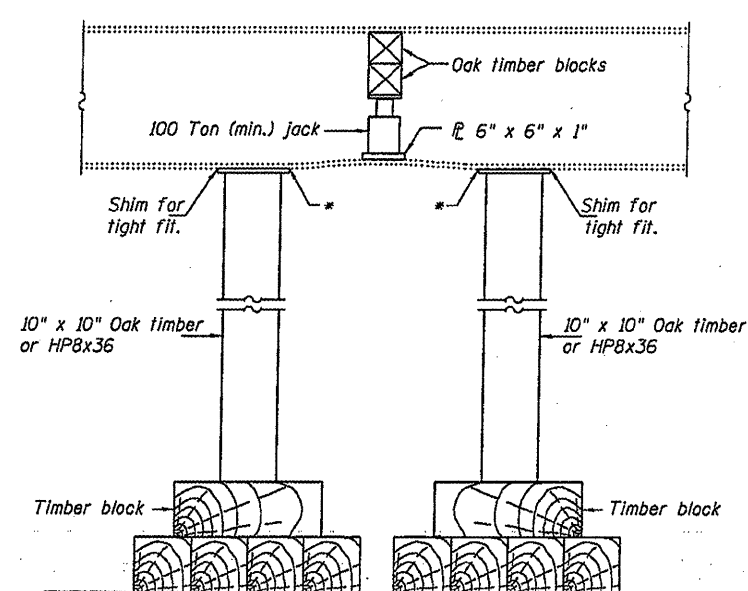
PARTIAL PLANS
SUGGESTED BEAM STRAIGHTENING METHODS
 Straightening force shall be maintained on all load transfer blocking during beam straightening.

* Edge of plate shall line up with edge of deformation.
 Note:
 Braces and jack assembly shall be placed on same side of web.
 Bent bottom flange shall be straightened before starting any horizontal straightening operations.
