**STRUCTURE REPAIR PLAN AT FLOOR BEAMS**  
(Span 7)

**STRUCTURE REPAIR DETAILS**  
**SPAN 7**  
**VACHEL LINDSAY BRIDGE REHABILITATION**  
**LONG BAY DRIVE OVER LAKE SPRINGFIELD**  
**SPRINGFIELD, ILLINOIS**

F.A.U. RTE.	SECTION	COUNTY	TOTAL SHEETS	SHEET NO.
8003	09-00469-00-BR	SANGAMON	36	17
CITY OF SPRINGFIELD		CONTRACT NO.		
FED. ROAD DIST. NO.		ILLINOIS FED. AID PROJECT

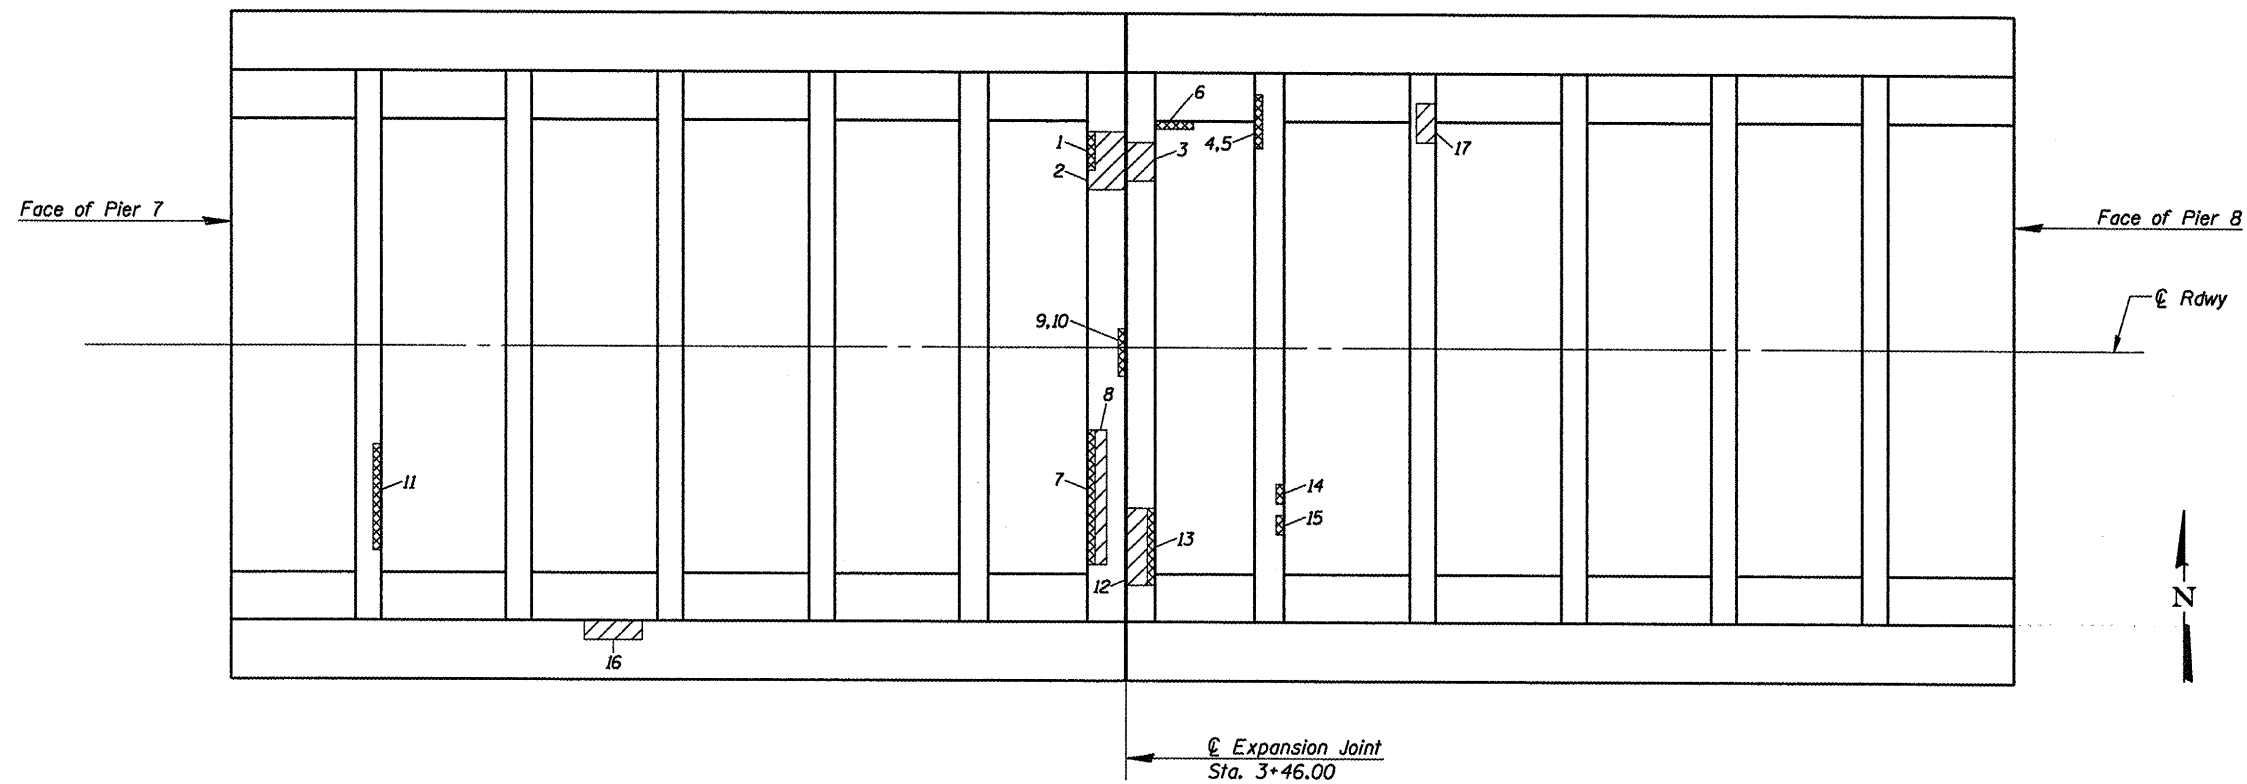
**STRUCTURAL REPAIR OF CONCRETE**  
**SPAN 7**
