**STRUCTURE REPAIR DETAILS**  
**SPAN 15**  
**VACHEL LINDSAY BRIDGE REHABILITATION**  
**LONG BAY DRIVE OVER LAKE SPRINGFIELD**  
**SPRINGFIELD, ILLINOIS**

F.A.U. RTE.	SECTION	COUNTY	TOTAL SHEETS	SHEET NO.
8003	09-00469-00-BR	SANGAMON	36	25
CITY OF SPRINGFIELD		CONTRACT NO. 93546		
FED. ROAD DIST. NO.		[ILLINOIS] FED. AID PROJECT

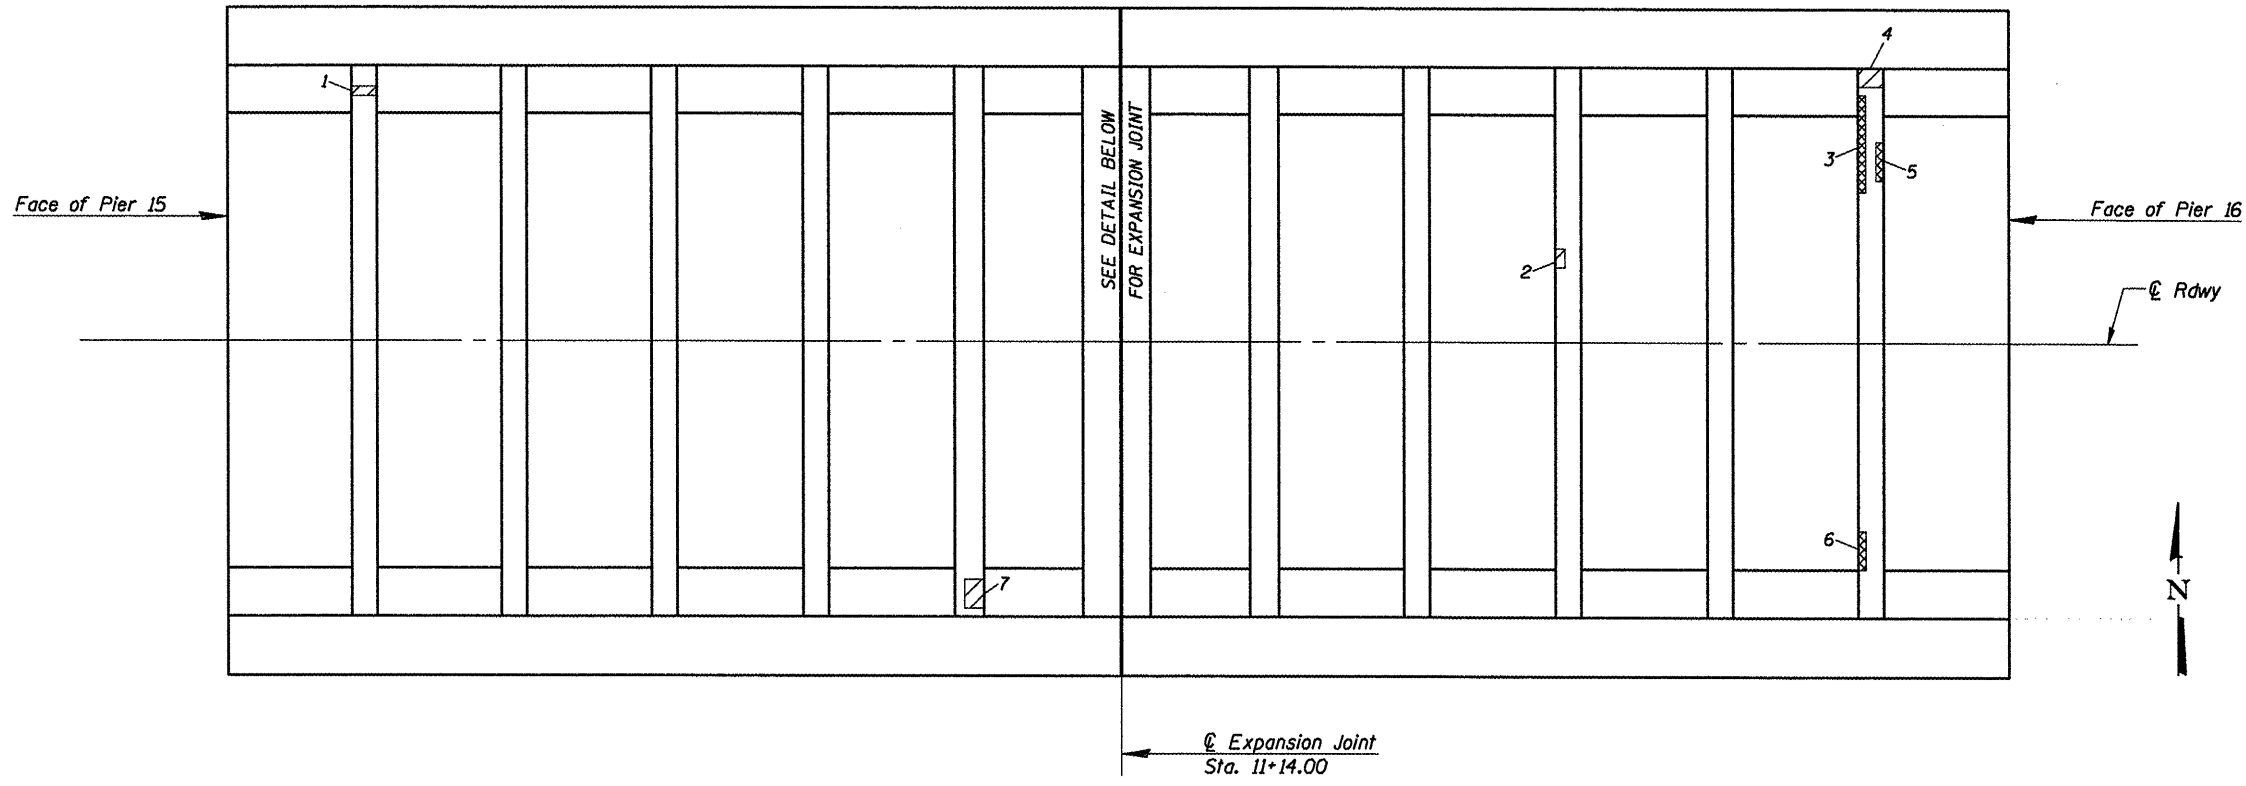
**STRUCTURE REPAIR PLAN AT FLOOR BEAMS**  
(Span 15)

Patch No.	Vert. or Horiz.	Dimensions	Area (SQ. FT.)
1	H	1.00'x0.50'	0.50
2	H	1.00'x0.50'	0.50
3	V	14.00'x1.00'	14.00
4	H	1.00'x1.25'	1.25
5	V	2.00'x1.00'	2.00
6	V	12.00'x1.00'	12.00
7	V	1.00'x1.50'	1.50
Subtotal of Vertical Repair Areas			29.50
Subtotal of Horizontal Repair Areas			2.25
Subtotal			31.75

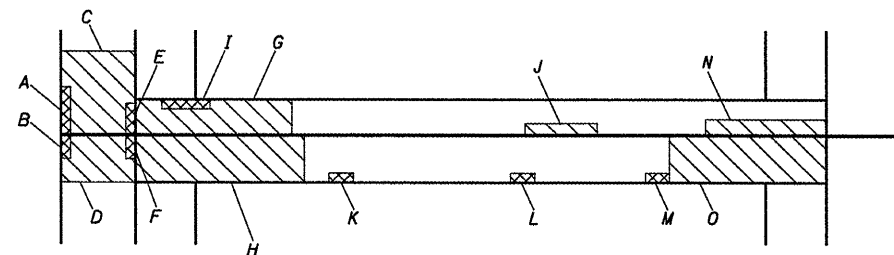
**PLAN AT EXPANSION JOINT**

Patch No.	Vert. or Horiz.	Dimensions	Area (SQ. FT.)
A	V	3.50'x2.00'	7.00
B	V	2.50'x1.00'	2.50
C	H	3.50'x1.33'	17.96
D	H	2.00'x1.33'	2.66
E	V	2.00'x1.50'	3.00
F	V	1.00'x1.50'	1.50
G	H	6.50'x1.33'	8.65
H	H	7.00'x2.00'	14.00
I	V	2.00'x1.25'	2.50
J	H	3.00'x0.50'	1.50
K	V	1.00'x1.00'	1.00
L	V	1.00'x1.00'	1.00
M	V	1.00'x1.00'	1.00
N	H	5.00'x0.67'	3.35
O	H	6.50'x2.00'	13.00
Subtotal of Vertical Repair Areas			19.50
Subtotal of Horizontal Repair Areas			61.12
Subtotal			80.62
