STRUCTURE REPAIR PLAN AT FLOOR BEAMS
(Spans 18-20)

STRUCTURE REPAIR DETAILS
SPANS 18-20
VACHEL LINDSAY BRIDGE REHABILITATION
LONG BAY DRIVE OVER LAKE SPRINGFIELD
SPRINGFIELD, ILLINOIS

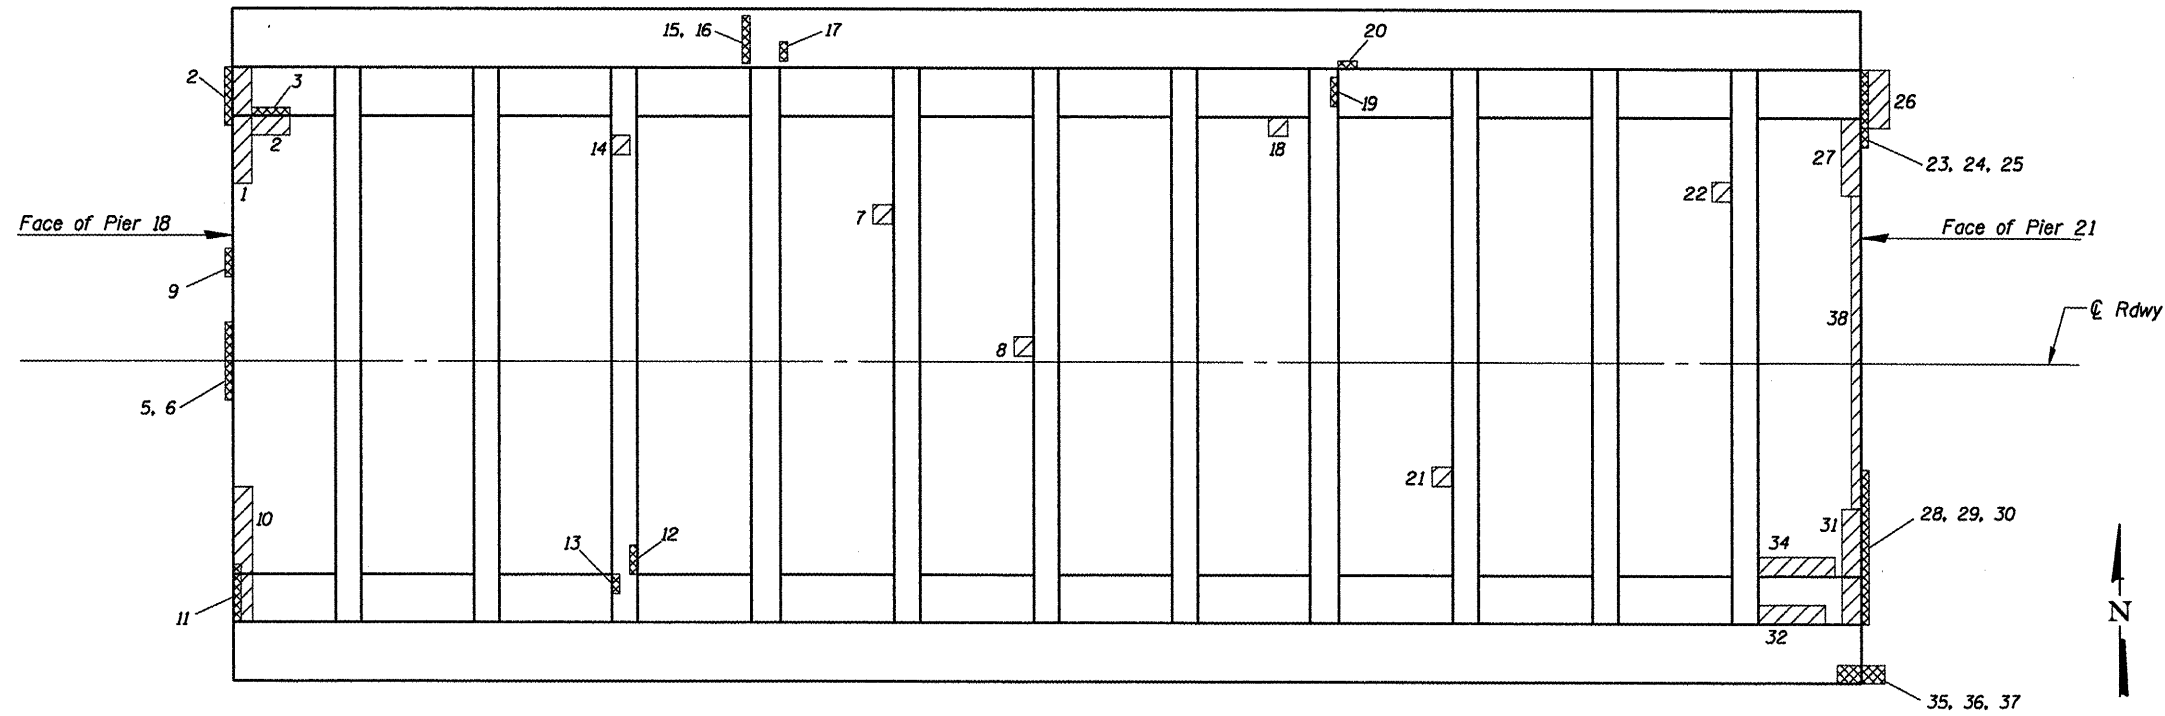
Note:
Repairs 35 and 36 are located on the column at the south side of Pier 21.
