**STATE OF ILLINOIS
 DEPARTMENT OF TRANSPORTATION**

**REPAIRS TO - PIER NUMBER 20 - COLUMNS
 STRUCTURE NO. 060-0255**

SHEET NO. 44 OF 48 SHEETS

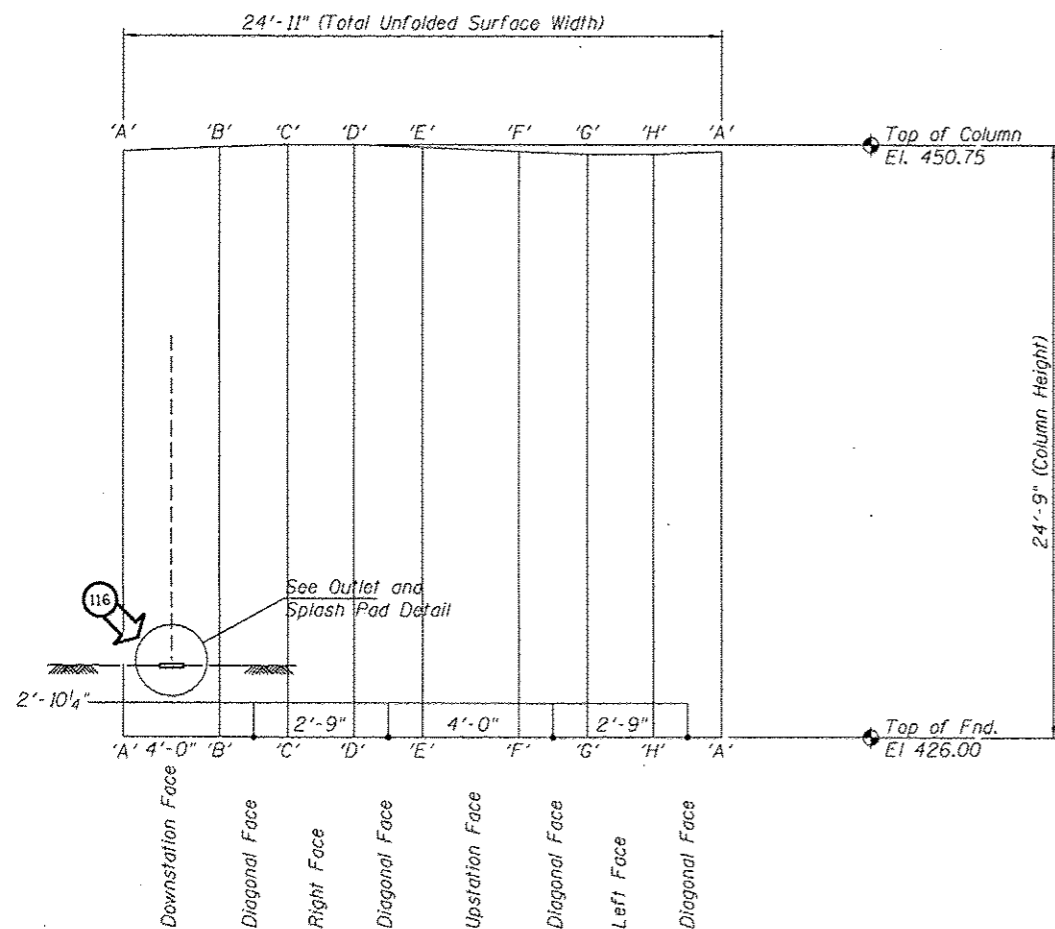
PIER NO. 20 - ELEVATION - LEFT COLUMN
 Column Surface Shown Unfolded

I.D.	Description	Pay Item	Units	Quantity
116	Erosion Under Drain Outlet	Slope Wall 6 Inch	SQ. YD.	1.78
117	Graffiti on Concrete	Graffiti Removal	SQ. YD.	19.37
-	-	-	-	-
-	-	-	-	-
-	-	-	-	-
-	-	-	-	-
-	-	-	-	-
