ROADWAY GEOTECHNICAL REPORT
SLOPE STABILITY INVESTIGATION AND STUDY
ILLINOIS 71 AT DIMMICK HILL

FAP 627 (IL 71)

Contract 66F07

April 21, 2016

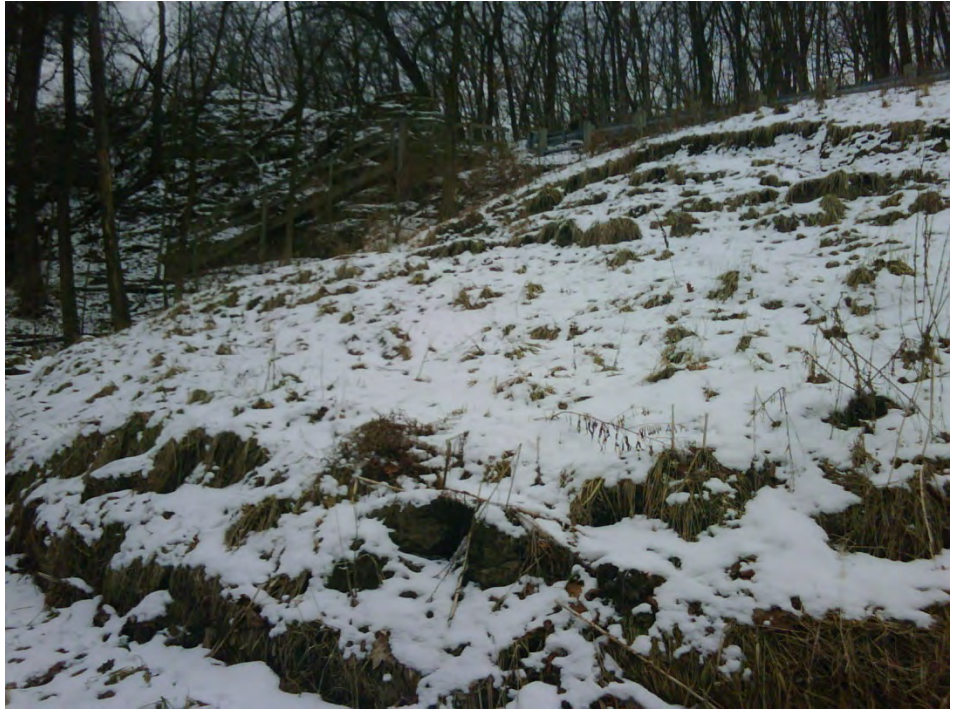
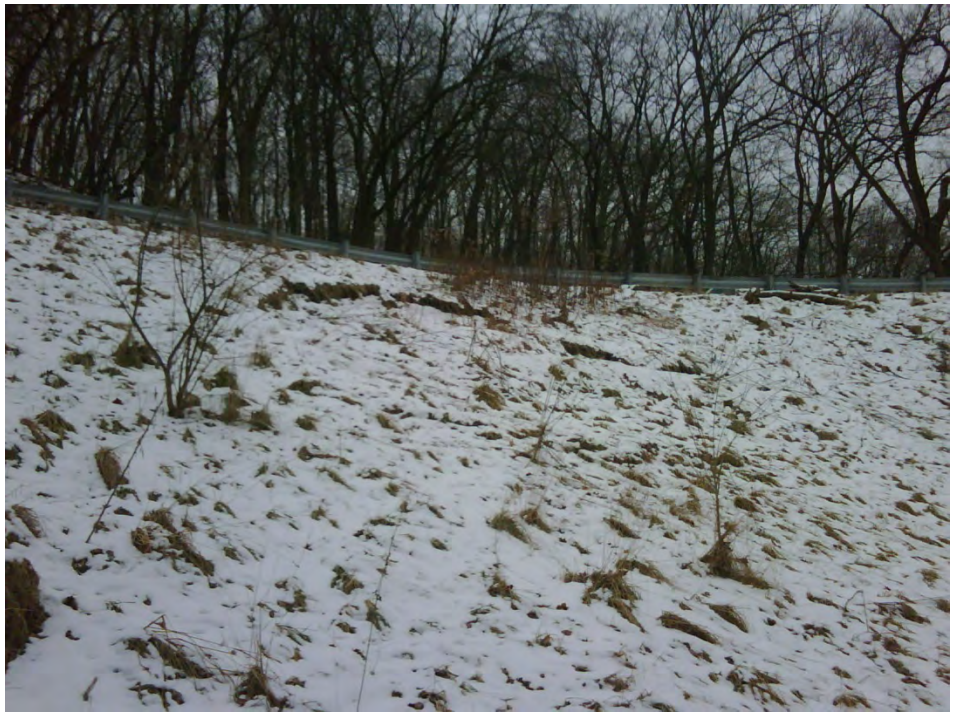
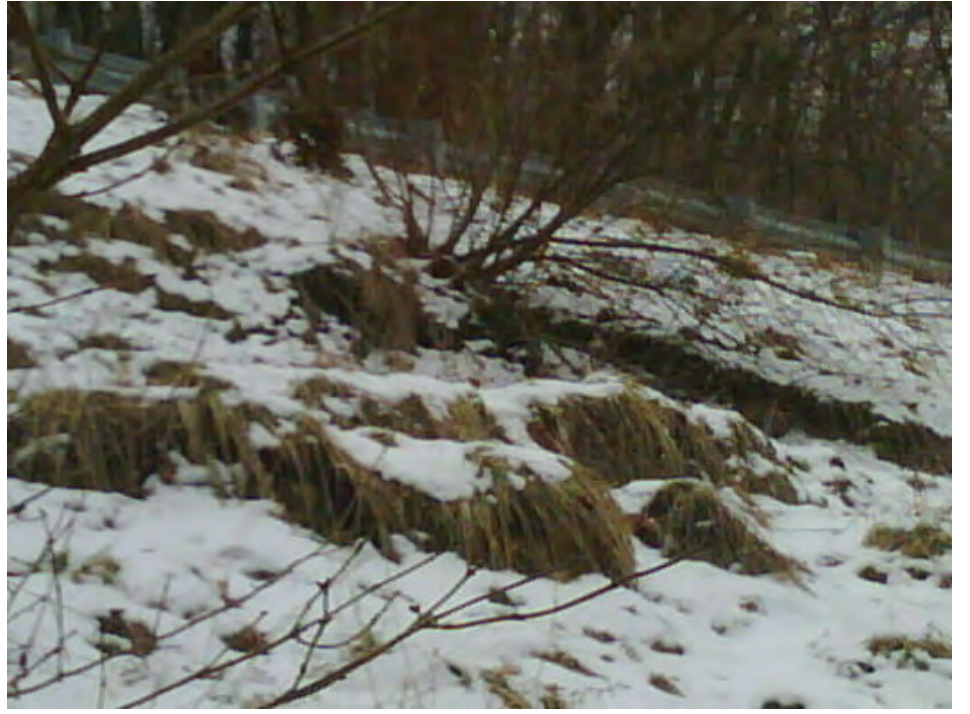
ILLINOIS 71 AT DIMMICK HILL
Field Inspection
February 4, 2010

By 2009, failure of the slope was evident by visual inspection. A field inspection was performed on February 4, 2010. Photos from this inspection are included in Appendix D-1.

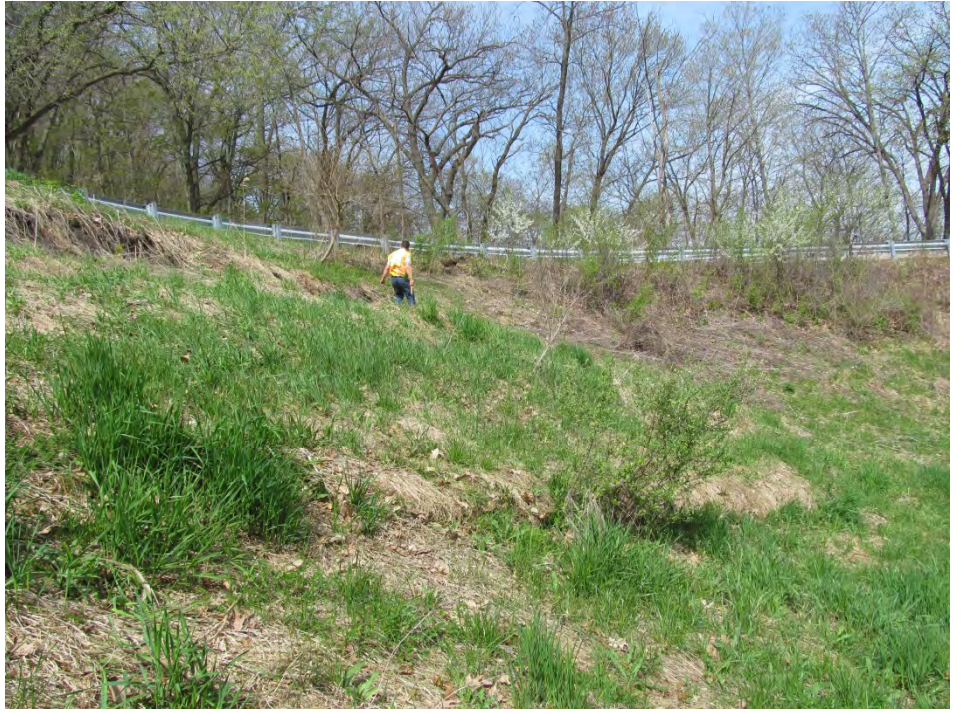
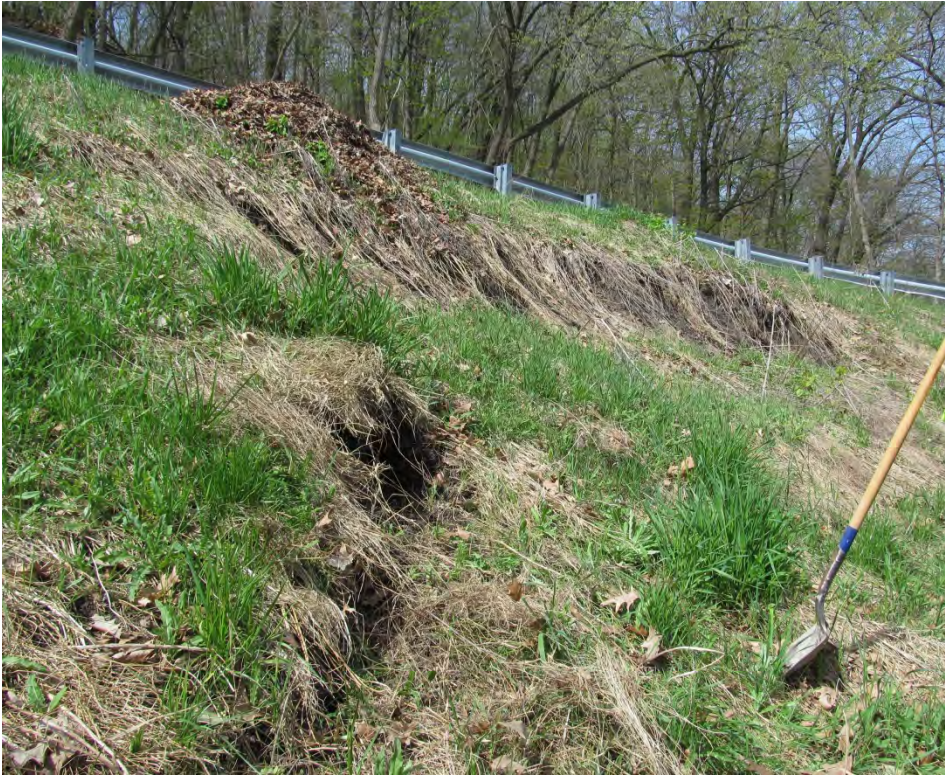
ILLINOIS 71 AT DIMMICK HILL
Field Inspection
May 5, 2014

On May 5, 2014 a field inspection was performed. Significant signs of slope failures were identified. Photos from this inspection and a drawing showing the limits of the slope failure are included in Appendix D-3.

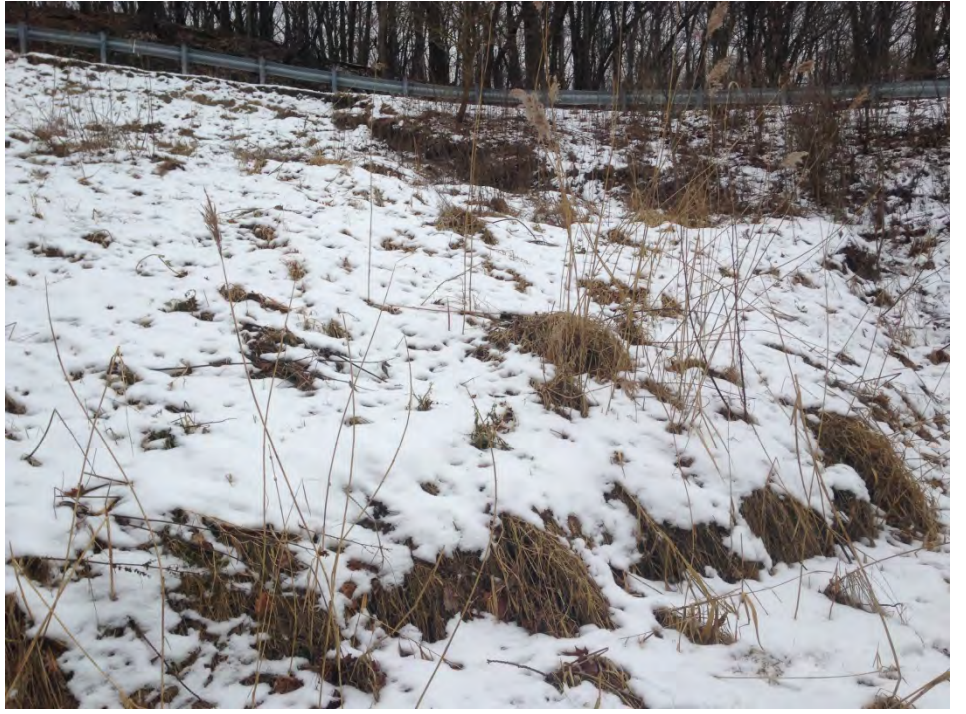
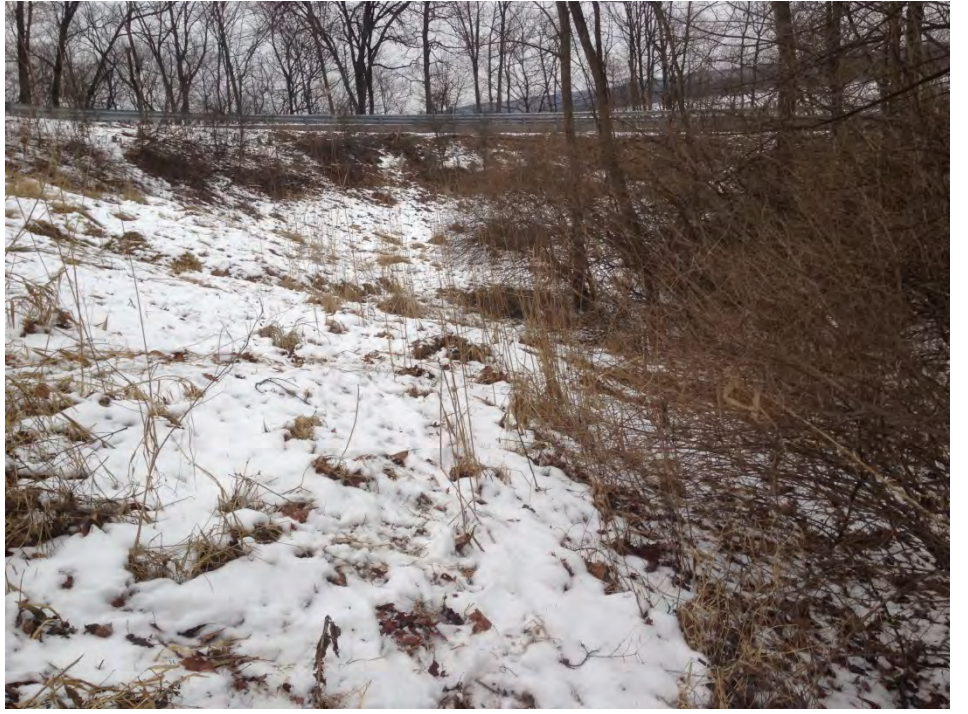
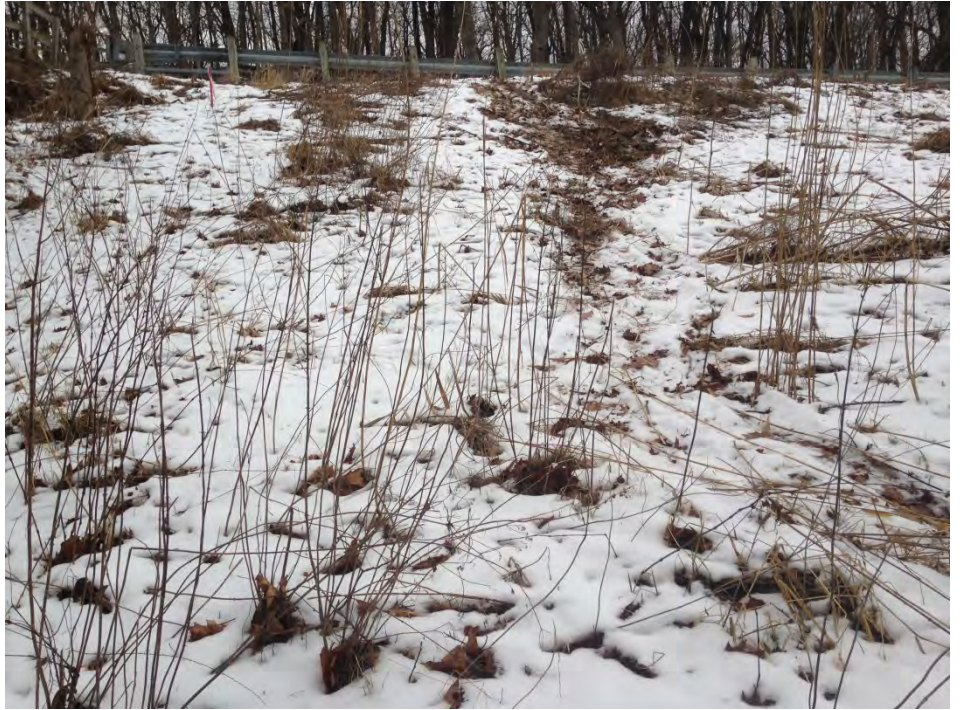
ILLINOIS 71 AT DIMMICK HILL
Field Inspection
January 25, 2016

On January 25, 2016 a field inspection consisting DCP testing was performed. The results are discussed later in this report. In addition a drawing showing the limits of the slope failure was prepared. Photos from this inspection and the drawing showing the limits of the slope failure are included in Appendix D-7.

When DCP testing was performed in the location of the current slope failure, between 2 and 3.5 feet of material at the surface demonstrated very low resistance. The underlying material exhibited a much higher penetration resistance, which indicates the shear strength of the soil is much higher at a depth of 3.5 feet below the surface. This observation indicates that the slope failure is caused by excessive moisture and the corresponding low shear strengths in the upper 3.5 feet of the embankment.

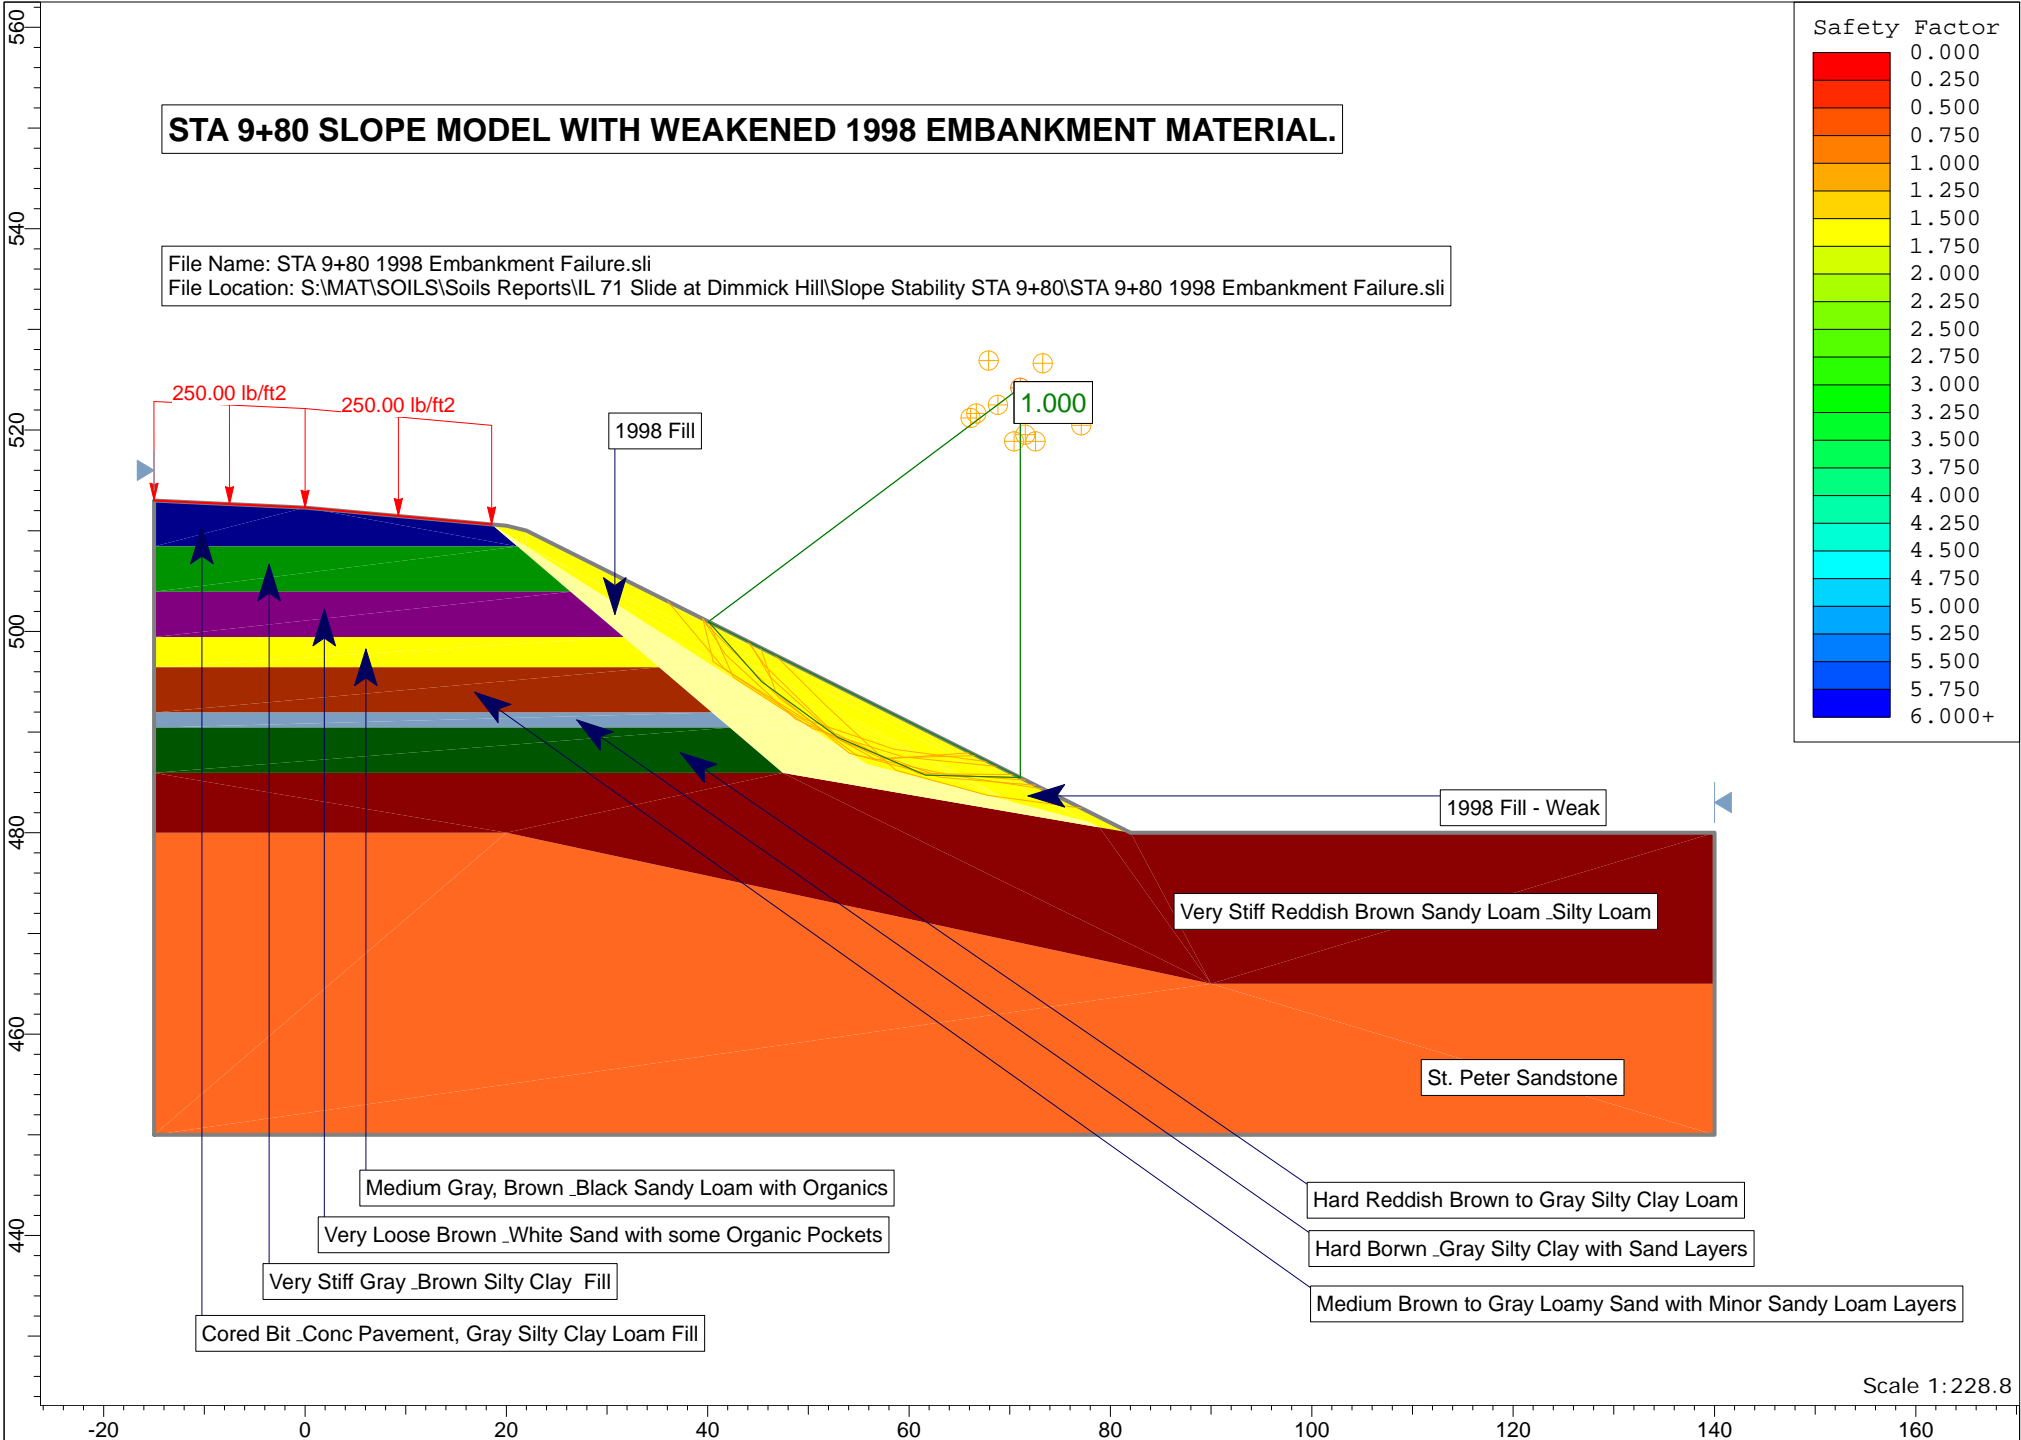
File Name: STA 9+80 1998 Embankment Failure.sli
 File Location: S:\MAT\SOILS\Soils Reports\IL 71 Slide at Dimmick Hill\Slope Stability STA 9+80\STA 9+80 1998 Embankment Failure.sli

The slope constructed in 1998 was evaluated using the Slide 5.044 software package to evaluate the conditions leading to the slope failure.

When the back analysis of the slope was performed, the cohesion of the “1998 Fill – Weak” material was originally estimated as 150 psf. Several iterations of the analysis were performed until the Factor of Safety was equal to 1.0. The corresponding value of cohesion was 129 psf for both a circular failure surface and for a non-circular failure surface. Since the soil is assumed to be saturated, the cohesion is equal to the shear strength. The shear strength value of 129 psf is reasonable when compared to the estimated values predicted using the two methods outlined above.
