SUBSTRUCTURE REPAIR DETAIL

SN 098-0051 NORTH ABUTMENT (LOOKING NORTH)

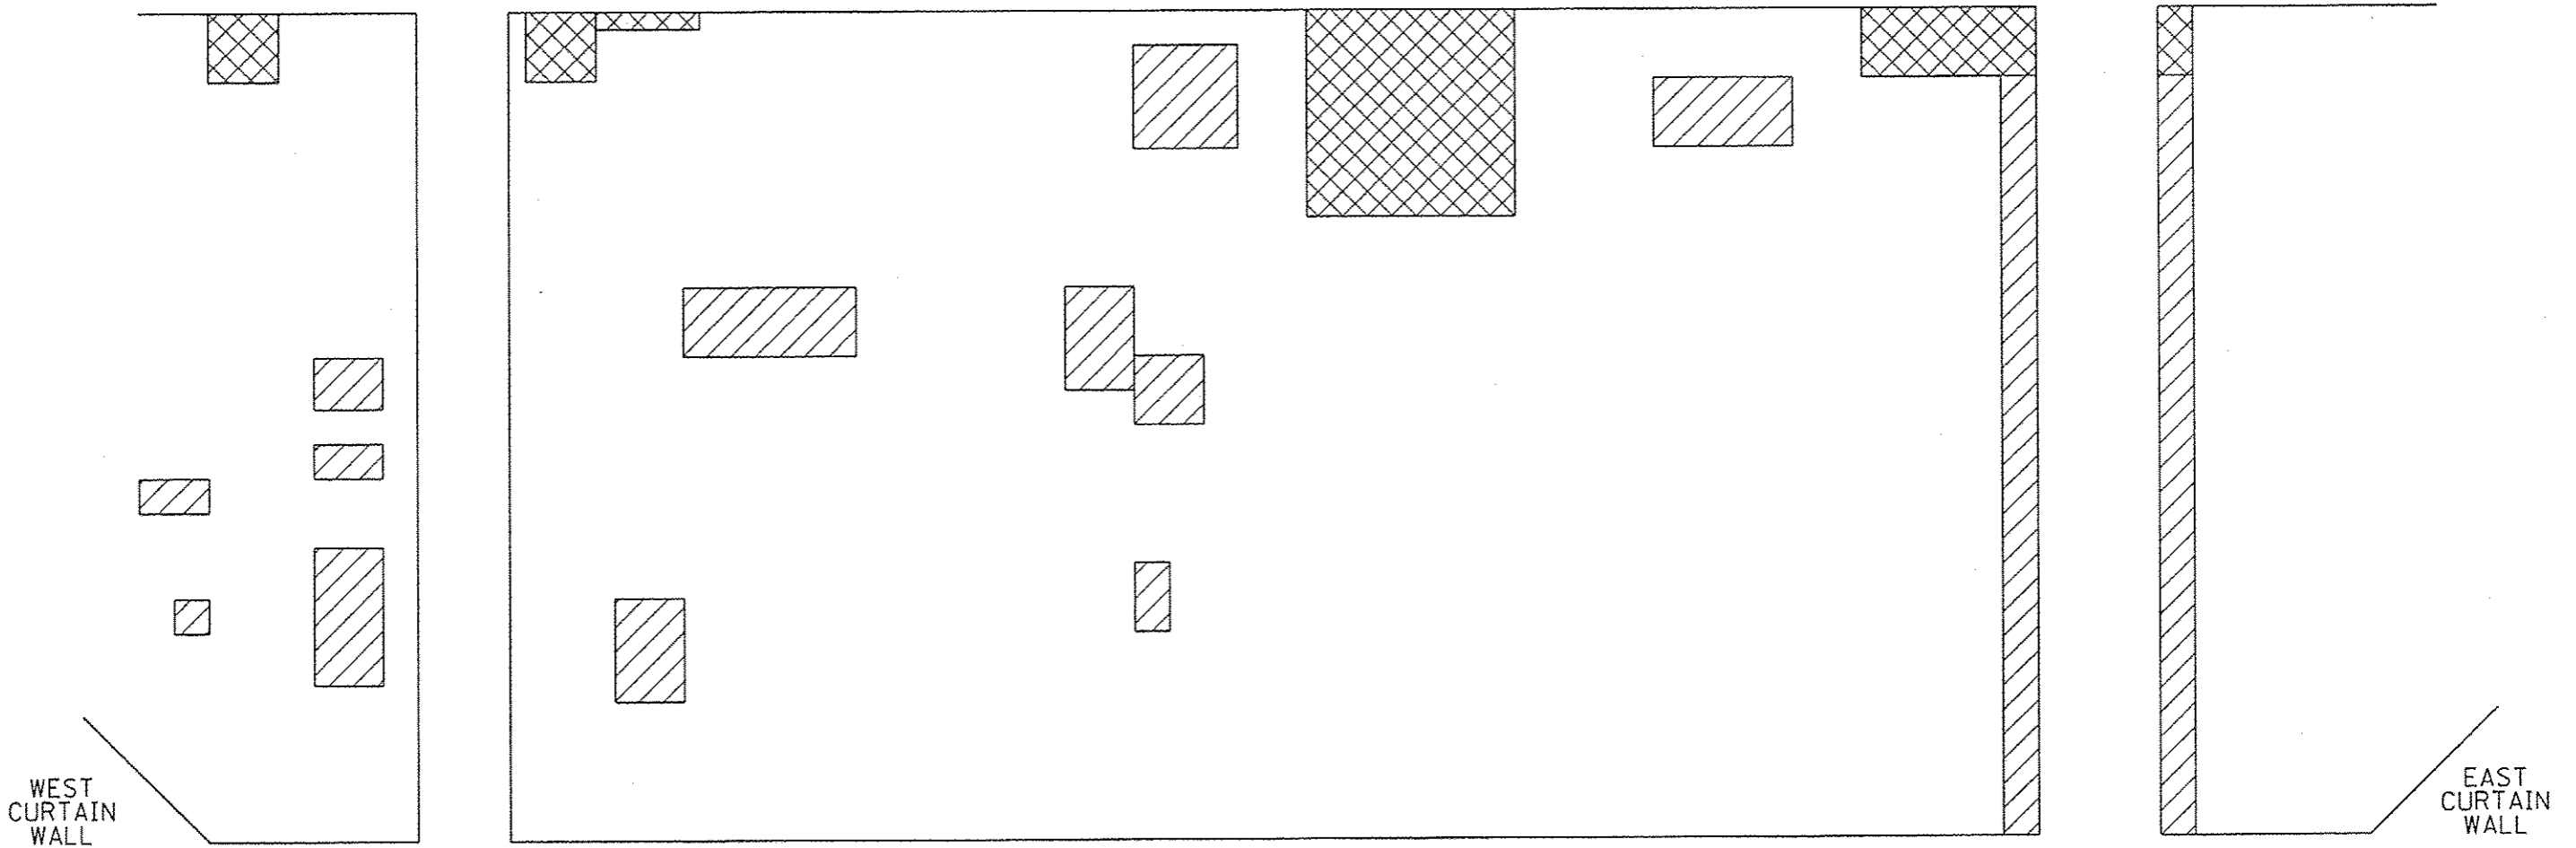
SN 098-0051
NORTH ABUTMENT (LOOKING NORTH)

(*) THIS IS AN ESTIMATED QUANTITY. THE ACTUAL LOCATION OF DELAMINATED AREAS AND QUANTITIES WILL BE DETERMINED BY THE RESIDENT ENGINEER IN THE FIELD.
