STATE OF ILLINOIS
DEPARTMENT OF TRANSPORTATION

MAIN SPANS FLOORBEAM WEB REPAIRS - 12
S.N. 082-6001 MLK BRIDGE OVER MISSISSIPPI RIVER

SHEET NO. S76 OF S138 SHEETS

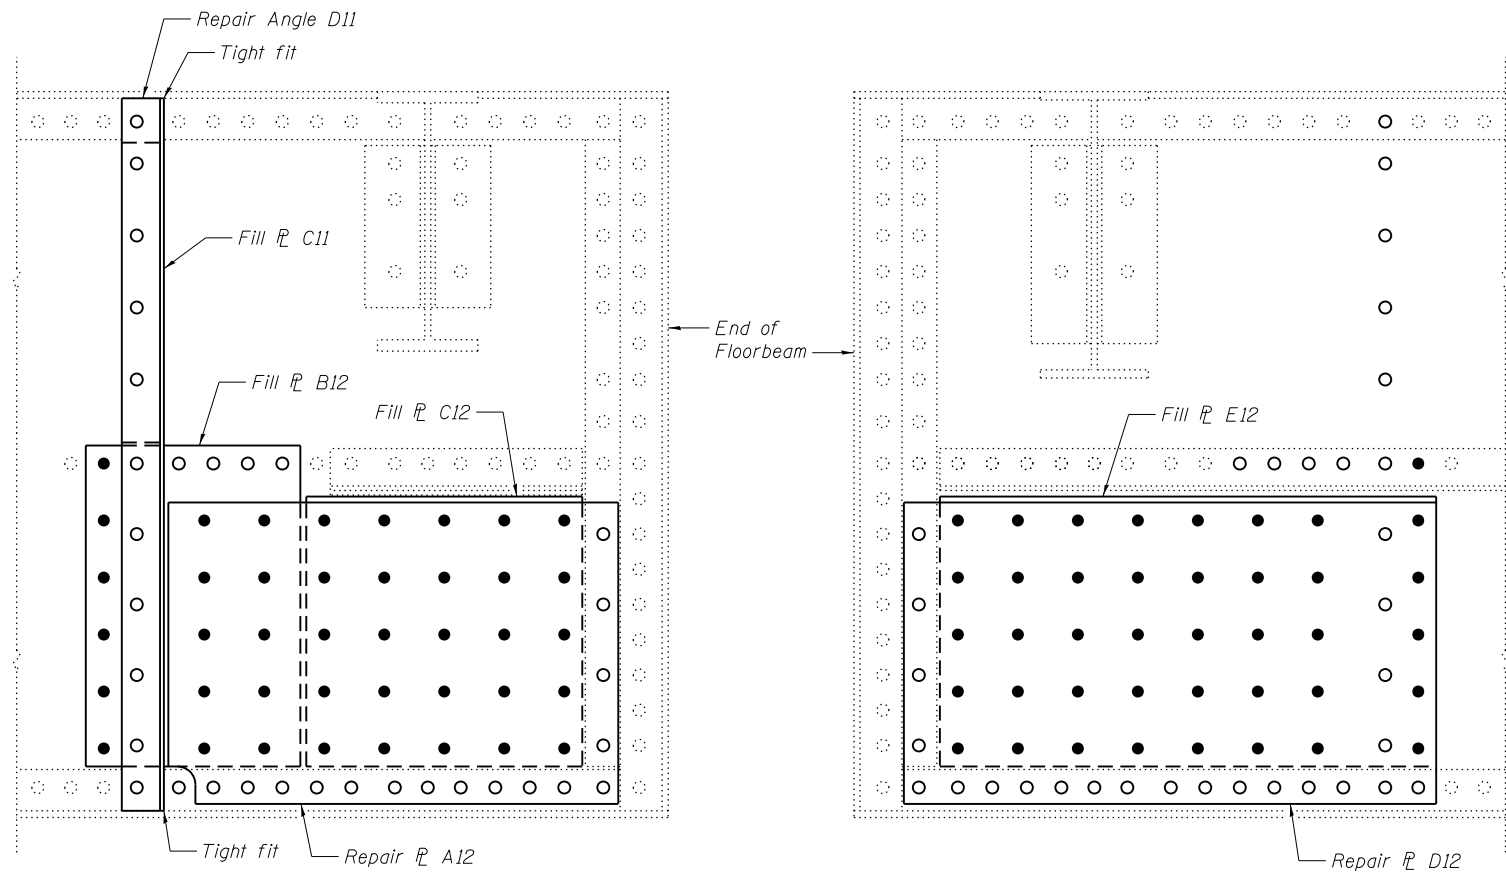
NORTH END AT PANEL POINT L6'
EAST FACE
(Span 11)

NORTH END AT PANEL POINT L6'
WEST FACE
(Span 11)

FLOORBEAM WEB REPAIRS

Note A:
Field drill holes using existing holes as template.
Remainder of holes may be shop or field drilled.
