**STATE OF ILLINOIS  
DEPARTMENT OF TRANSPORTATION**

**MISCELLANEOUS REPAIRS  
S.N. 082-6001 MLK BRIDGE OVER MISSISSIPPI RIVER**

SHEET NO. S87 OF S138 SHEETS

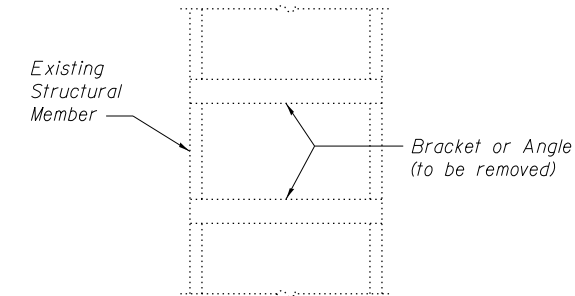
**MISCELLANEOUS STEEL REMOVAL DETAIL**

**REMOVE MISCELLANEOUS STEEL WELDED TO STRUCTURAL MEMBERS**

Notes:  
 Remove existing brackets or angles welded to the structure and grind smooth to an ANSI 250 finish. Cost of removal is included with Structural Steel Repair. See table for specific repair locations.

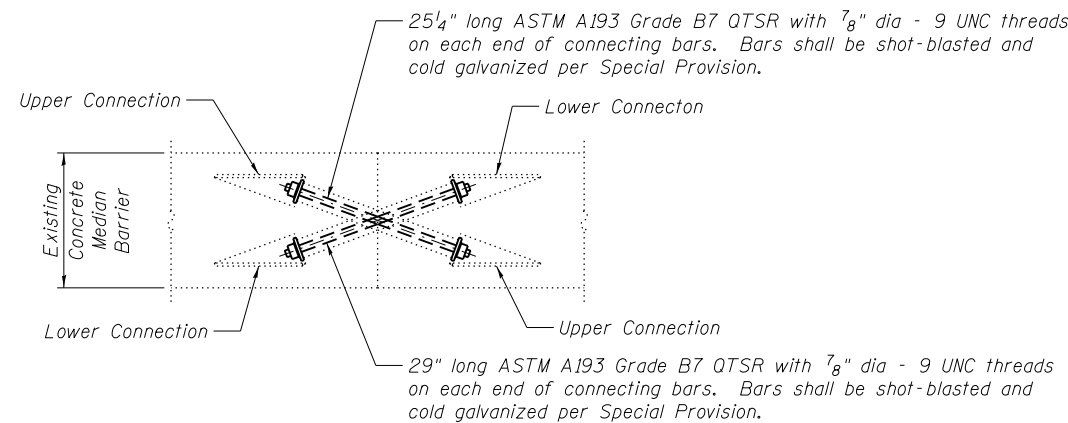
**TOP VIEW OF CONCRETE MEDIAN BARRIER SHOWING SIDE LEAVE OUTS FOR TIE RODS**

**REPLACE DEFECTIVE OR MISSING TIE RODS TO CONCRETE MEDIAN BARRIER**

Notes:  
 Replace defective tie rods and fill empty holes with 7/8" dia. tie rods (per detail) as noted in table. Additional defective or missing tie rods encountered during construction shall be replaced with 7/8" dia. tie rods (per detail) as directed by the Engineer. Cost of replacement is included with Concrete Barrier Repair.

Tie Rod Installation:  
 Torque the hardened ASTM A563 Grade D or DH heavy hex nuts, galvanized to ASTM B695 Class 55, to 50-70 Ft-Lbs. Round hardened steel washers meeting ASTM F436, galvanized to ASTM B695 Class 55, shall be placed between the cold galvanized 3"x3"x3/8" plate washer (5/16" dia. hole) and the nut. Field clean threads by stiff brush. Field apply two coats by swab of cold galvanizing compound meeting MIL-P-46105 or DOD-P-21035 to the exposed threads after nuts are torqued. Allow galvanizing to cure. Field apply an IDOT approved non-shrink grout and cure. Field apply linseed oil emulsion over grout, typ. Cost included with Concrete Barrier Repair.
