Structure Number: 016-0194 District: 1 Date: 02/21/2014
 Carried/Crossed: IL-1/CSXT RR Proposed Year of Improvement: 2014
 Inspection Date: 07/17/2013 Inspector(s): WAB Reviewed by: BKR/WAB

Remarks: 9 Span (2 Span Continuous; 5 Span Continuous; 2 Span Continuous) WF Girders. Beam 10 on North side of Pier 2 has a bearing section loss of 13.5 sq. in. due to the bearing overhanging concrete step. Piers 2 and 7 have spalling throughout their stems with some delamination in columns. Both abutments have vertical cracking.

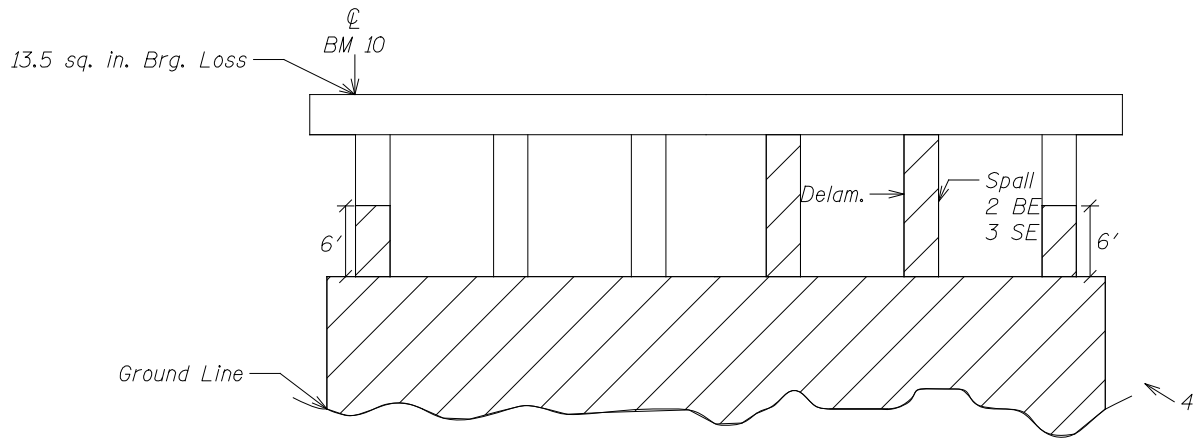
Pier 2
(Looking South)

Delamination/Scattered Spall
-

Spalling with Stirrups Exposed (SE) and/or Bars Exposed (BE)
