REVISIONS		FATIGUE RETROFIT STATE OF ILLINOIS DEPARTMENT OF TRANSPORTATION REHABILITATION AND RETROFIT REPAIRS FAI ROUTE 70 POPLAR STREET BRIDGE APPROACHES ST. CLAIR COUNTY STRUCTURE NO. 082-0142 (RAMP S) SCALE: DATE: 02/28/2006
NAME	DATE

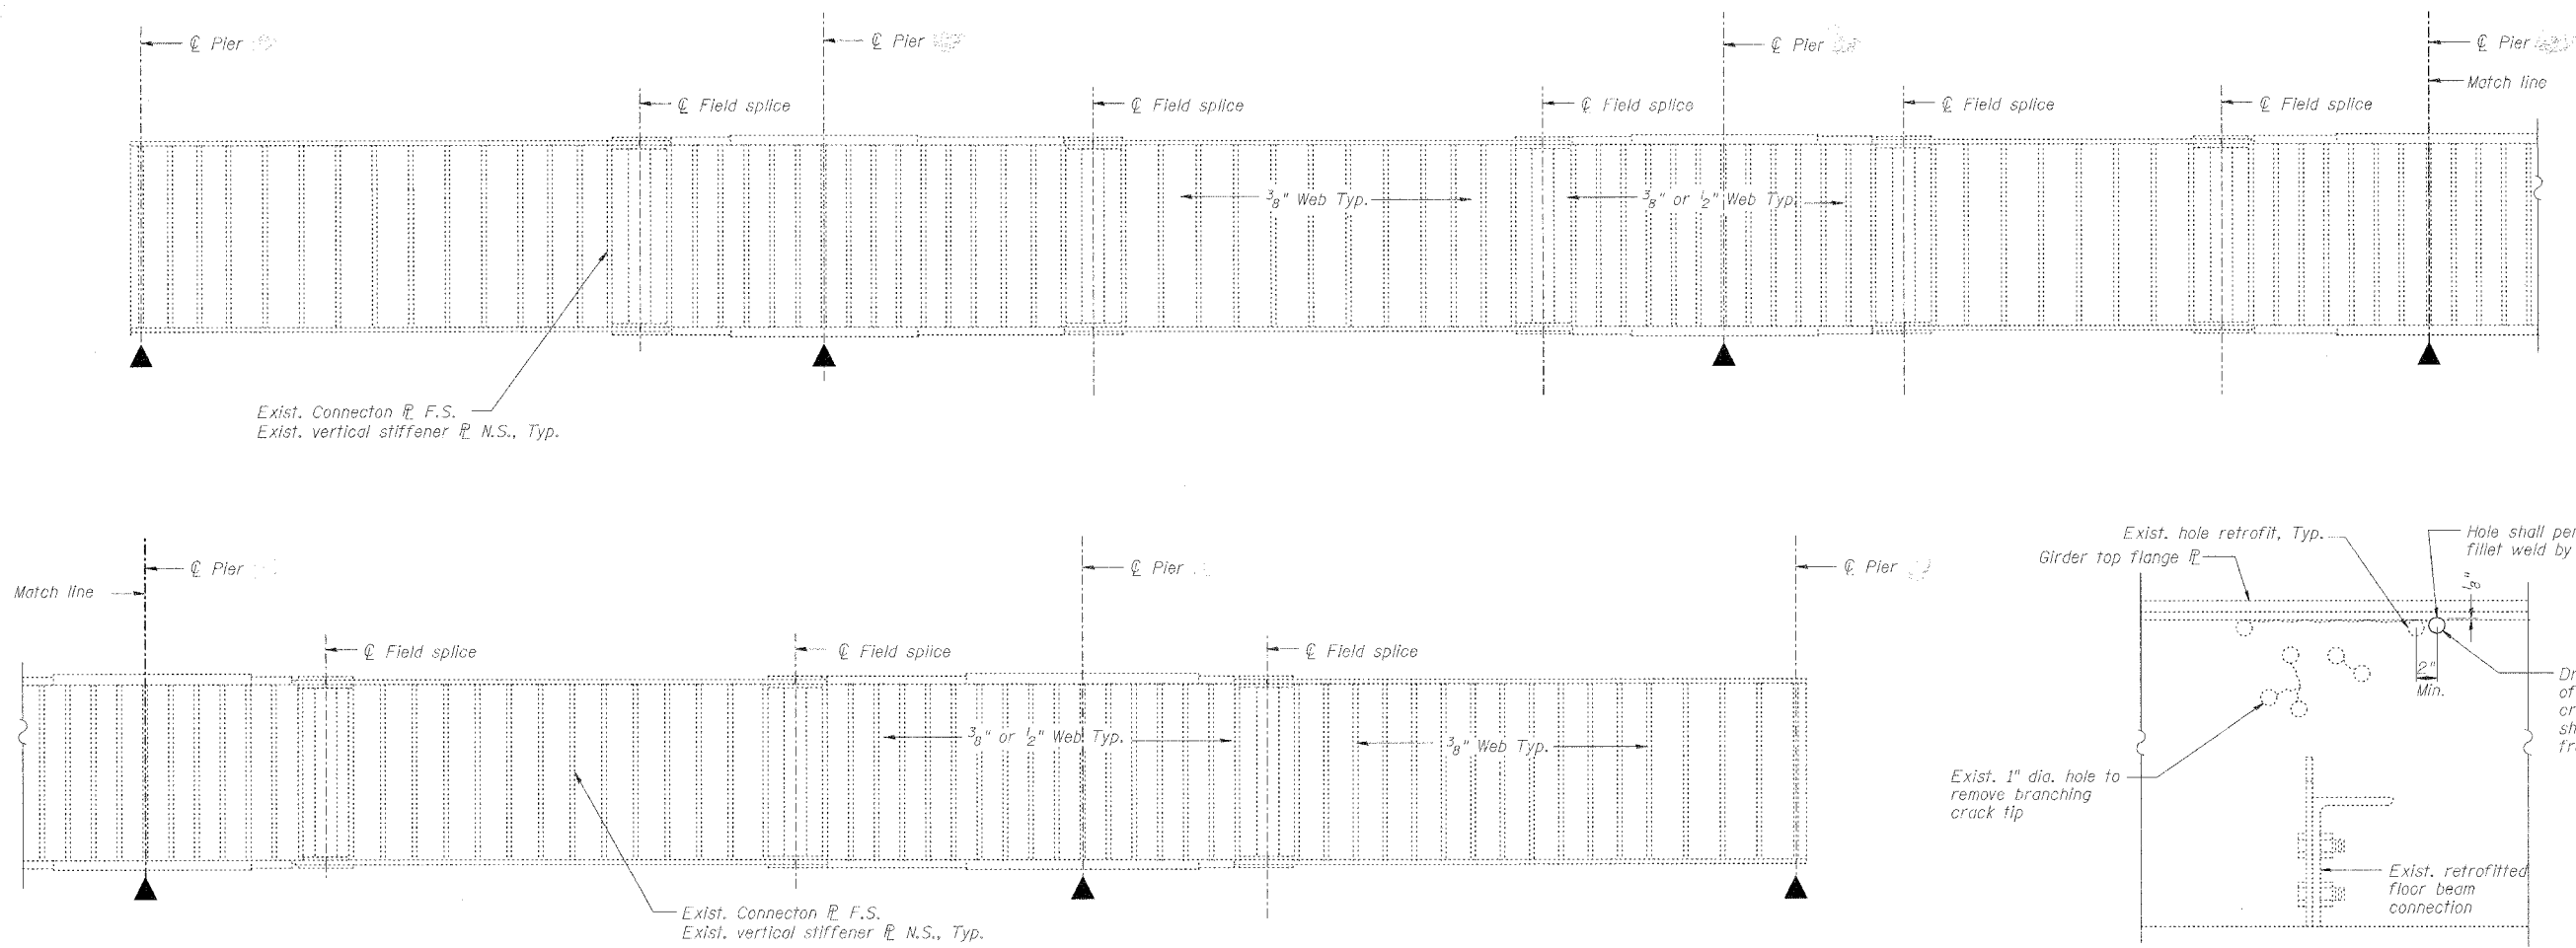
1 GIRDER 1 ELEVATION INDICATING TYPICAL FATIGUE RETROFIT LOCATIONS FOR FIVE-SPAN CONTINUOUS UNIT  
S44 GIRDER 2 - OPPOSITE HAND

Note A:  
Fatigue retrofit locations also apply to three and four-span continuous units.
