ILLINOIS DEPARTMENT OF TRANSPORTATION	
I-270 OVER MISSISSIPPI RIVER STRUCTURE NUMBER: 060-0035	
PIER 18 INSPECTION NOTES	
Drawn By: DR	Date: OCT., 2004
Checked By: ART	Scale: 1"=20'
Code: 39790012	Figure No.: 19

SHEET NO. 36	F.A.I. RTE.	SECTION	COUNTY	TOTAL SHEETS	SHEET NO.
	270	60B-I-8	MADISON	49	49
36 SHEETS			CONTRACT NO. 76A92		
FED. ROAD DIST. NO. 8 ILLINOIS FED. AID PROJECT

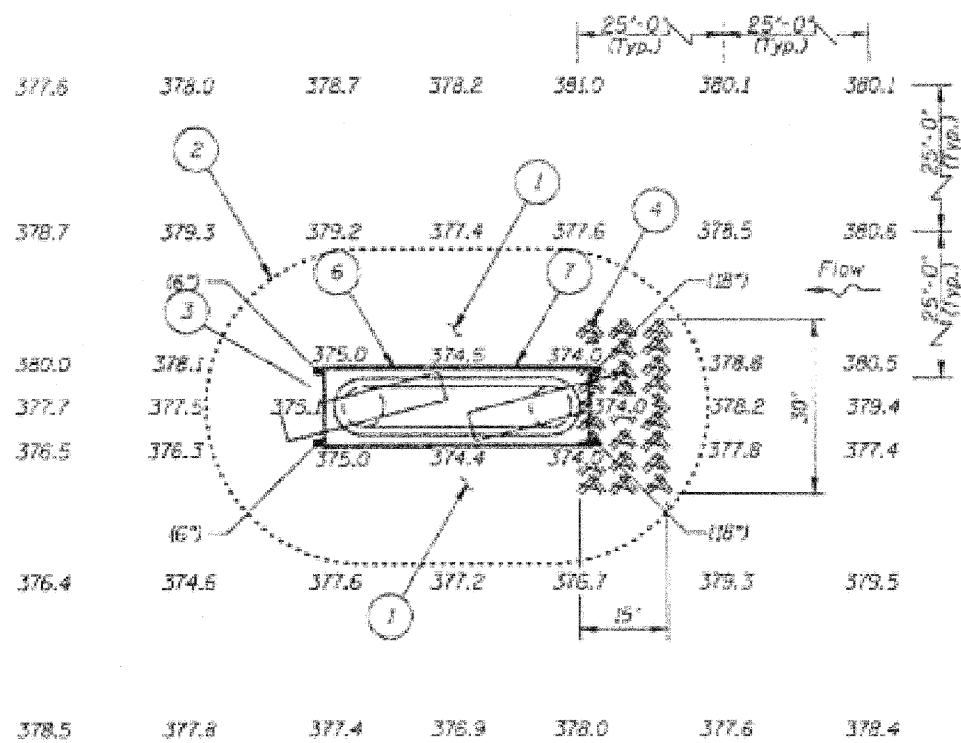
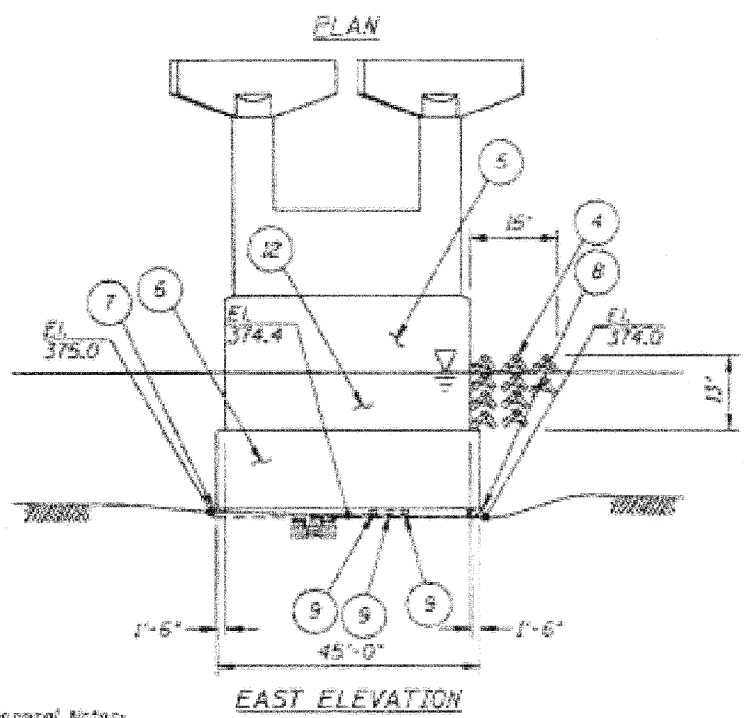
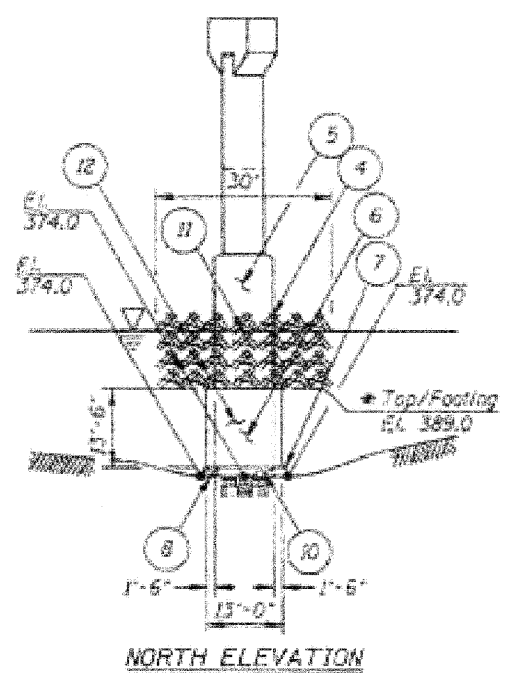
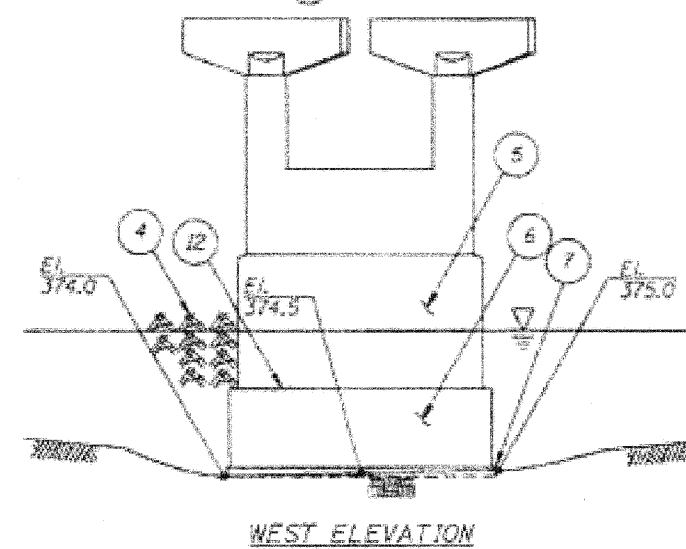
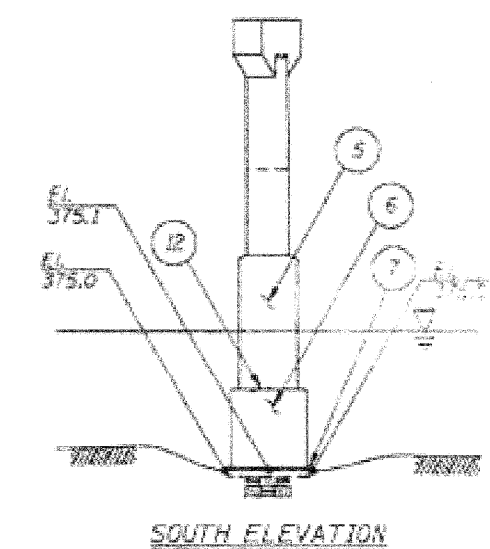
- 1 The channel bottom material around Pier 18 typically consisted of bedrock with no probe rod penetration possible. Along the east side of the pier, the bedrock channel bottom was rough and irregular while along the west side, the channel bottom was smoother.

- 2 25-foot-radius, 4-foot-deep scour depression located around the entire perimeter of the pier.
- 3 Sand infilling with up to 6 inches of probe penetration located on the channel bottom around the downstream end of the pier.

- 4 Light accumulation of timber debris extending out from the upstream nose in a 15-foot-radius. The debris consisted of branches and trees up to 1.5 feet in diameter and extended from 3 feet above to 10 feet below the waterline.

- 5 Random hairline map cracking above the waterline on all faces of the pier.
- 6 13.5-foot-high footing completely exposed around the entire perimeter of the pier.

- 7 6-inch-wide concrete step extending from the bottom of the footing into the channel with vertical exposures as noted. Random timber formwork was found along the faces of the step in various locations. The surface of the concrete step was typically rough but sound.

- 8 1.5-foot-high area of section loss with up to 2.5 feet of penetration located on the 6-inch-wide concrete step. The section loss extended for 2 feet along the north face and for 2.5 feet along the east face.

- 9 Area of section loss on the 6-inch-wide concrete step, measuring 1 foot long by 2 inches high, with up to 4 inches of penetration.
- 10 Several areas of section loss on the upstream vertical face of the 6-inch-wide concrete step, measuring 6 inches in diameter, with up to 3 inches penetration.

- 11 Band of light scaling with less than 1/4 inch of penetration extending from 1 foot above to 3 feet below the waterline on the upstream nose of the pier.

- 12 No damage on the pier wall or the footing.
