ROUTE NO.	SECTION	COUNTY	TOTAL SHEETS	SHEET NO.
F.A.P. 866	4N-1	LAKE	165	74
FED. ROAD DIST. NO. 7	ILLINOIS	FED. AID PROJECT

PROPOSED REHABILITATION AREAS

ILLINOIS DEPARTMENT OF TRANSPORTATION
BRIDGE DECK THERMOGRAPHIC SURVEY
IL RTE. 132 LAND BRIDGE
FAP RTE 866 - SEC 4N-1
LAKE COUNTY
STA. 1+143.3
SN 049-D002
DATE: 11-06-09
DRAWN BY BLB
CHECKED BY WJV

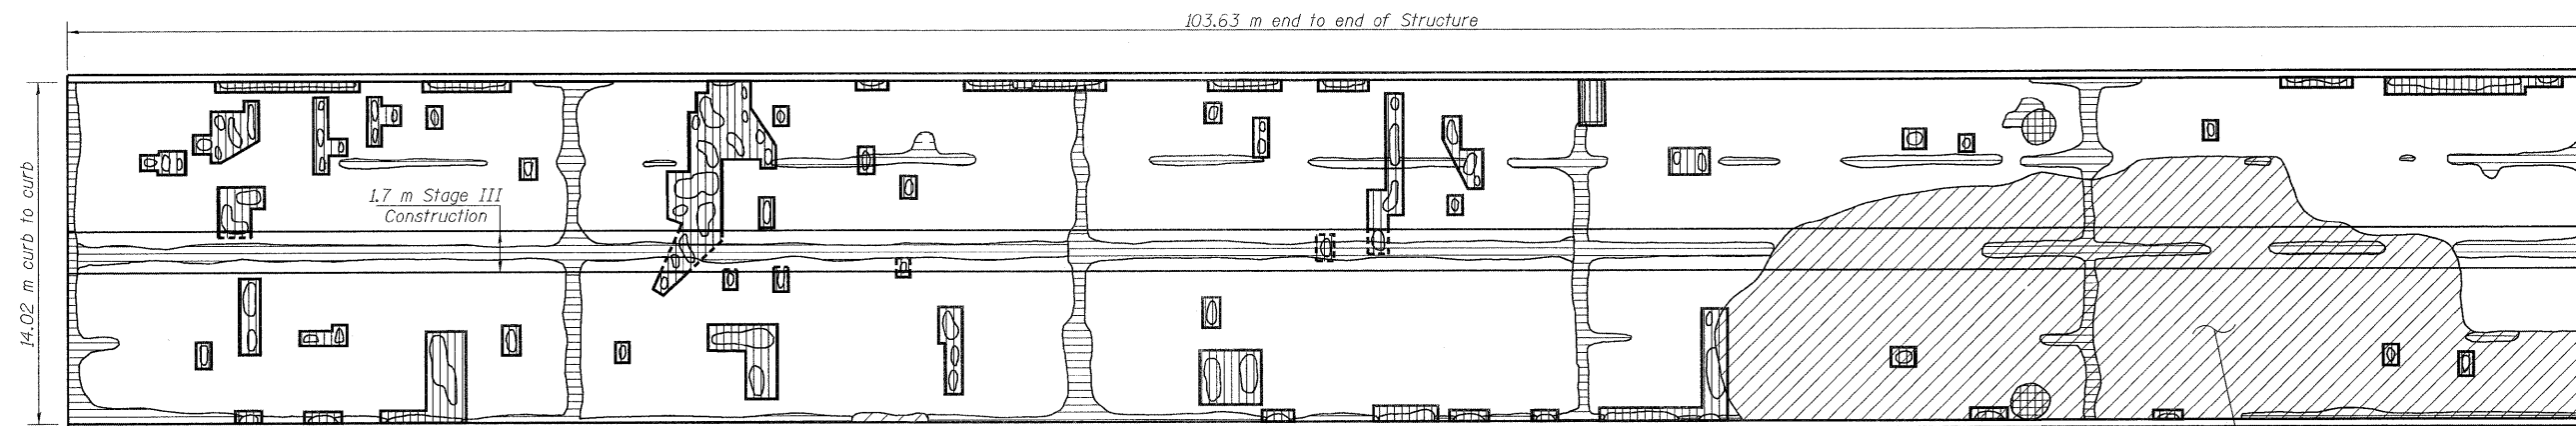
PLAN

Defects in shade located by visual observations and soundings.

FIELD OBSERVATIONS SUMMARY				LEGEND	
ITEM	UNIT	QUANT.	%		
TOTAL AREA	m ²	1453.0		DECK PREPARATION AREA	
SHADE/DEBRIS	m ²	1.0		SHADE/DEBRIS	
PARTIAL DEPTH REHAB	m ²	112.4	7.7	DELAMINATION	
PARTIAL DEPTH REHAB /BELOW STEEL	m ²	11.2	0.8	SPALL	
FULL DEPTH DECK REPAIR	m ²	30.0	2.0	DEBOND	
TOTAL SAWCUT LENGTH	m	357		ASPHALT PATCH	
				CONCRETE PATCH

- Repair areas outlined with dashed lines fall within the Stage III Removal area and are not included in the Deck Slab Repair quantity.
- The Engineer shall record the location of the actual full-depth deck repair areas in order to document as-built conditions for future reference.
- The quantities for Full Depth Deck Slab Repair are nominal quantities which have been added to the Contract in order to establish a unit price.
- If the existing ground beneath the Full Depth Deck Slab Repair areas has settled, the Contractor shall add Porous Granular Backfill up to the bottom elevation of the slab. Cost of Porous Granular Backfill is included with Deck Slab Repair (Full Depth) of the appropriate type. For estimating purposes, the Contractor may assume an average settlement of 6-12".
- Quantities for Partial Depth repair are provided for information only, to assist the Contractor in bidding.
