STATE OF ILLINOIS
DEPARTMENT OF TRANSPORTATION

Contract #78030

BENT 2
IL. ROUTE 146 OVER CACHE RIVER
F.A.P. ROUTE 885 / SECTION 107BR-1
JOHNSON COUNTY
STATION 727+23.00
STRUCTURE NO. 044-0014

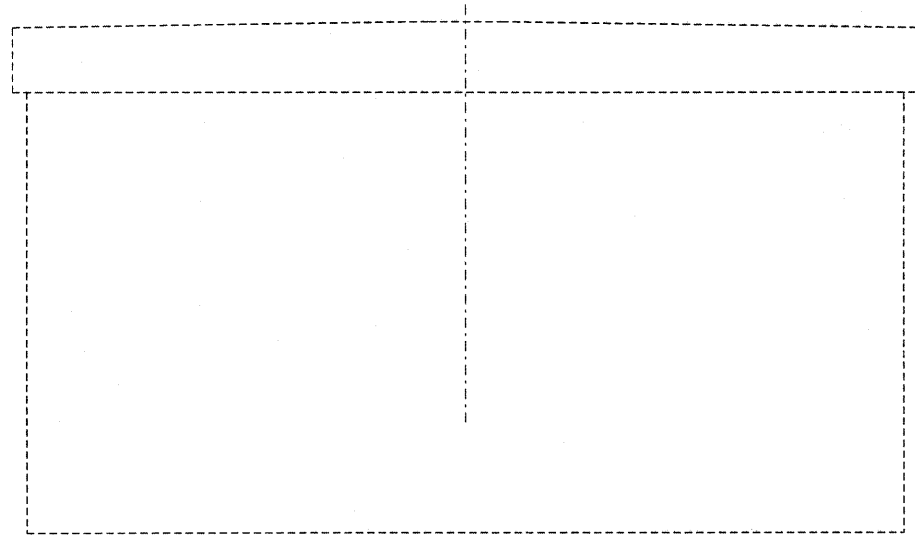
WEST ELEVATION
(Looking East)

Pier Structural Repair of Concrete areas and Crack Repair lengths are estimated from a 10/24/2007 inspection.

The existing pier bearing seat is to be inspected by the Engineer after deck beam removal. Deteriorated concrete areas shall be repaired if deemed necessary using Structural Repair of Concrete (Depth equal to or less than 5"). Concrete Sealer shall be applied to Concrete Repair areas. Cost included in Concrete Repair item.
