STATE OF ILLINOIS
DEPARTMENT OF TRANSPORTATION

ROUTE NO.	SECTION	COUNTY	SHEET	SHEET NO.
FAP 869	105BR-1	SALINE	118	36
PROJECT NO. 78031				18 SHEETS

NORTH ABUTMENT
IL 34 OVER
MIDDLE FORK SALINE RIVER OVERFLOW
FAP ROUTE 869 - SECTION 105BR-1
SALINE COUNTY
STATION 1542+00.00
STRUCTURE NO. 083-0037

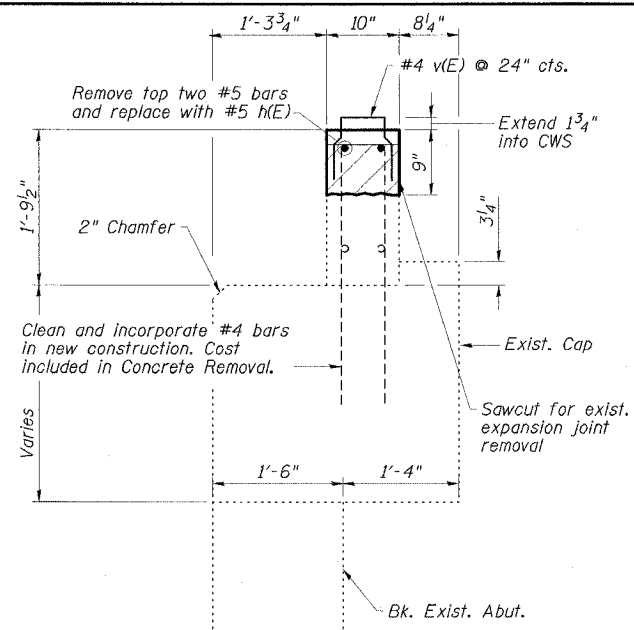
SECTION A-A

EXISTING BEARING SEAT TO BE INSPECTED BY THE ENGINEER AFTER DECK BEAM REMOVAL. DETERIORATED CONCRETE AREAS SHALL BE REPAIRED (ESTIMATED 15 S.F. STRUCTURAL REPAIR OF CONCRETE DEPTH < 5") AND CRACKS SHALL BE SEALED (ESTIMATED 20' EPOXY CRACK INJECTION) IF FOUND. CONCRETE SEALER SHALL BE APPLIED TO CONCRETE REPAIR AREAS.

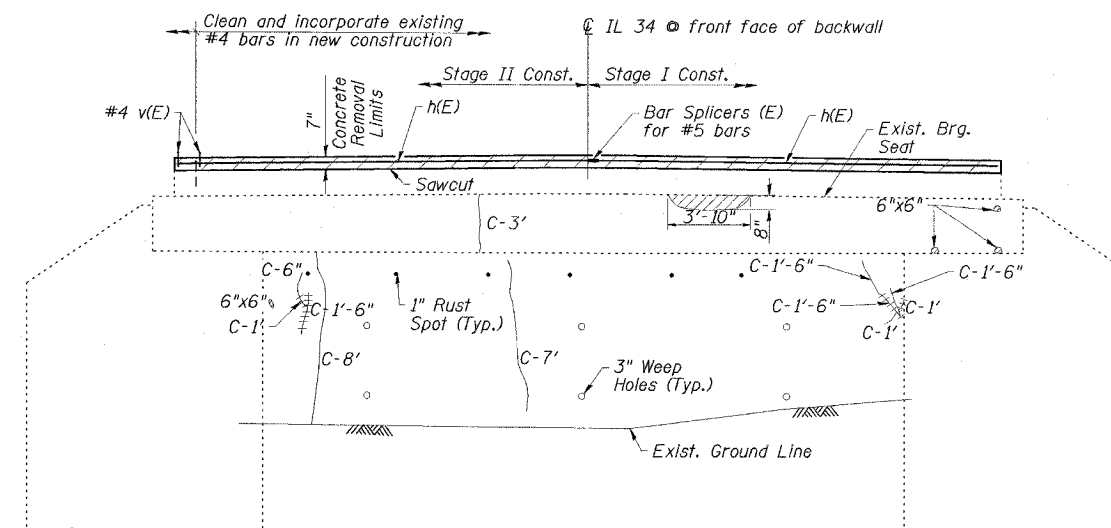
ELEVATION

NOTE: ABUTMENT CRACK REPAIR LENGTHS AND STRUCTURAL REPAIR OF CONCRETE AREAS ARE ESTIMATED FROM 12-17-07 SURVEY WORK. ACTUAL LOCATIONS AND QUANTITIES OF REPAIRS SHALL BE SHOWN BY THE ENGINEER ON THE AS-BUILT PLANS FOR THIS SECTION.
