STATE OF ILLINOIS
DEPARTMENT OF TRANSPORTATION

Inspection Date: 12/14/06

**SOUTH ABUTMENT
IL 34 OVER BANKSTON CREEK
FAP ROUTE 869 - SECTION (105A)BR-1
SALINE COUNTY
STATION 1582+30.00
STRUCTURE NO. 083-0040**

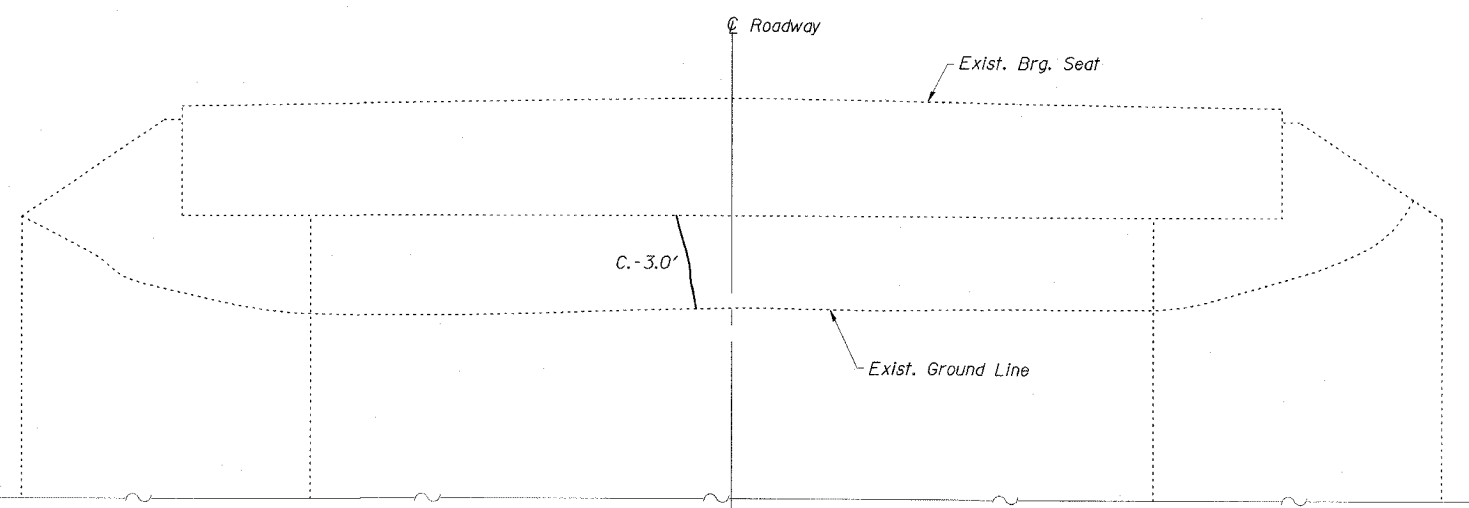
ELEVATION

- C.-6' Crack to be epoxy injected
- S.F. Delaminated or Spalled Area - Use Structural Repair of Concrete

NOTE: ABUTMENT CRACK REPAIR LENGTHS AND STRUCTURAL REPAIR OF CONCRETE AREAS ARE ESTIMATED FROM 12-14-06 SURVEY WORK. ACTUAL LOCATIONS AND QUANTITIES OF REPAIRS SHALL BE SHOWN BY THE ENGINEER ON THE AS-BUILT PLANS FOR THIS SECTION.
