ROUTE NO.	SECTION	COUNTY	STATION	SHEET NO.	SHEET NO. 13 17 SHEETS
FAP 328	*	WHITE	42	24	
PROJ. ROAD DIST. NO.	ILLINOIS		FEATURED PROJECT		
98997			*105X1BR

PIER 1
US 45 OVER SKILLET FORK OVERFLOW
FAP ROUTE 328 - SECTION (105X)BR
WHITE COUNTY
STATION 598+76.00
STRUCTURE NO. 097-0019

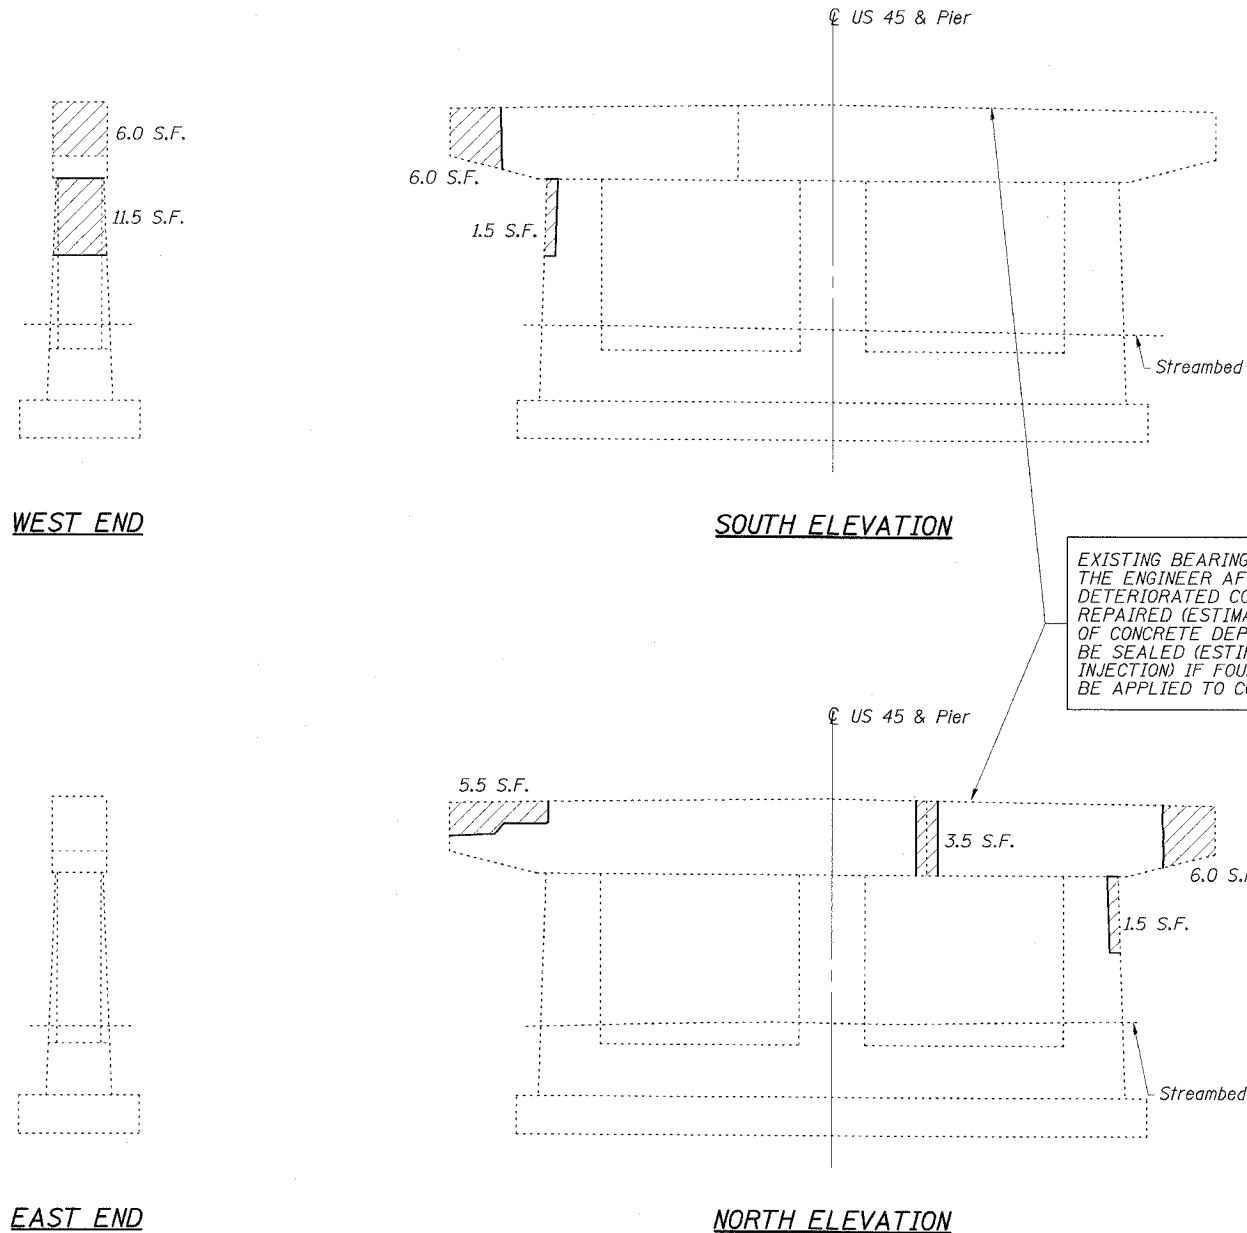
NOTE: PIER CRACK REPAIR LENGTHS AND STRUCTURAL REPAIR OF CONCRETE AREAS ARE ESTIMATED FROM 12-14-06 SURVEY WORK. ACTUAL LOCATIONS AND QUANTITIES OF REPAIRS SHALL BE SHOWN BY THE ENGINEER ON THE AS-BUILT PLANS FOR THIS SECTION.

EXISTING BEARING SEAT TO BE INSPECTED BY THE ENGINEER AFTER DECK BEAM REMOVAL. DETERIORATED CONCRETE AREAS SHALL BE REPAIRED (ESTIMATED 18.5 S.F. STRUCTURAL REPAIR OF CONCRETE DEPTH < 5") AND CRACKS SHALL BE SEALED (ESTIMATED 20' EPOXY CRACK INJECTION) IF FOUND. CONCRETE SEALER SHALL BE APPLIED TO CONCRETE REPAIR AREAS.
