STATE OF ILLINOIS  
DEPARTMENT OF TRANSPORTATION

EAST ABUTMENT  
STRUCTURE NO. 060-0198

SHEET 9 OF 11	F.A.I. RTE.	SECTION	COUNTY	TOTAL SHEETS	SHEET NO.
	55	60-3RS-1, 60-(3HB,3HB-1)I	MADISON	123	101
STA. 363+22.00		CONTRACT NO. 76601			
FED. ROAD DIST. NO.		ILLINOIS FED. AID PROJECT

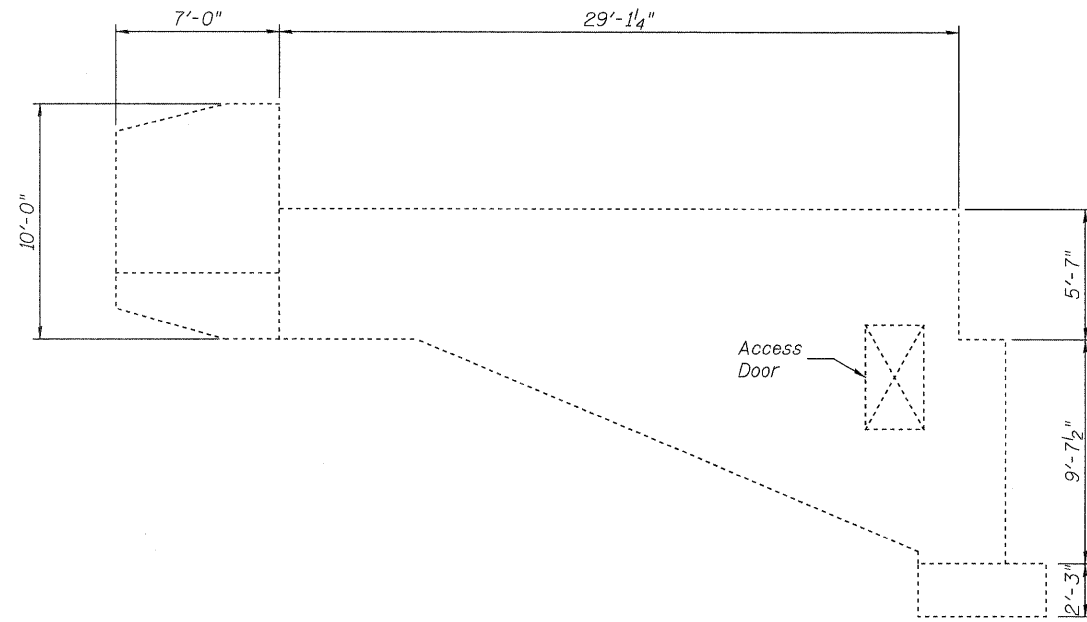
ELEVATION - NORTH WING

Notes:  
Abutment Condition Survey performed 4/15/2010.

Plan quantities assume that all marked areas will be repaired.

Repair areas are estimated, the Engineer shall determine actual repair locations and record them on the As-Built plans.
