Asbestos Abatement Survey

Job Order No.: R-91-016-20

600 Des Plaines Street

August 30, 2024

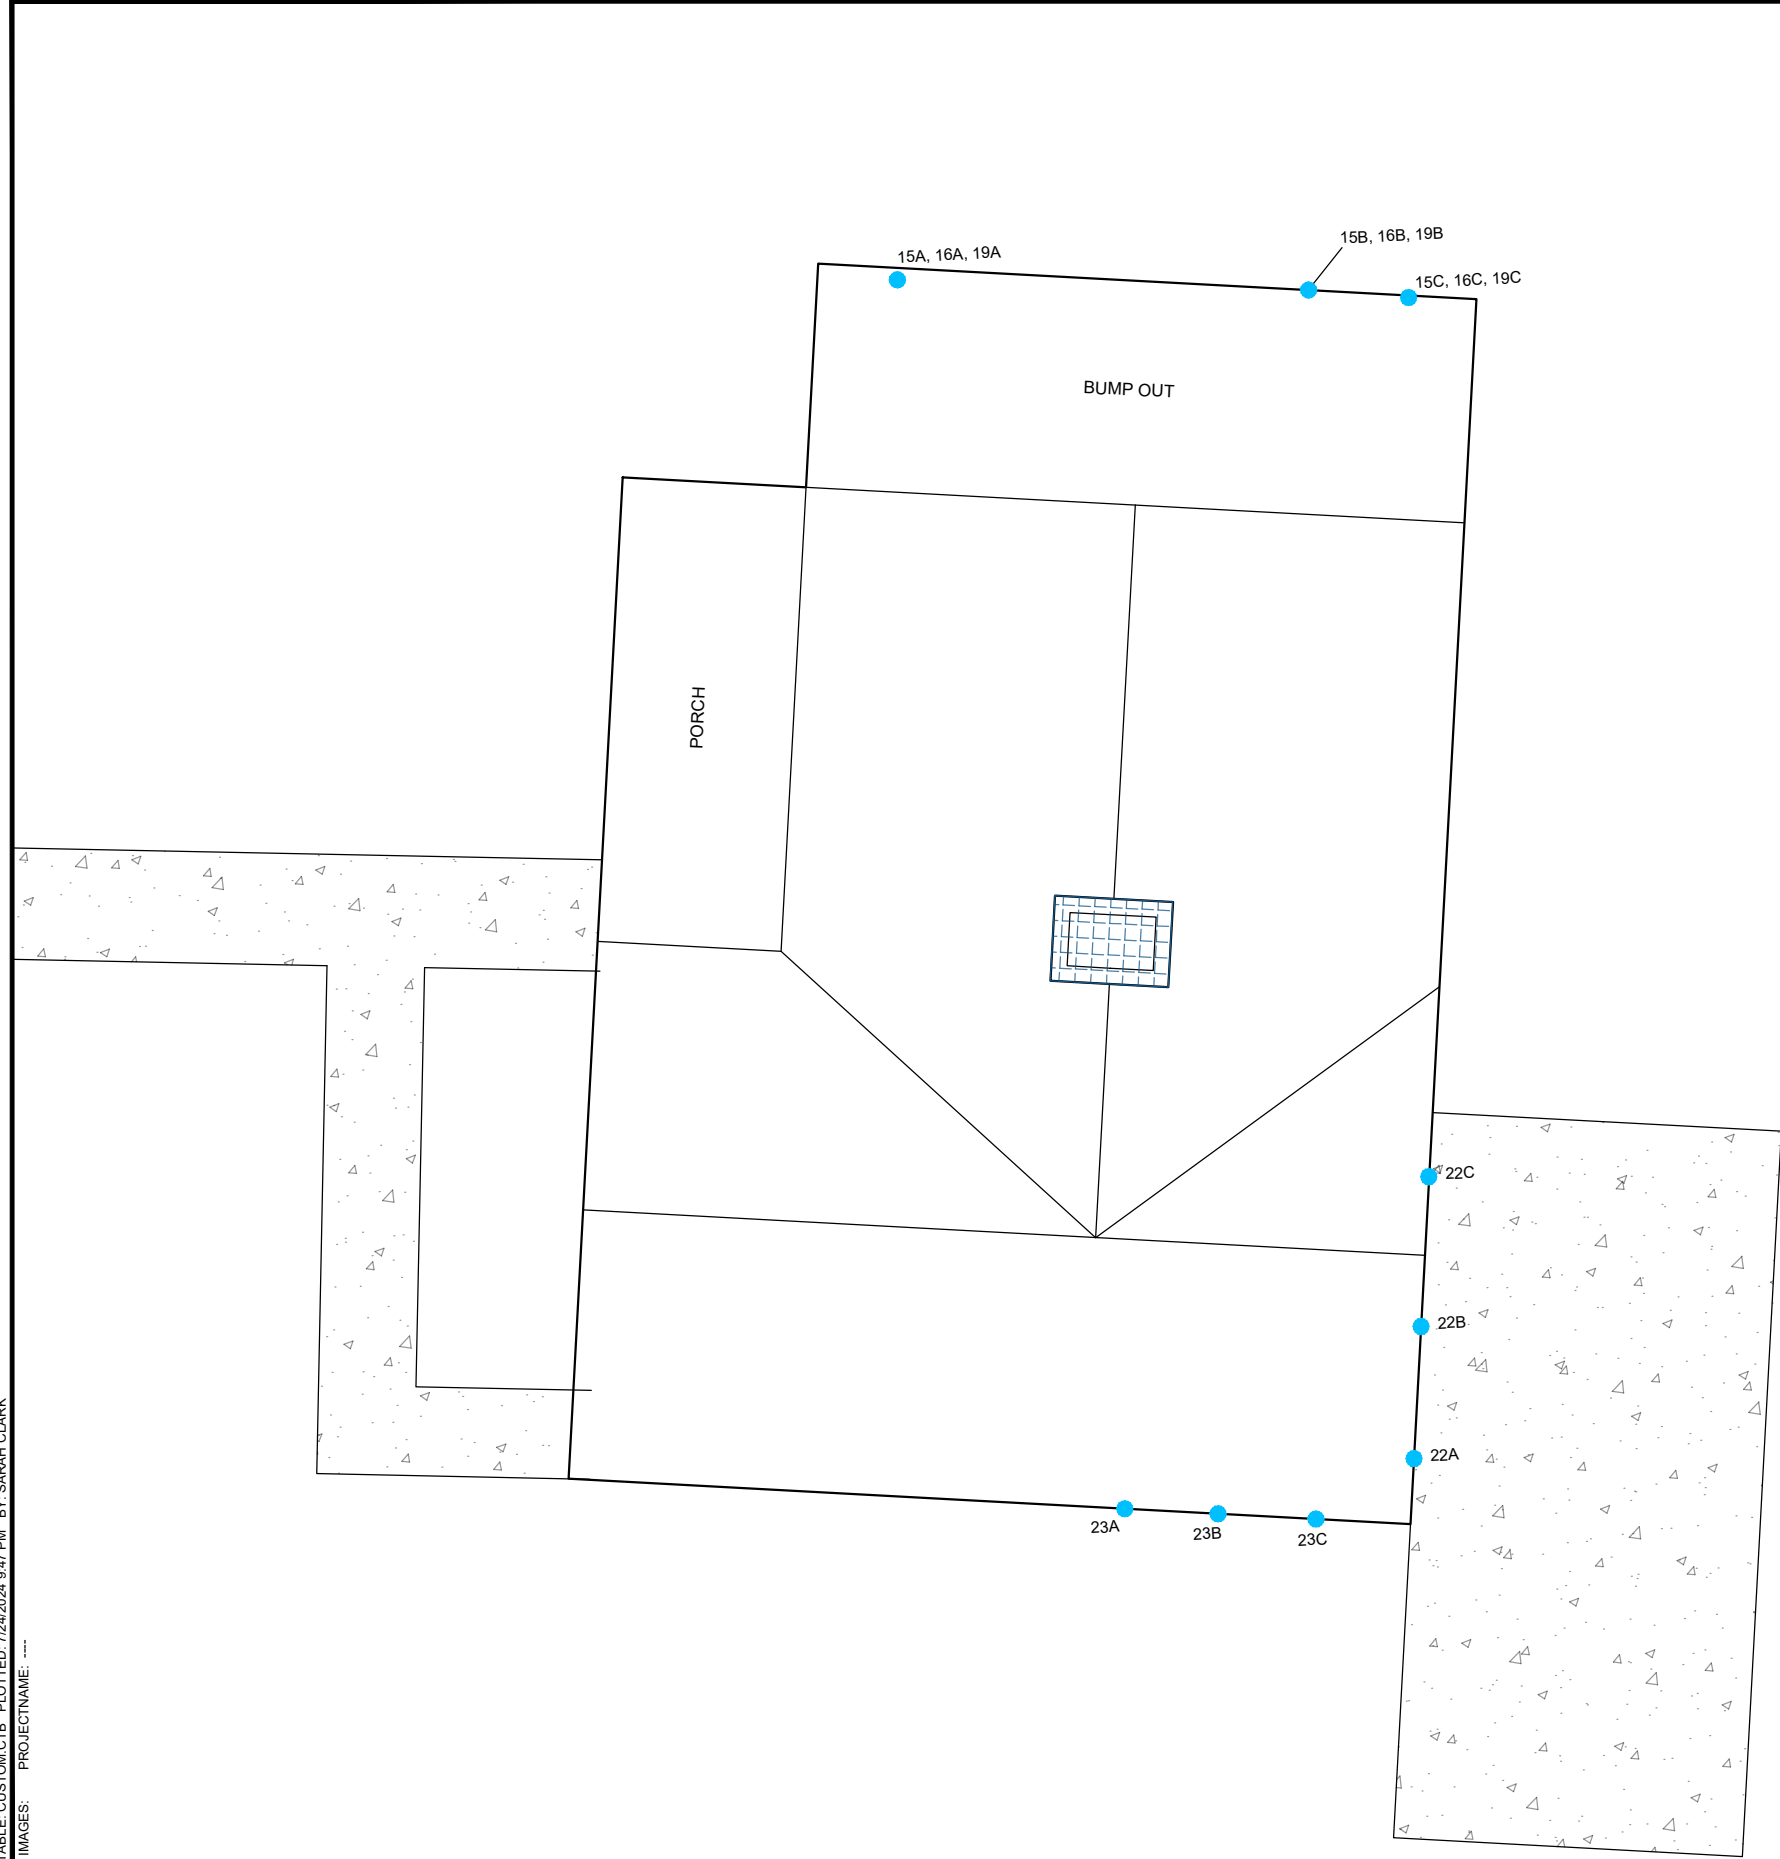
FIGURE
5

- HA-17: Black Sealant on the Chimney on the House Roof

- LEGEND**
- ASBESTOS SAMPLE
 - ▤ HA-17: Assumed ACM - Black Chimney Sealant

ACMs identified at the site that may be disturbed during demolition activities, must be removed by a licensed asbestos abatement contractor utilizing industry standard work procedures in accordance with all federal, state, and local regulations governing asbestos.

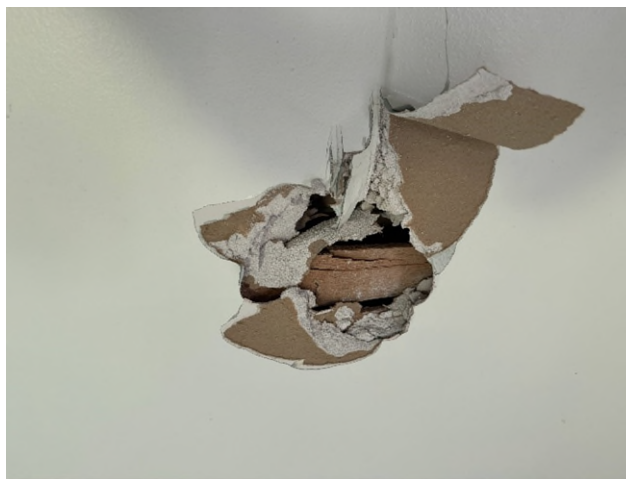
HA-1: White Gypsum Board

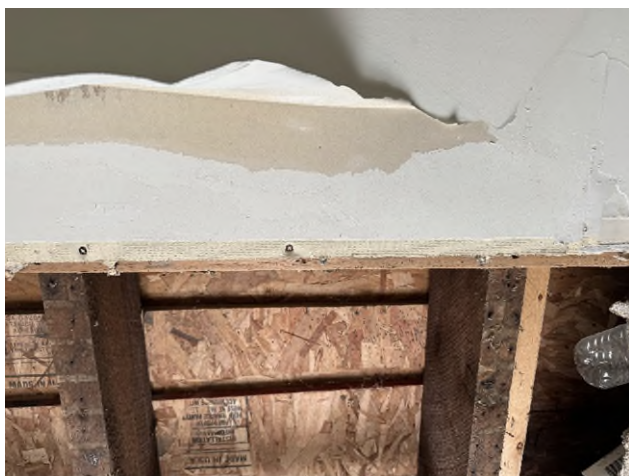
HA-2: White Joint Compound associated with HA-1

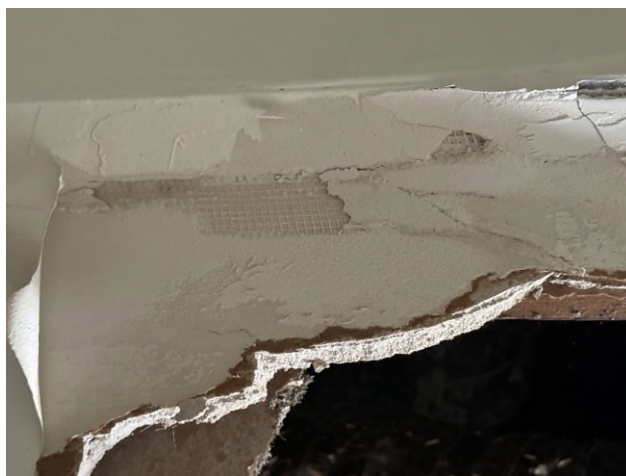
HA-3: Beige Drywall Tape associated with HA-1

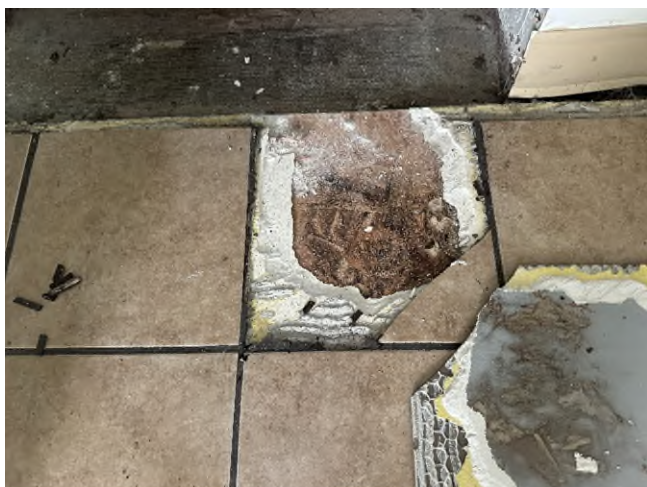
HA-4: Beige 12" x 12" Ceramic Tile
HA-5: White Adhesive associated with HA-4
HA-6: Dark Gray Grout associated with HA-4

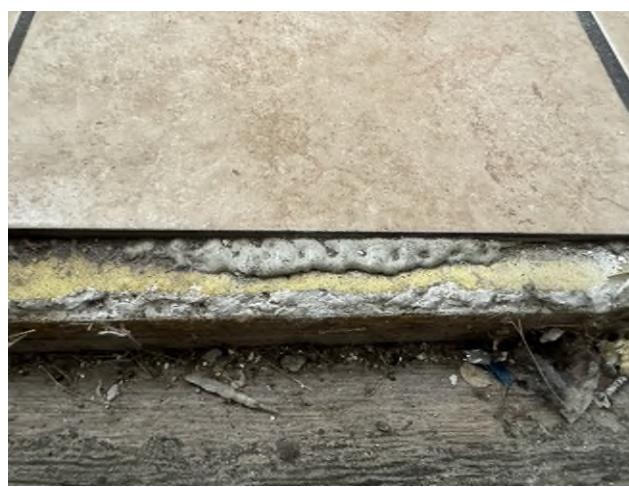
HA-7: Tan with Red Tint 12" x 12" Ceramic Tile;
HA-8: Gray Adhesive associated with HA-7
HA-9: Black Grout associated with HA-7

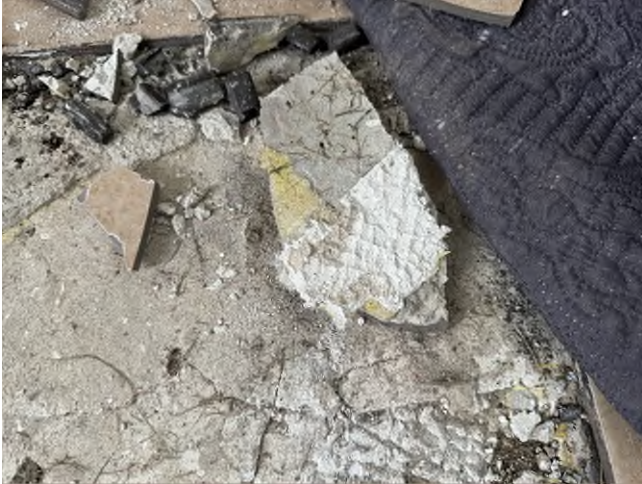
HA-10: Gray Leveling Compound under HA-5

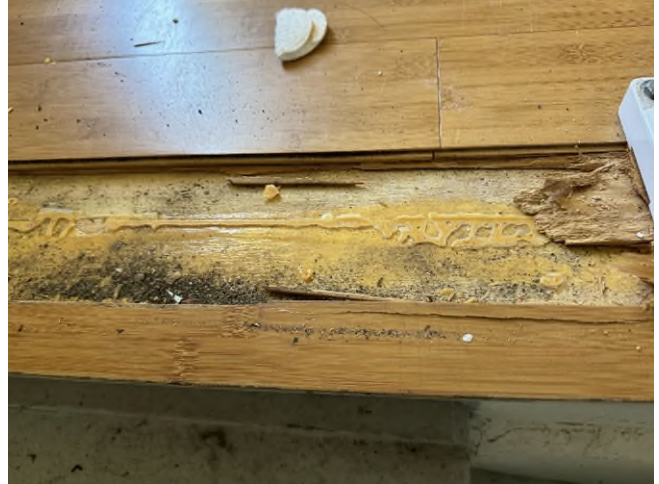
HA-11: Yellow Glue under Wood Laminate Flooring

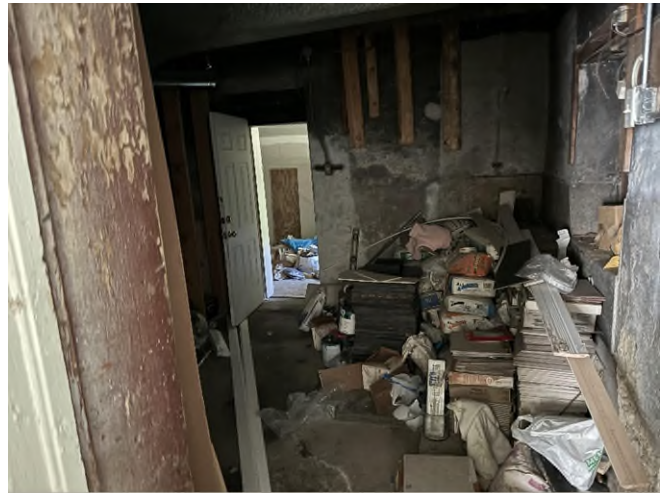
HA-14: Gray Concrete Foundation

HA-13: Gray Plank Flooring

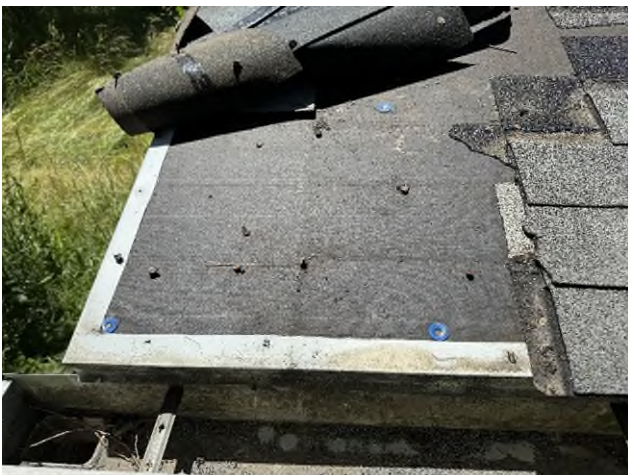
HA-15: Black Asphalt Shingles
HA-16: Black Felt Layer under HA-15

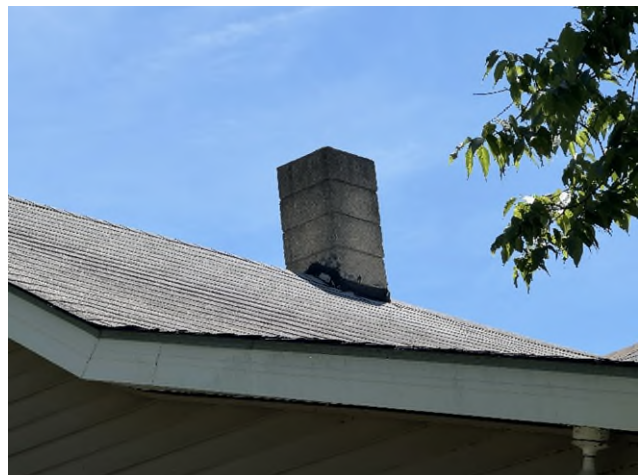
No HAs have been confirmed to be ACM. One HA was identified as assumed ACM:

HA-17: Black Sealant

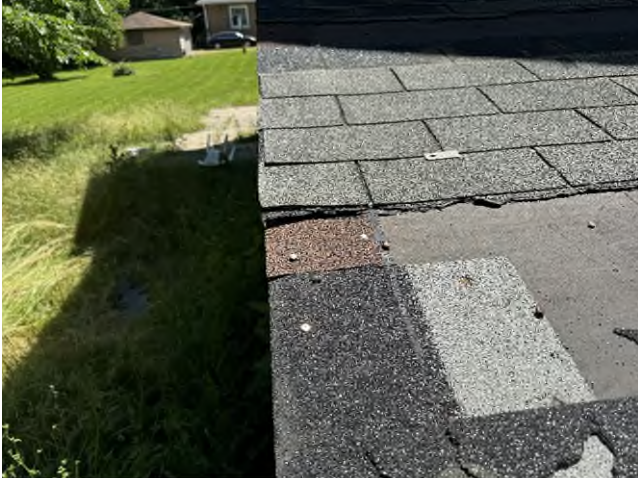
HA-19: Red/Black Asphalt Shingle under HA-15

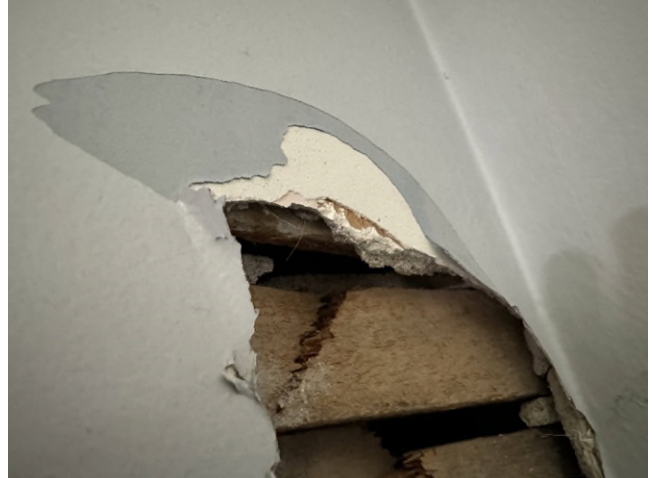
**HA-20: White Skimcoat Plaster
HA-21: Gray Base Coat Plaster**

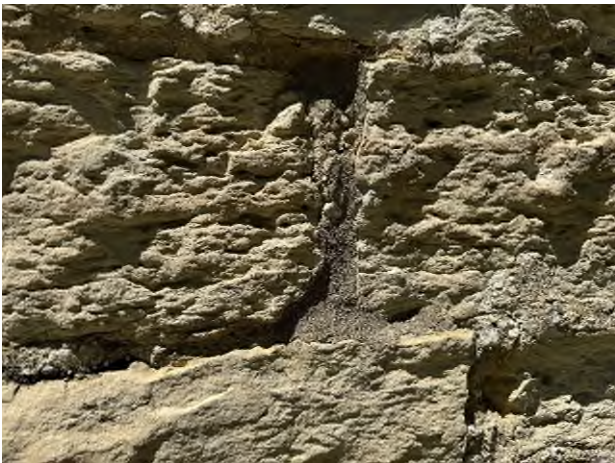
HA-22: Gray Mortar associated with Stone

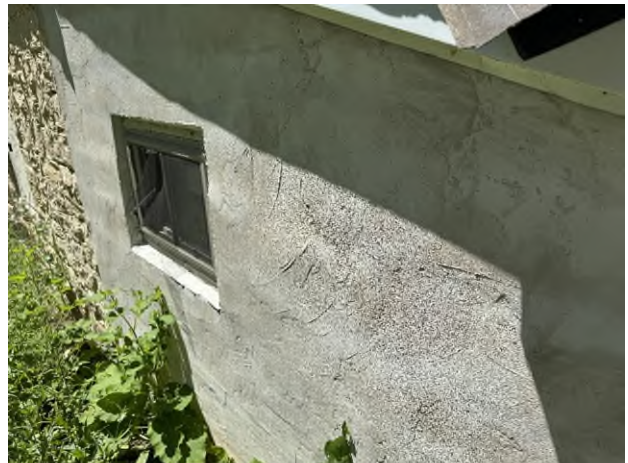
HA-23: Gray Troweled on Mortar

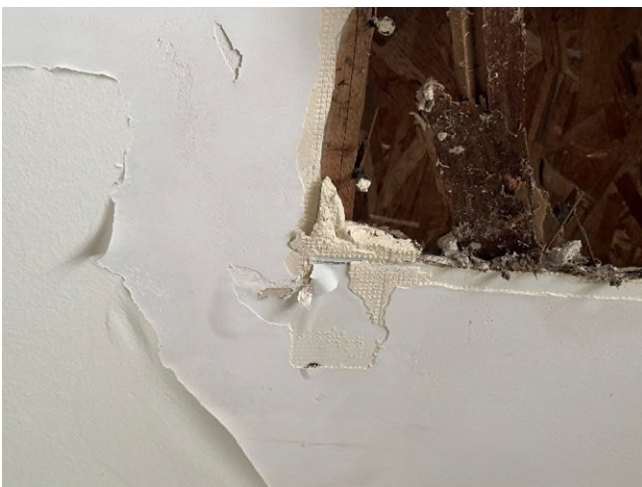
HA-24: Beige Joint Compound associated with HA-1
