Illinois Department of Transportation

Asbestos Abatement Survey

Job Order No.: R-91-016-20

603 Kiep Avenue

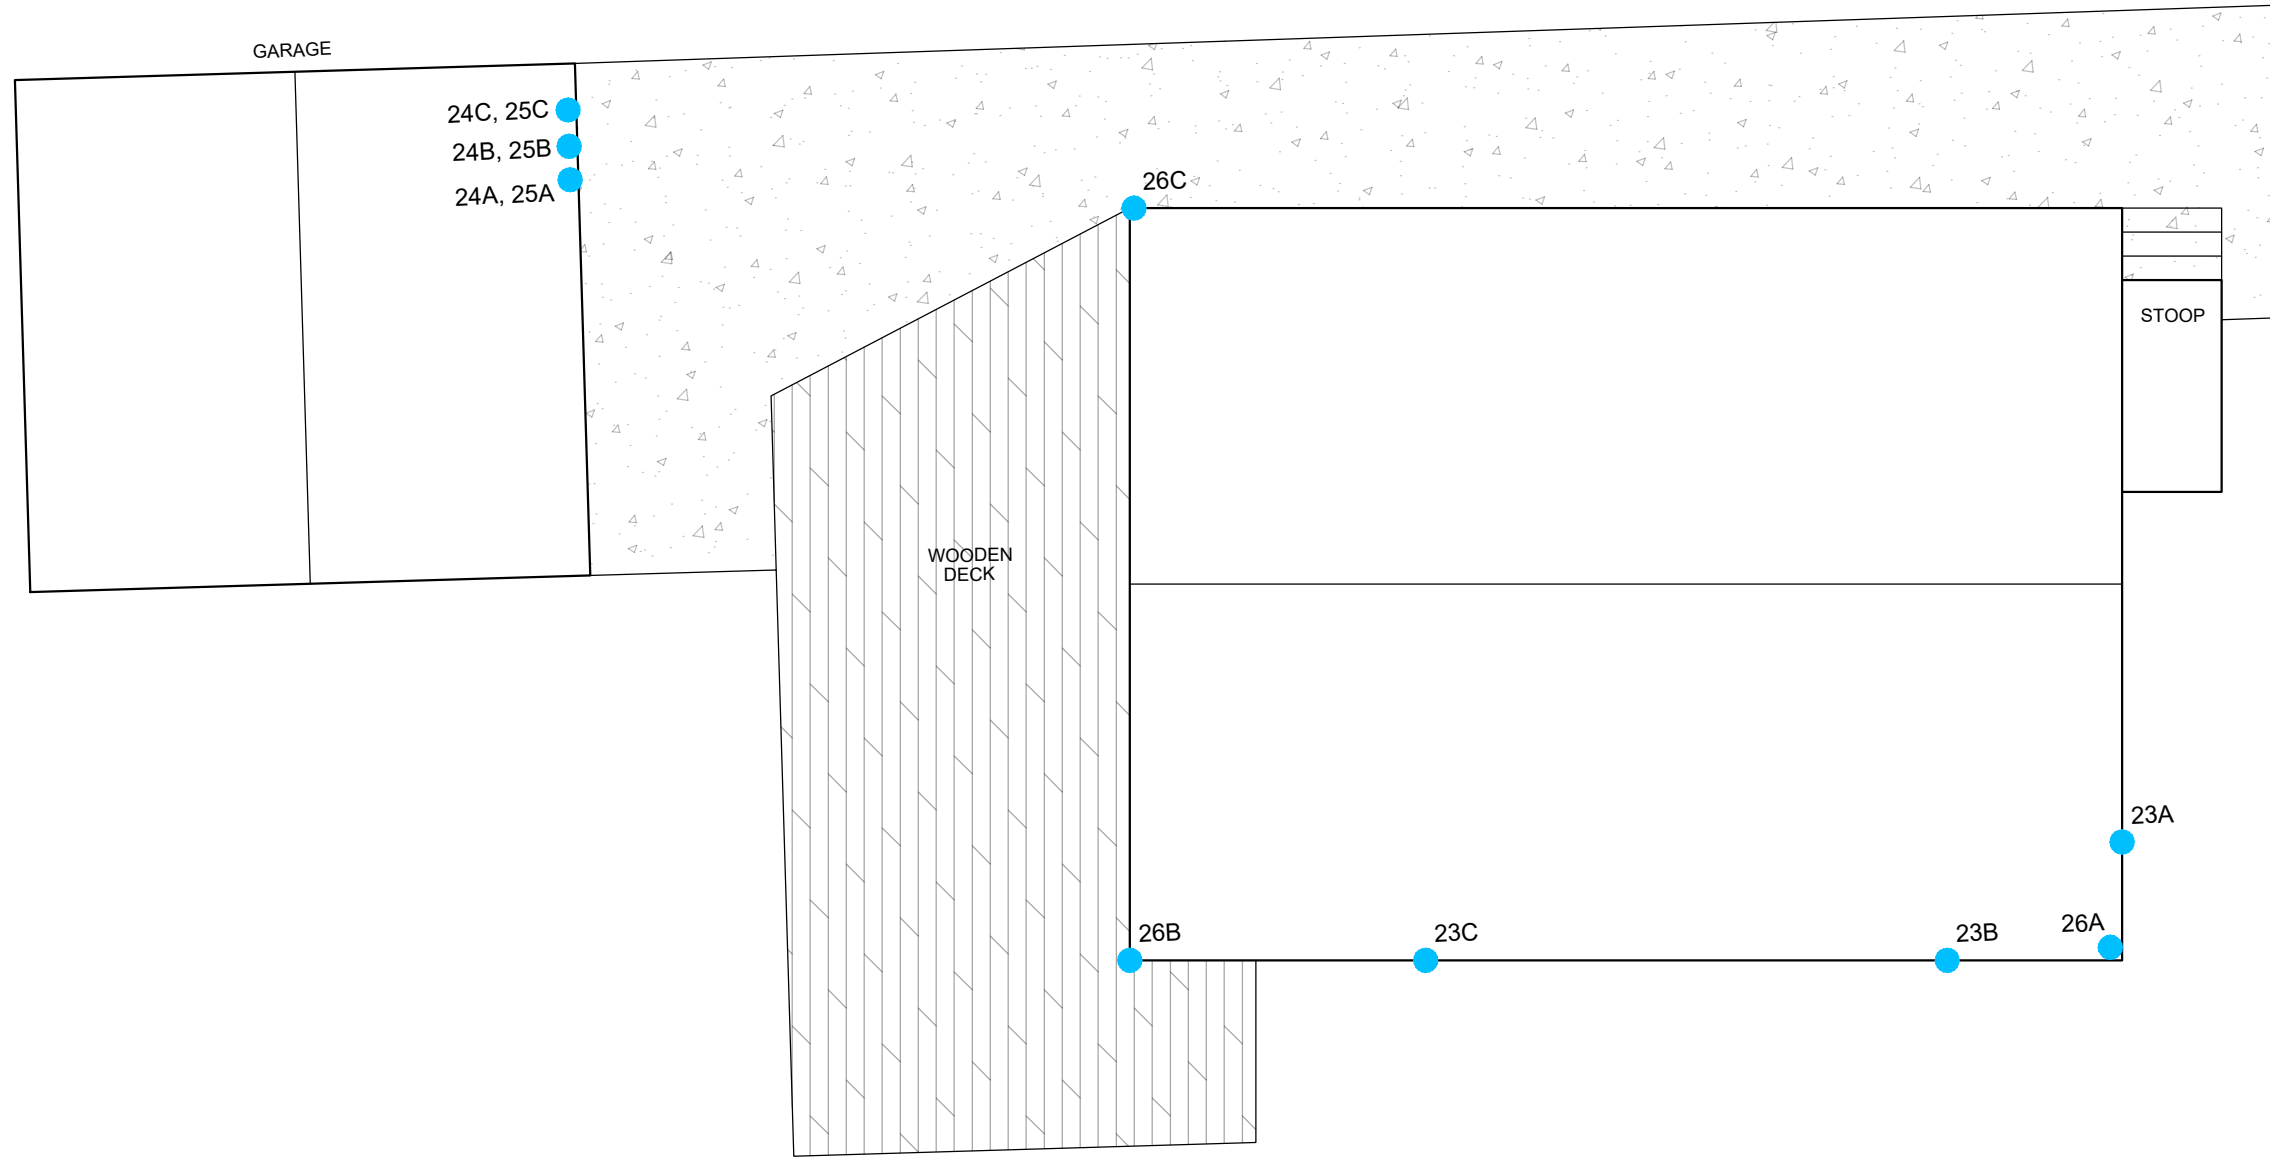
**SAMPLING LOCATIONS -
EXTERIOR**

Arcadis identified 29 HAs from which 87 samples were collected and analyzed. A listing of the identified HAs, including each HA material description, location, sample number, condition, asbestos content, and estimated quantity, are presented in Table 1. Approximate sampling locations are shown on Figures 1-3.

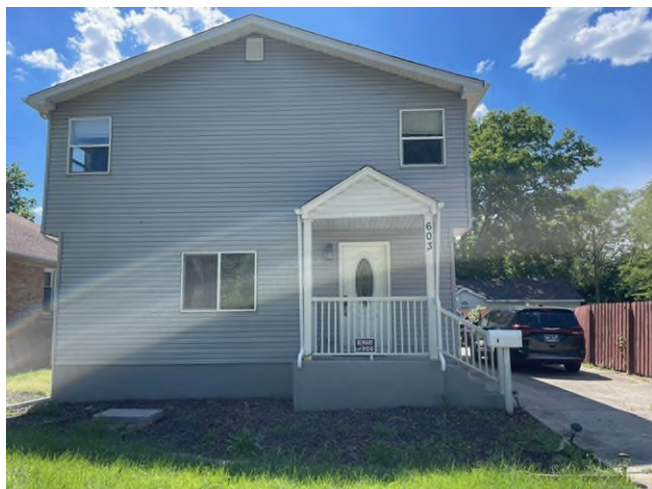
View of House

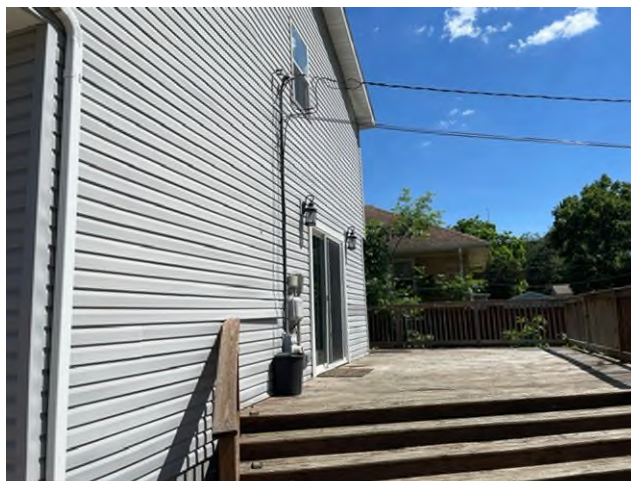
Rear View of House

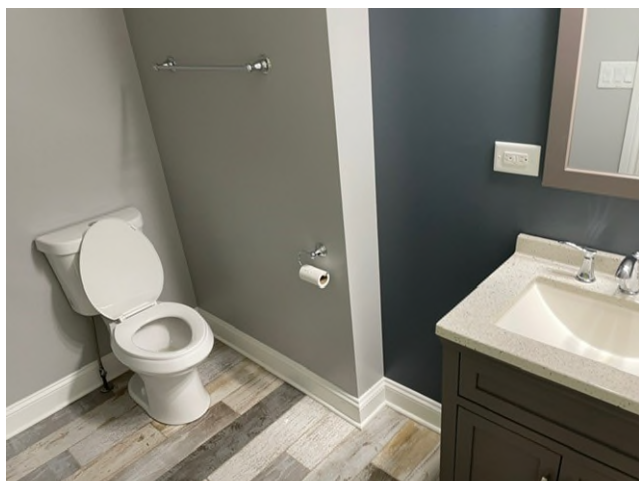
HA-1: Gypsum board

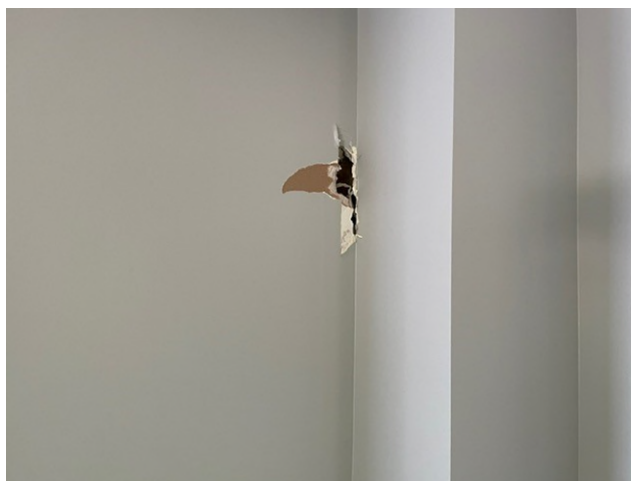
**HA-2: Joint Compound associated with HA-1
HA-3: Drywall Tape associated with HA-1**

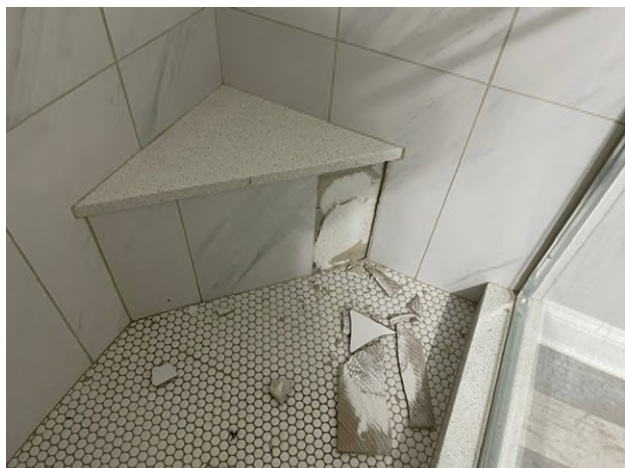
**HA-4: White 1' x 3' Ceramic Wall Tile
HA-5: White Adhesive associated with HA-4
HA-6: Gray Grout associated with HA-4**

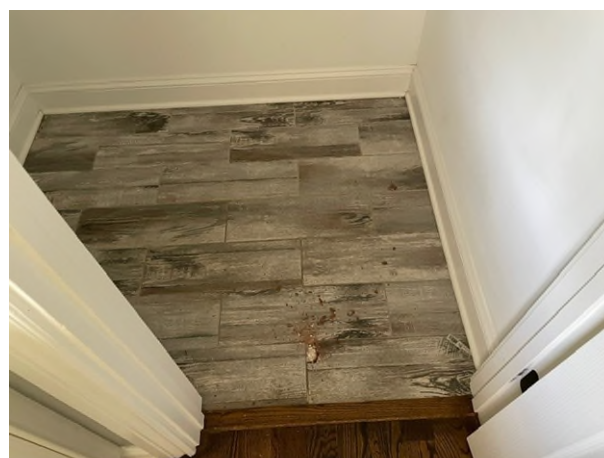
**HA-7: Gray 18" x 6" Wood Pattern Ceramic Floor Tile
HA-8: White Adhesive associated with HA-7
HA-9: Gray Grout associated with HA-7**

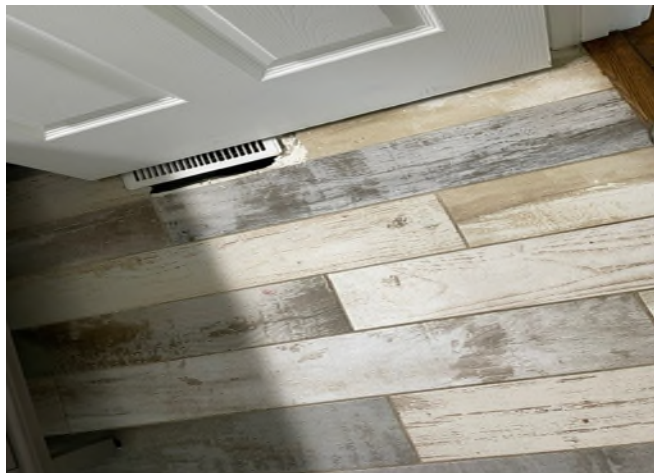
HA-10: White 30" x 6" Wood Pattern Ceramic Floor Tile
HA-11: White Adhesive associated with HA-10
HA-12: Gray Grout associated with HA-10

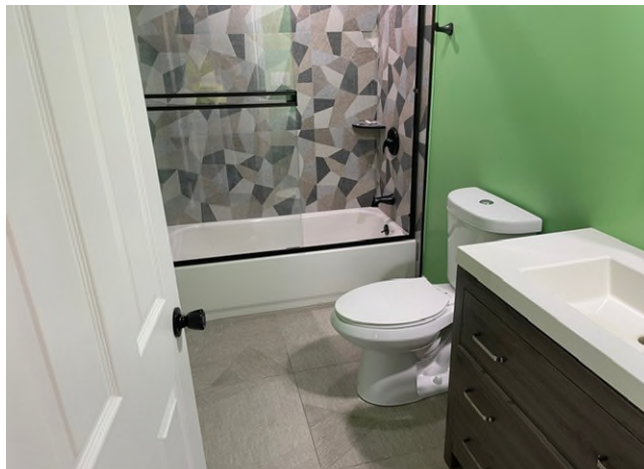
HA-13: Tan 2' x 2' Ceramic Wall and Floor Tile

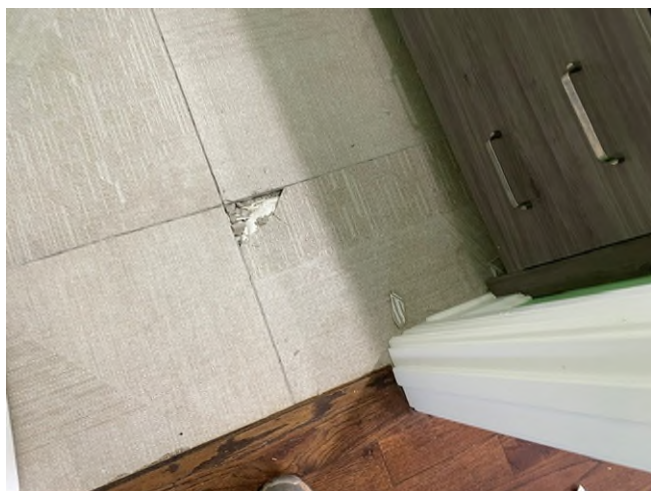
HA-14: White Adhesive associated with HA-13

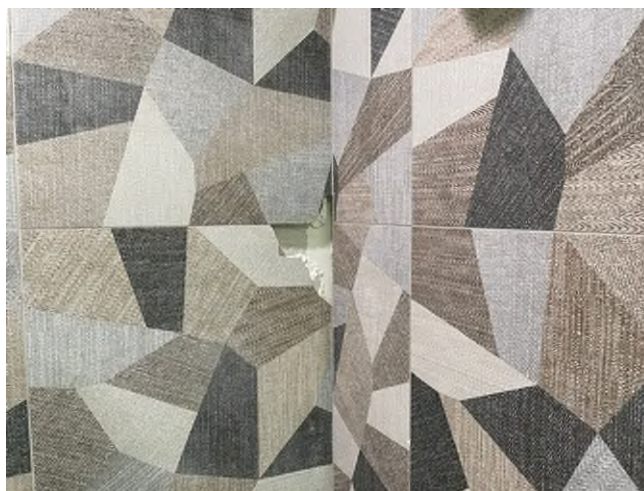
HA-15: Gray Grout associated with HA-13

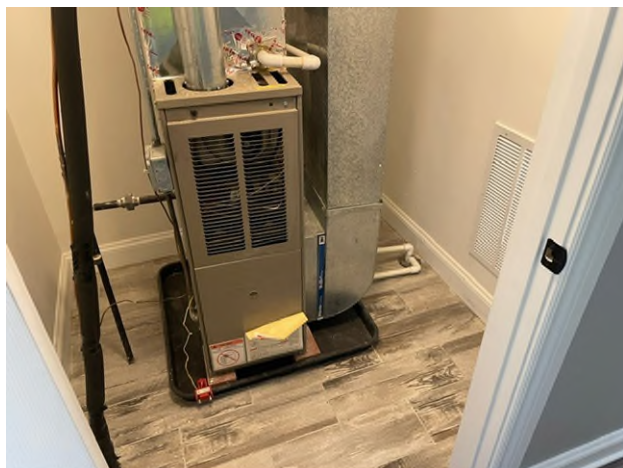
HA-16: Brown 6' x 24' Wood Pattern Ceramic Floor Tile

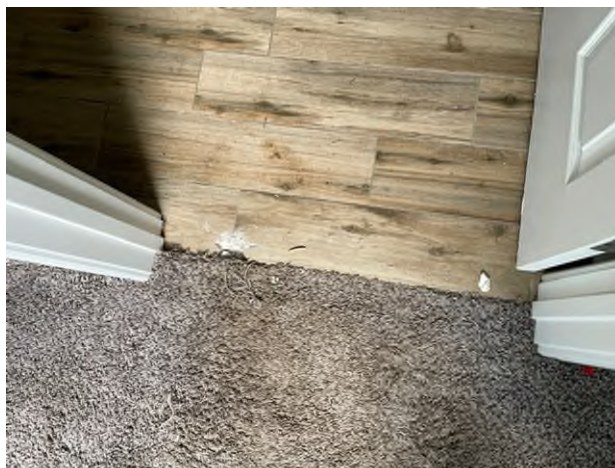
HA-17: White Adhesive associated with HA-16
HA-18: Gray Grout associated with HA-16

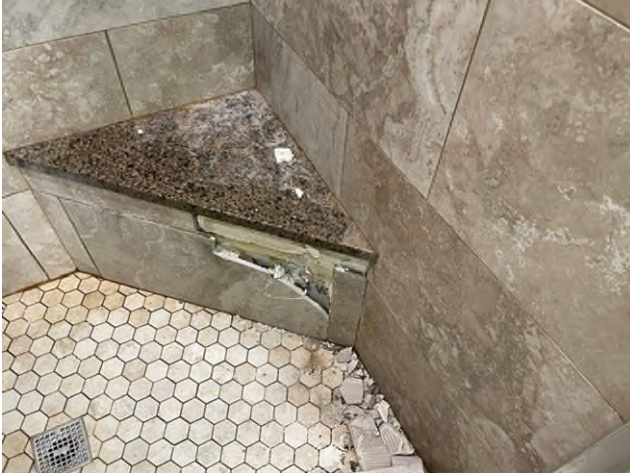
HA-19: Beige 1' x 2' Ceramic Wall Tile
HA-20: White Adhesive associated with HA-19
HA-21: Dark Gray Grout associated with HA-19

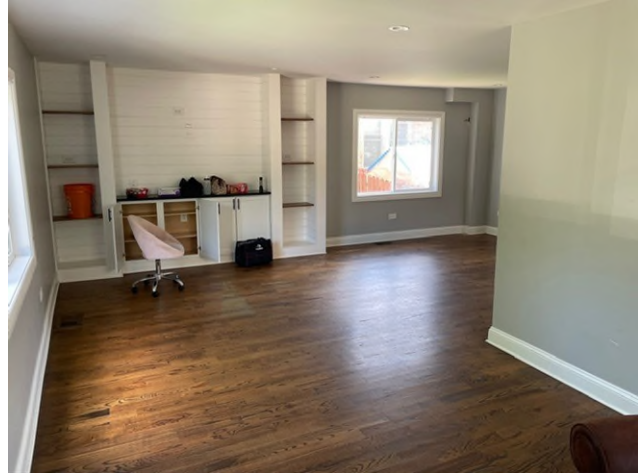
HA-22: Vapor Barrier beneath Hardwood Flooring

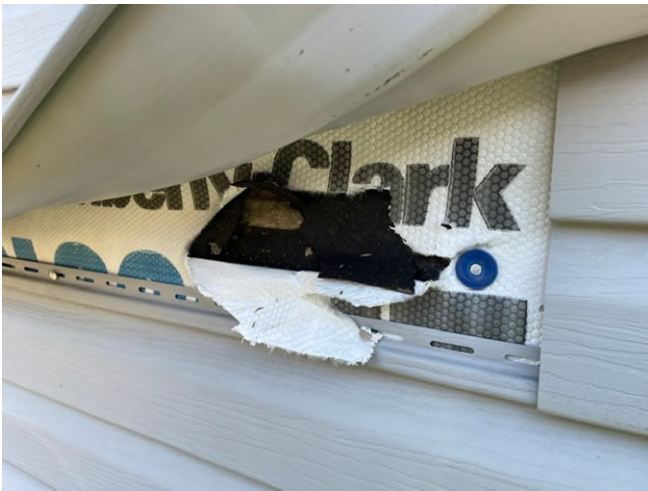
HA-23: Black Exterior Vapor Barrier

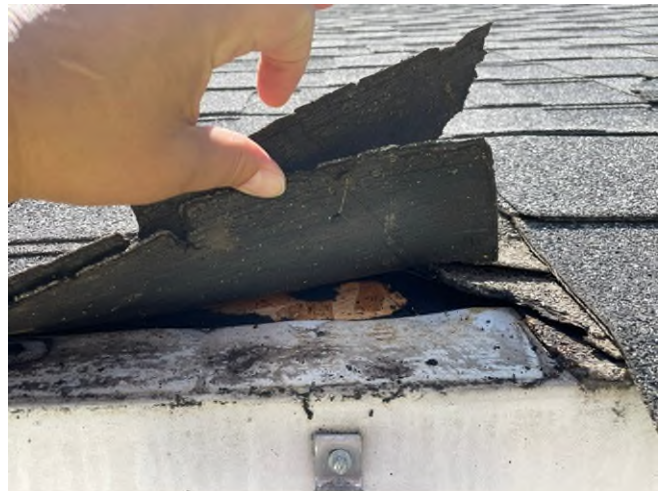
HA-24: Asphalt Roof Shingles

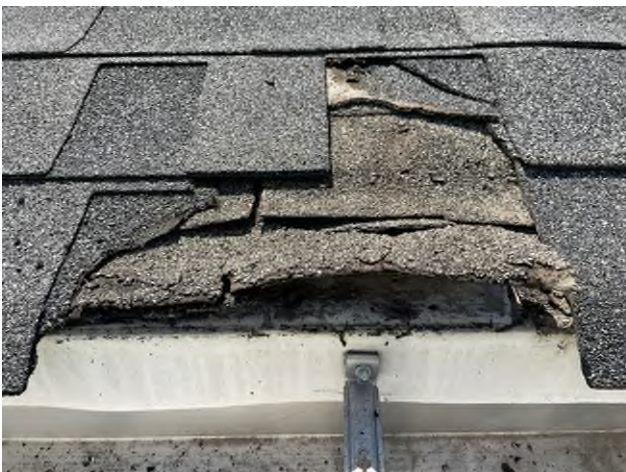
HA-25: Tar/Felt Roofing Paper beneath HA-24

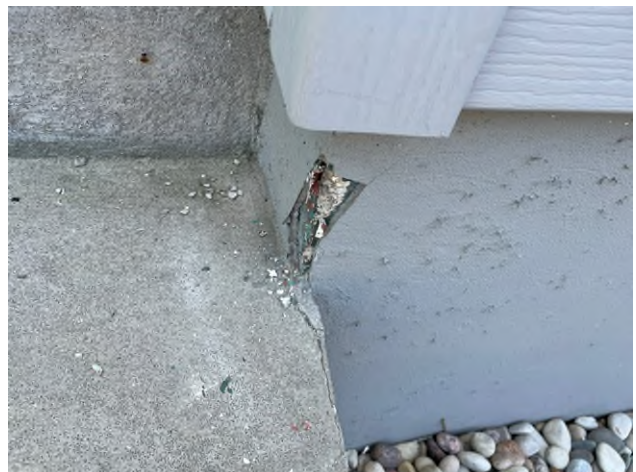
HA-26: Concrete Foundation

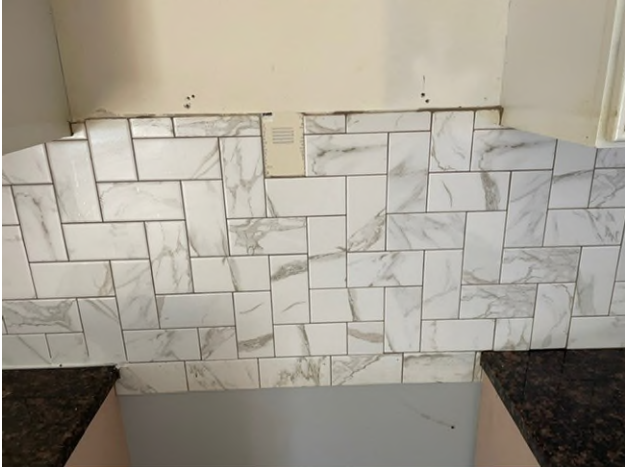
HA-27: White Ceramic Wall Tile Backsplash
HA-28: Beige Adhesive associated with HA-27
HA-29: Brown Grout associated with HA-27
