ASBESTOS SURVEY REPORT

**Asbestos Survey for Building Demolition (I-80) at Gardner Road Bridge
615 Gardner Street, Joliet, Illinois
Region One/District One**

Asbestos Survey Report
PTB 198-003
FAI-80 (I-80) over Des Plaines River Bridge
Job N. D-91-204-19
615 Gardner Street, Joliet, IL
Parcel No. 1P10193

615 Gardner Street, Joliet, IL

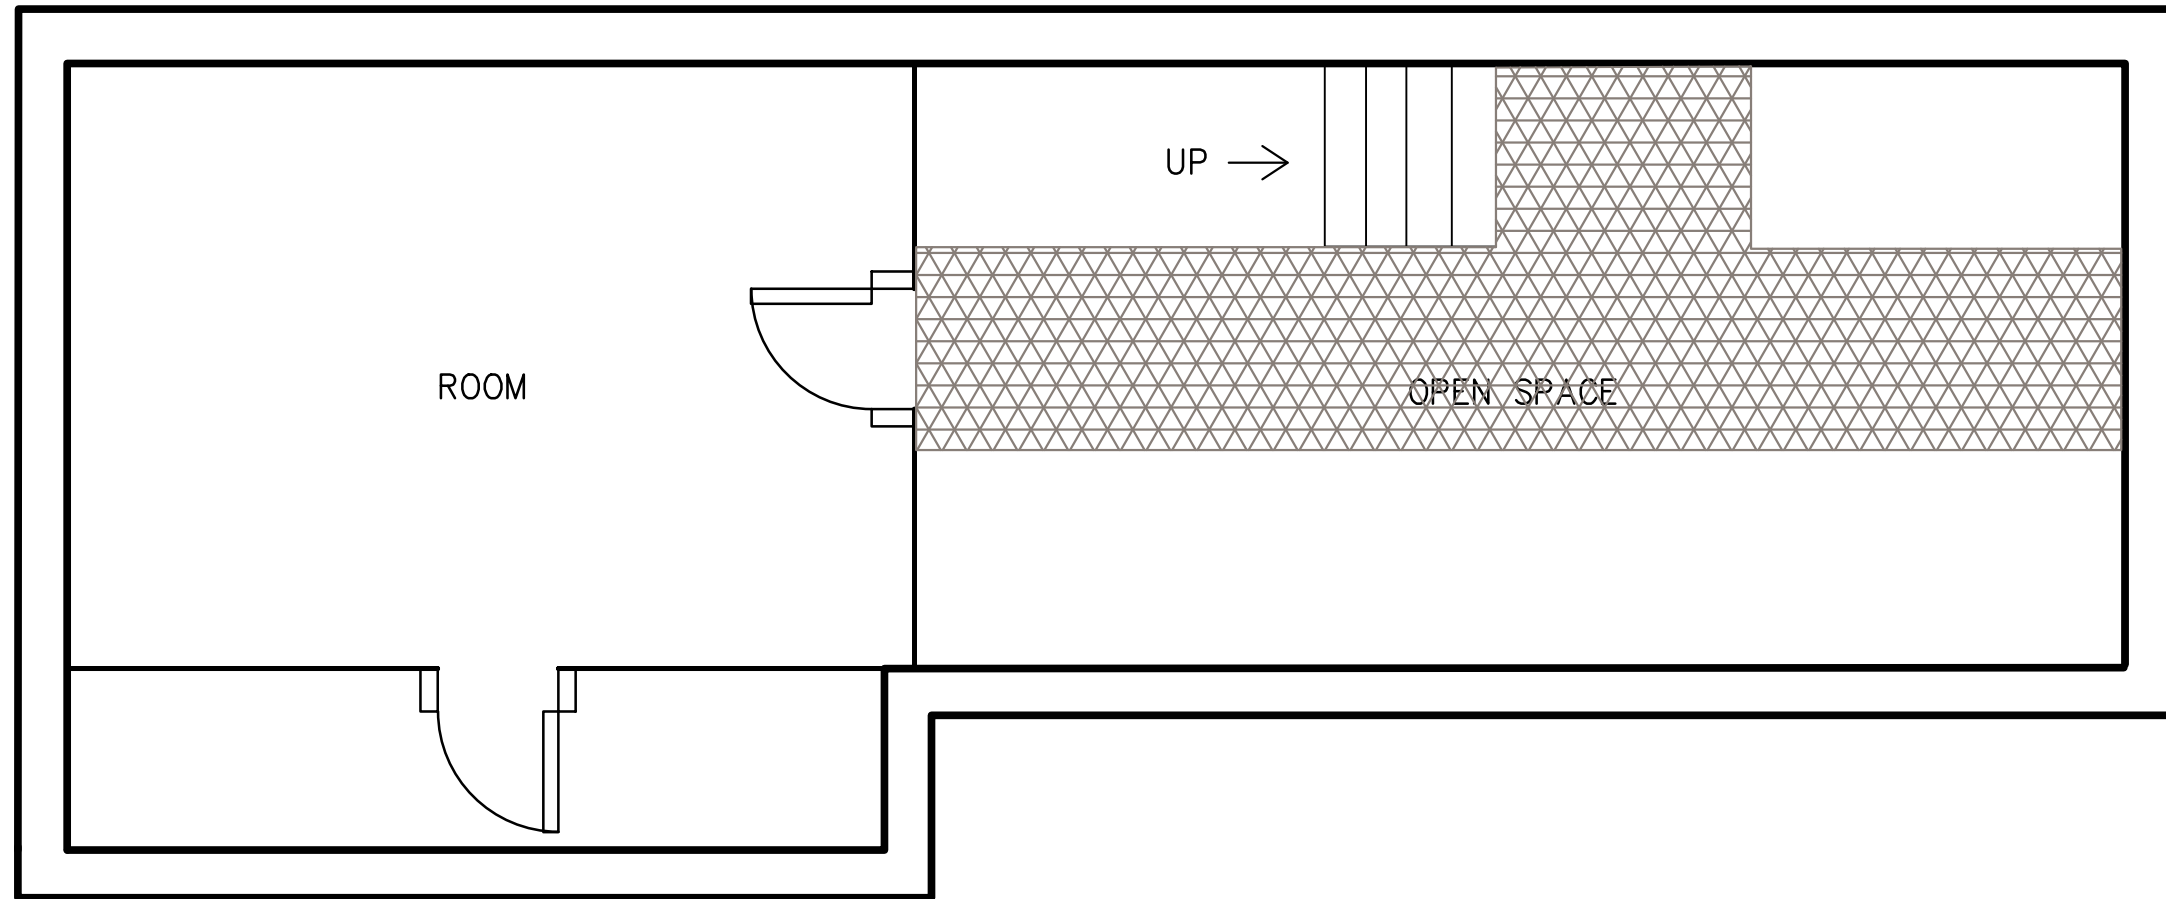
ACM-1

The laboratory reported that asbestos was Not Detected (ND) in the remaining bulk samples collected by GSG. **Exhibit 2, ACM Location**, shows the approximate locations of ACMs present in the building.

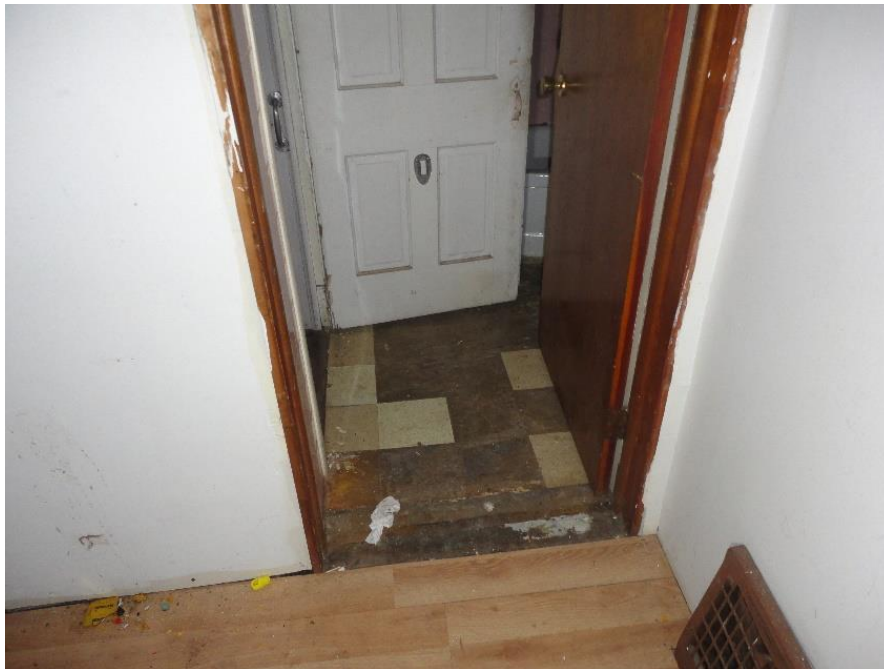
Photo Location:
Bathroom, First floor

Material Description:
Suspect ACM 9"x9" Floor Tile, Yellow/Grey Spots and Beige Colored Mastic

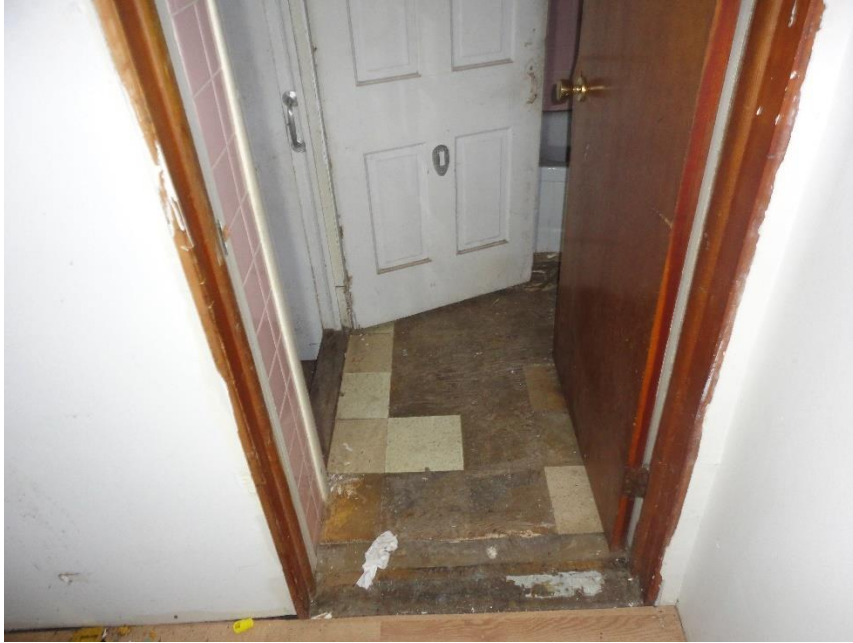
Photo Location:
Bathroom, First Floor

Material Description:
Suspect ACM 9"x9" Floor
Tile, Beige/Brown Spots and
Beige Colored Mastic

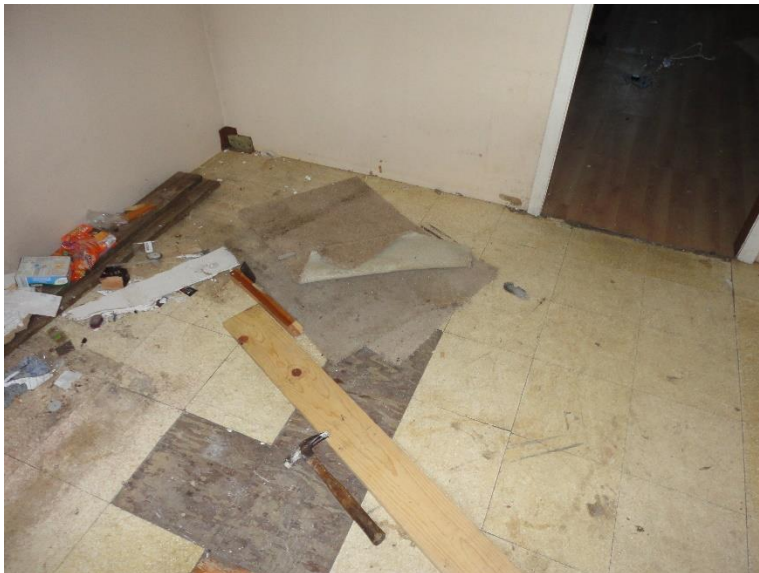
Photo Location:
Back Room, by Exit Door

Material Description:
Suspect ACM 12"x12" Beige
Floor Tile, Yellow Spots,
Beige Mastic

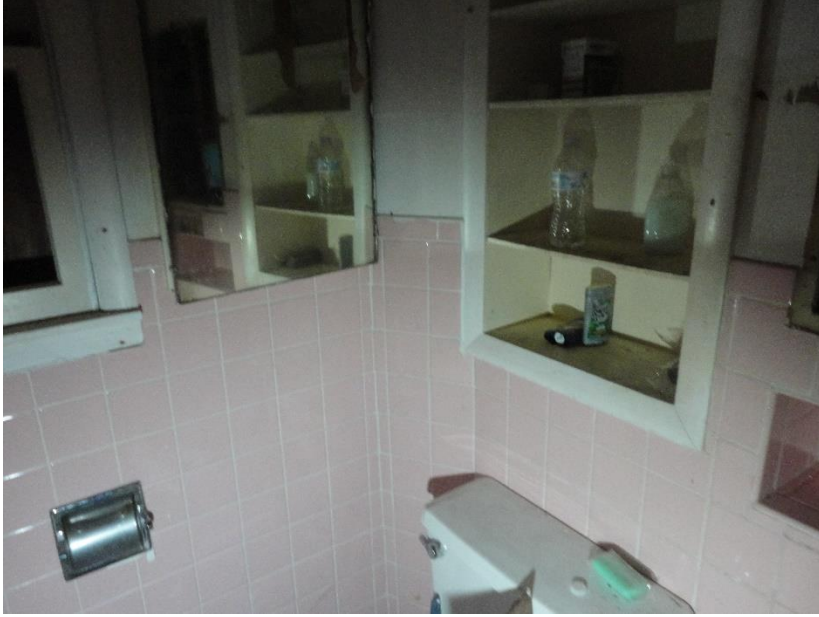
Photo Location:
Bathroom, First Floor

Material Description:
Suspect ACM 4"x4" Pink
Ceramic Wall Tile,
Grout/Mortar

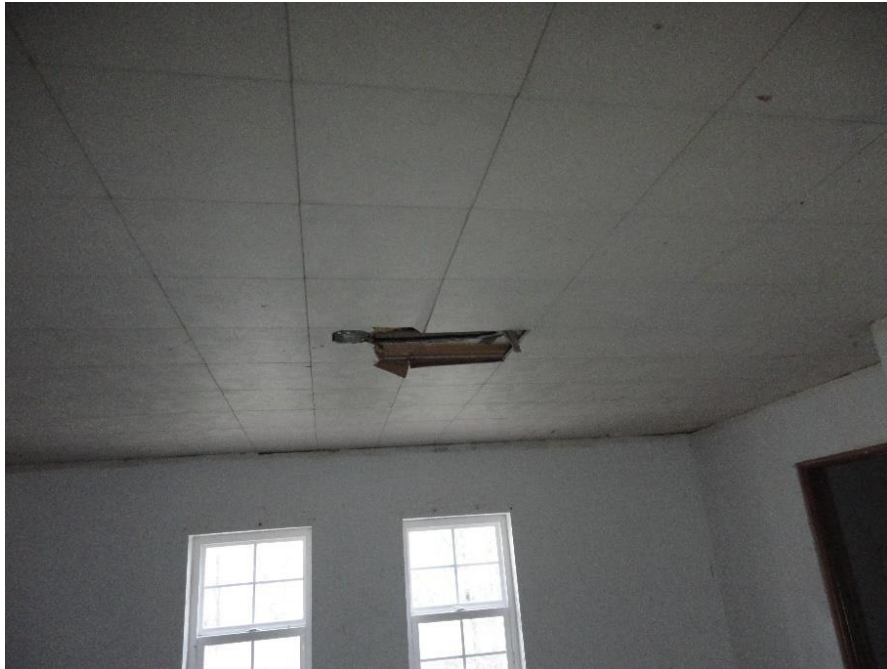
Photo Location:
Hall, First Floor

Material Description:
Suspect ACM 1'x1' White
Ceiling Tile

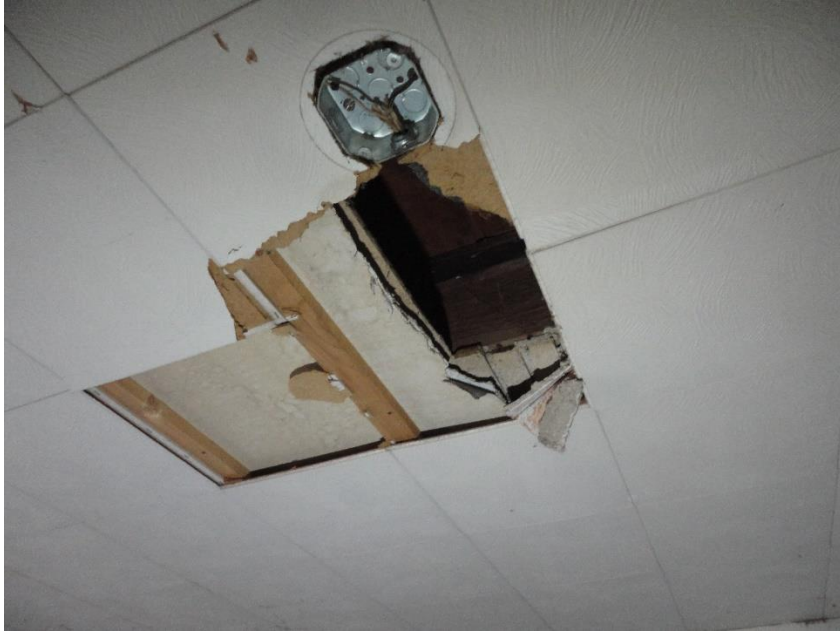
Photo Location:
Hall, First Floor

Material Description:
Suspect ACM Ceiling
Drywall/Pink Paper

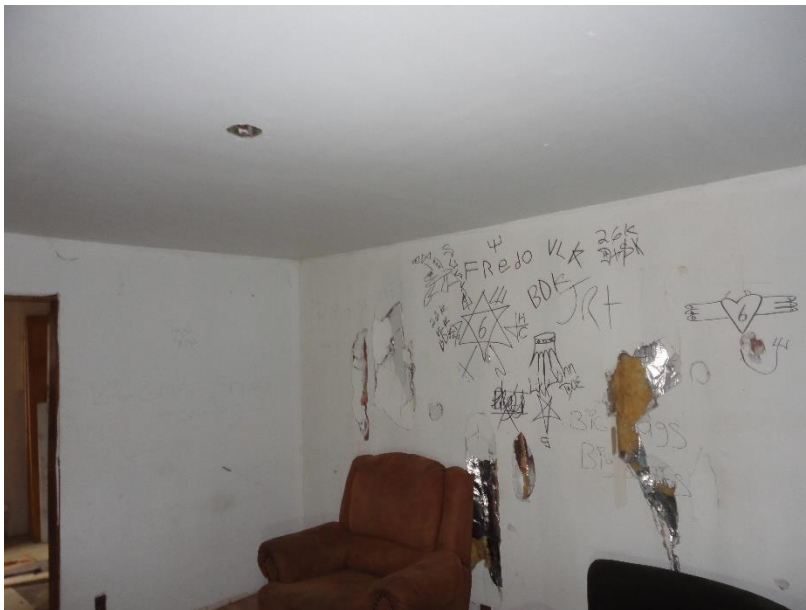
Photo Location:
Living Room, First Floor

Material Description:
Suspect ACM Drywall
System, White

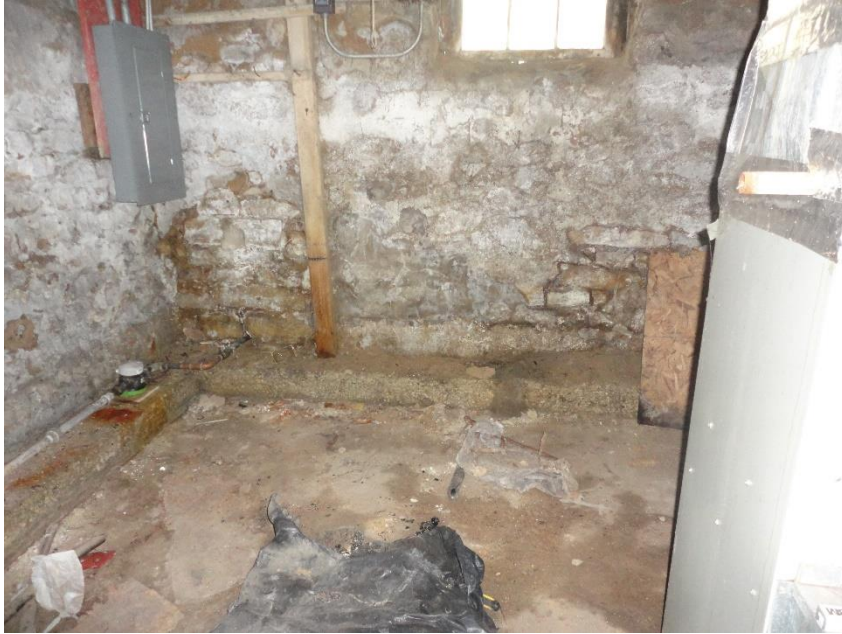
Photo Location:
Basement

Material Description:
Suspect ACM Wall Plaster,
Grey

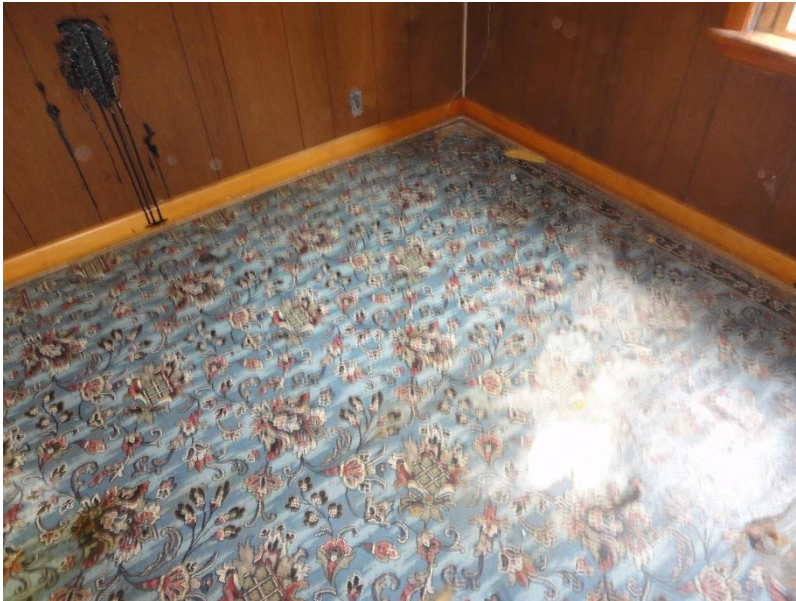
Photo Location:
Second Floor, Bedroom

Material Description:
Suspect Linoleum Sheet
Flooring, Blue

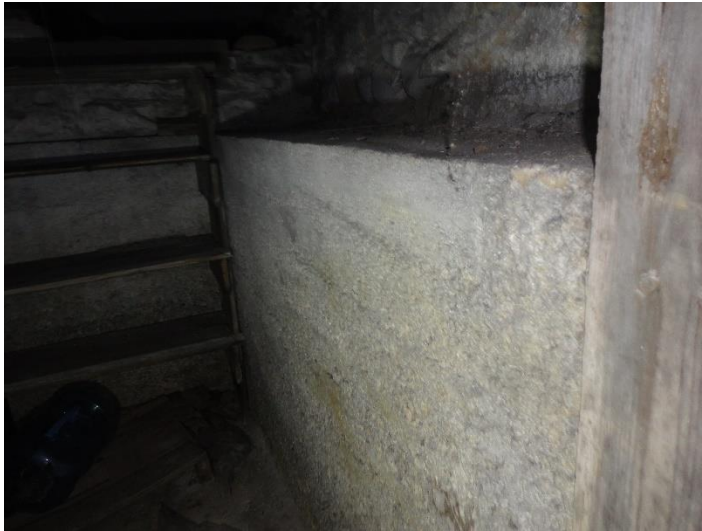
Photo Location:
Basement

Material Description:
Suspect ACM Textured Wall,
Grey

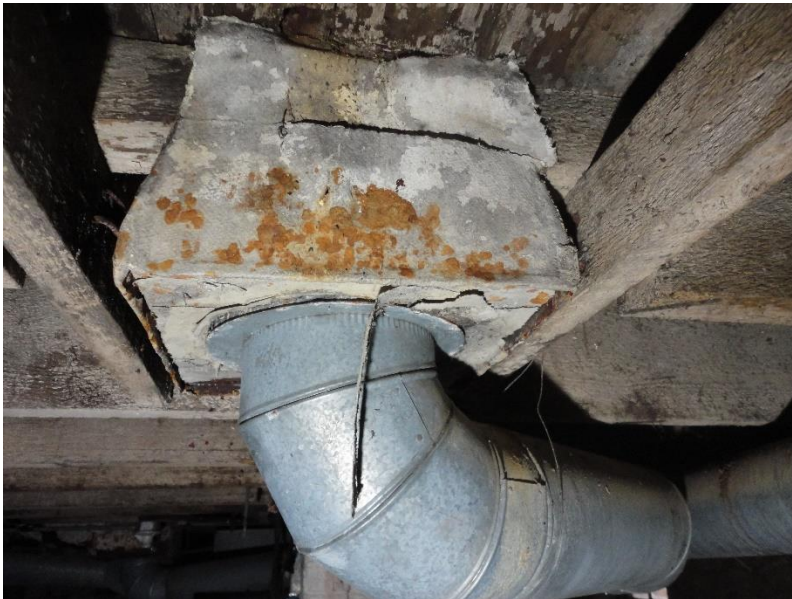
Photo Location:
Basement

HA No.	Material Description	Location	Type ⁽¹⁾	Condition	Friable	% Asbestos*	# of Samples	Estimated Quantity ⁽²⁾
11	Duct Tape, Grey	Basement	TSI	Significantly Damaged	Yes	Chrysotile 10-15%	3	40 LF
12	Fiber Glass, Seal/Wrap Paper	2 nd Floor Attic	TSI	Good	No	ND	3	N/A
13	Window Glazing, Grey	Exterior, South Wall	Misc.	Good	No	Chrysotile 1-5%	3	325 LF (13 Window Systems)
14	Tar Seal, Black	East Wall, Edges Under Siding	Misc.	Significantly Damaged	No	ND	3	N/A
15	Exterior Wall Siding, Brick Pattern/Fibrous	Under All Siding	Misc.	Good	No	ND	3	N/A
16	Tar Paper Siding	Under Exterior Wall Siding	Misc.	Good	No	ND	3	N/A
17	Text Painting, Grey	South Wall	Misc.	Good	No	ND	3	N/A
18	Siding Barrier, Cloth, White	Under Siding	Misc.	Good	No	ND	3	N/A
19	Chimney, Brick/Mortar, Grey	Detached Garage	Misc.	Good	No	ND	3	N/A
20	Window Caulk, Grey	Detached Garage, Skylight Window	Misc.	Significantly Damaged	No	ND	3	N/A
21	Window Glazing, Grey	Detached Garage	Misc.	Significantly Damaged	No	Chrysotile 1-5%	3	100 LF (4 Window Systems)

- HA-11: Grey Duct Tape, located in the basement;
- HA-13: Grey Window Glazing, located on the exterior of the main building; and
- HA-21: Grey Window Glazing, located on the exterior of the garage.

Material Description:
Duct Tape, Grey, HVAC Duct
Work - **Tested Positive for
Asbestos**

All friable asbestos-containing building materials (ACBMs) identified shall be removed from any building(s) or other structures before demolition. Non-friable ACMs may be left in place, unless during demolition, the ACMs may become friable. If other suspect materials not referenced in this survey report, within or on the outside of the buildings, are identified, not listed in **Table 1**, such materials shall be assumed ACMs until the materials are inspected by a licensed asbestos inspector, sampled, and submitted for laboratory analysis. As the floor tile identified as asbestos containing is a Category I non-friable material which is not likely to become friable during demolition, it does not need to be removed prior to demolition.

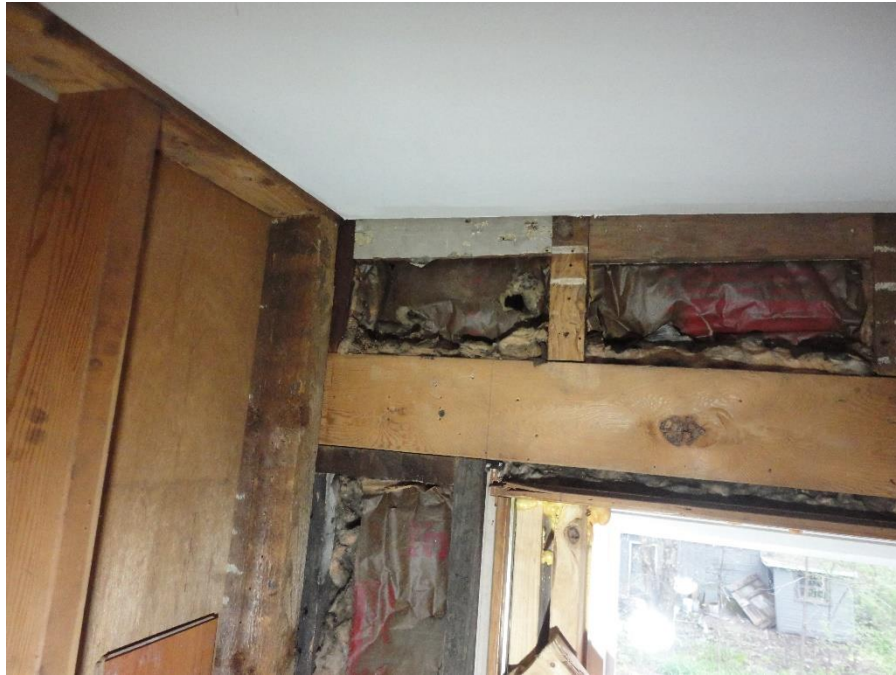
Photo Location:
Second Floor/Attic

Material Description:
Suspect ACM Fiber Glass
Seal/Wrap Paper

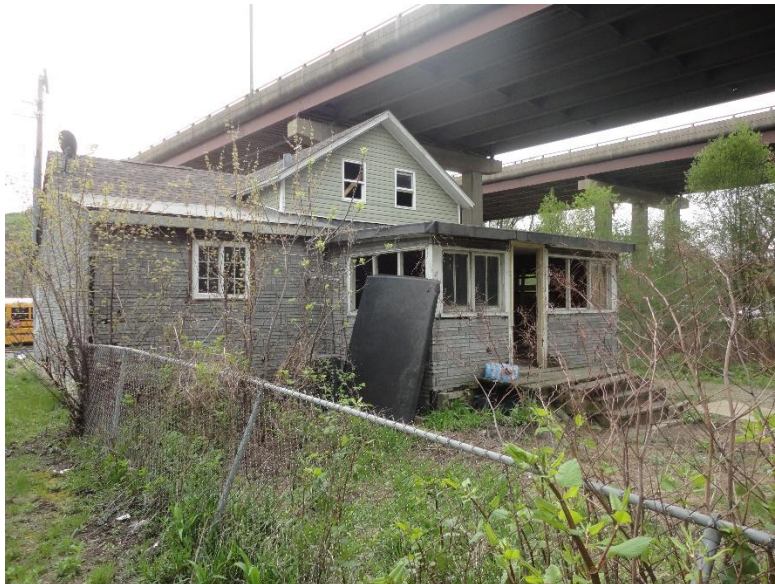
Photo Location:
Exterior

Material Description:
Window Glazing, Exterior,
Grey - **Tested Positive for
Asbestos**

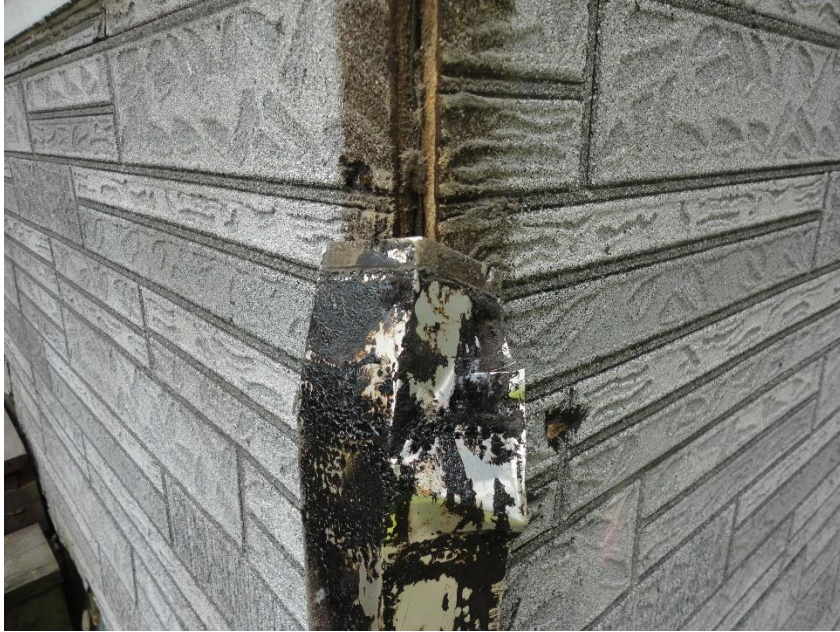
Photo Location:
Exterior, Siding
Edges/Seams

Material Description:
Suspect ACM Tar Seal
Spacing, Black

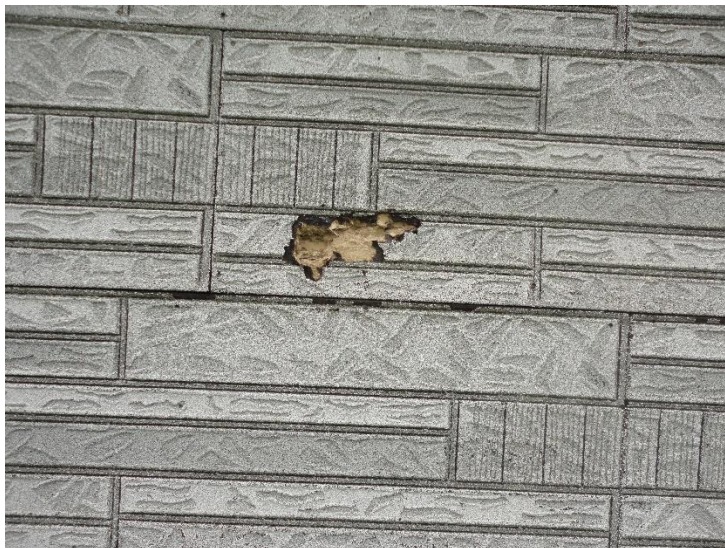
Photo Location:
Exterior

Material Description:
Suspect ACM Exterior Wall
Siding, Brick Pattern, Grey

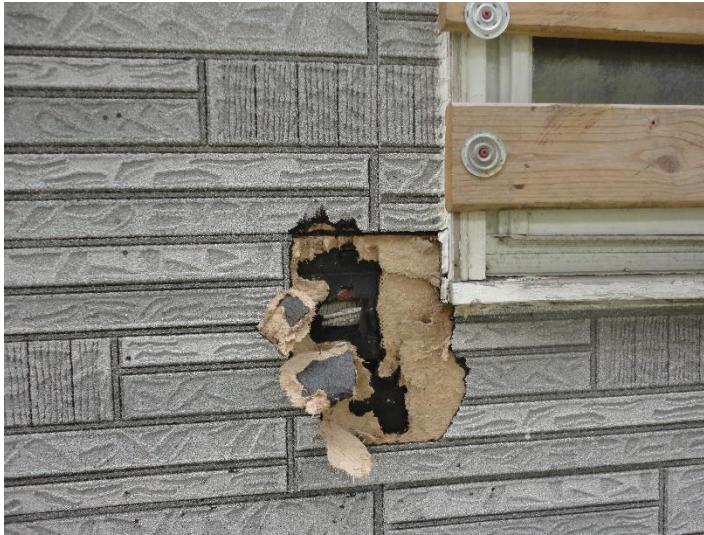
Photo Location:
Exterior

Material Description:
Suspect ACM Tar Paper,
Black, Under Exterior Siding

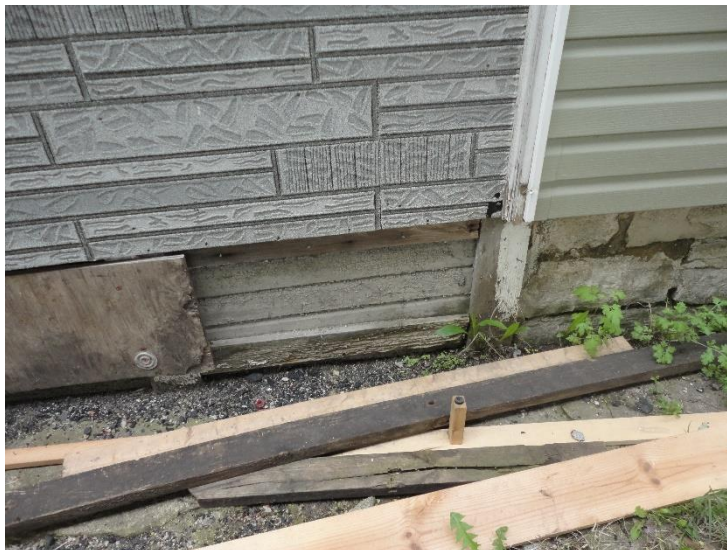
Photo Location:
Exterior

Material Description:
Suspect ACM Textured
Painting, Grey

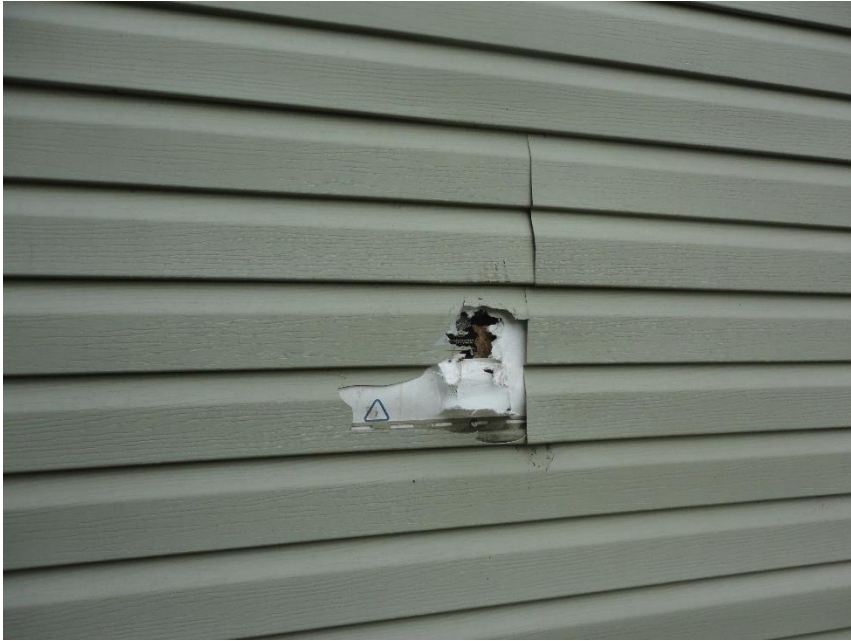
Photo Location:
Exterior

Material Description:
Suspect ACM Siding Barrier Cloth, White

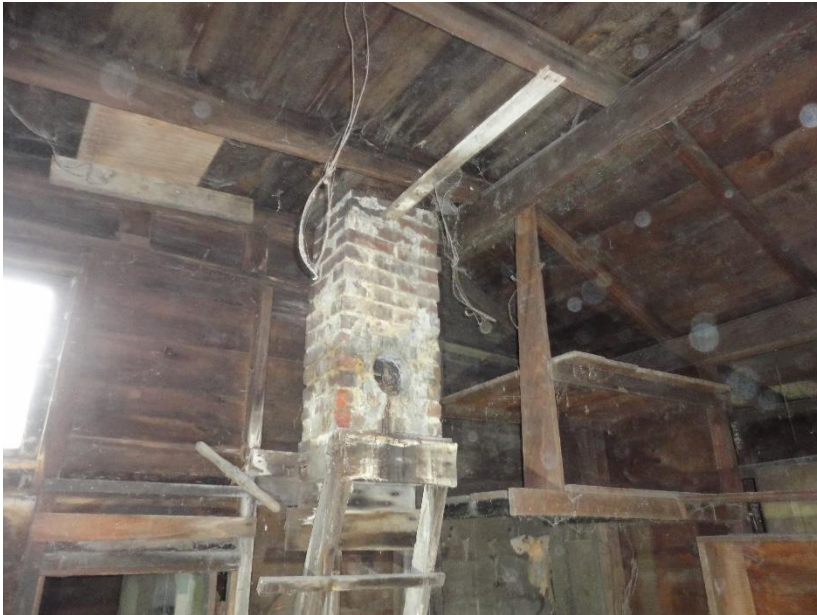
Photo Location:
Detached Garage

Material Description:
Suspect ACM Chimney
Brick/Mortar

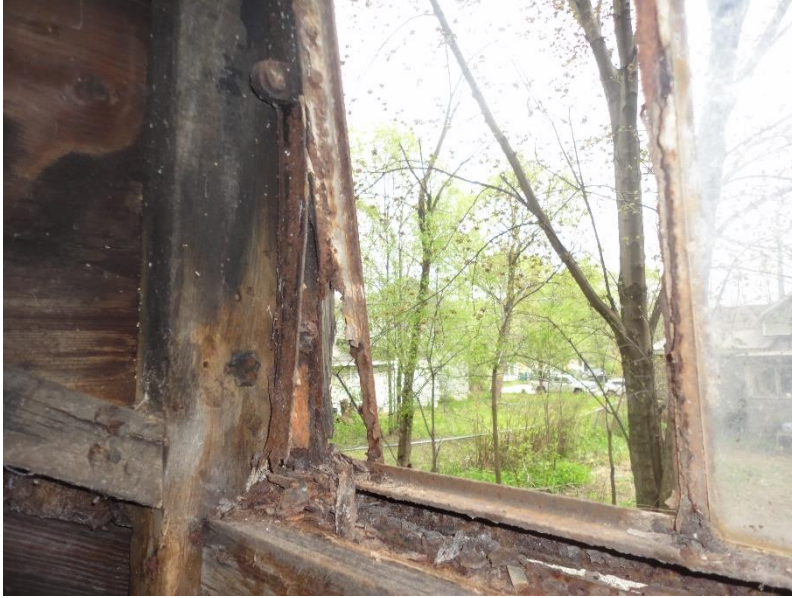
Photo Location:
Detached Garage

Material Description:
Suspect ACM Window Caulk,
Grey

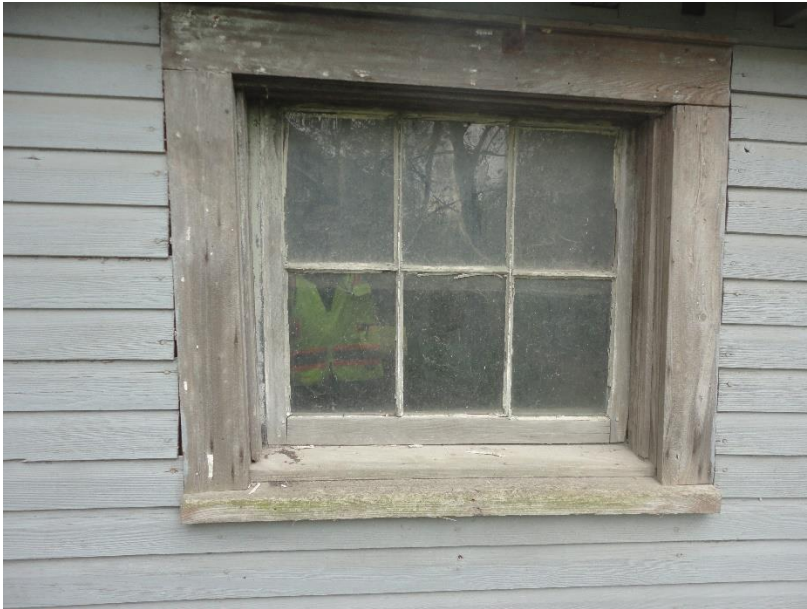
Photo Location:
Detached Garage

Material Description:
Window Glazing, Grey -
**Tested Positive for
Asbestos**

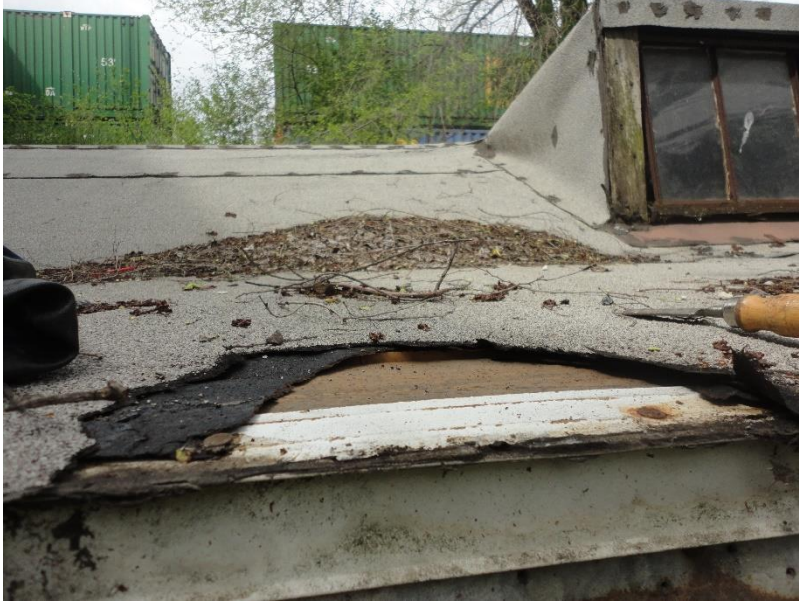
Photo Location:
Detached Garage

Material Description:
Suspect ACM Roof – Shingle
and Tar Paper

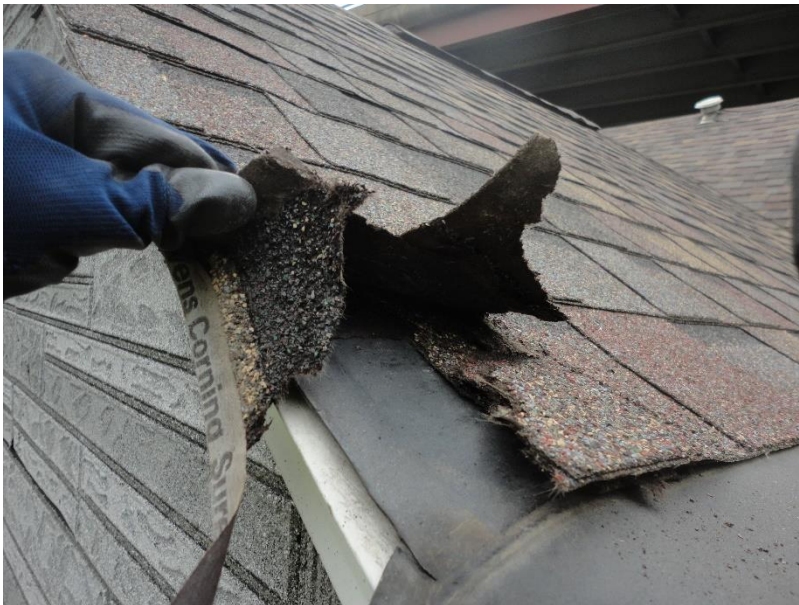
Photo Location:
House Roof

Material Description:
Suspect ACM Main Roof-
Shingles, Tar Paper

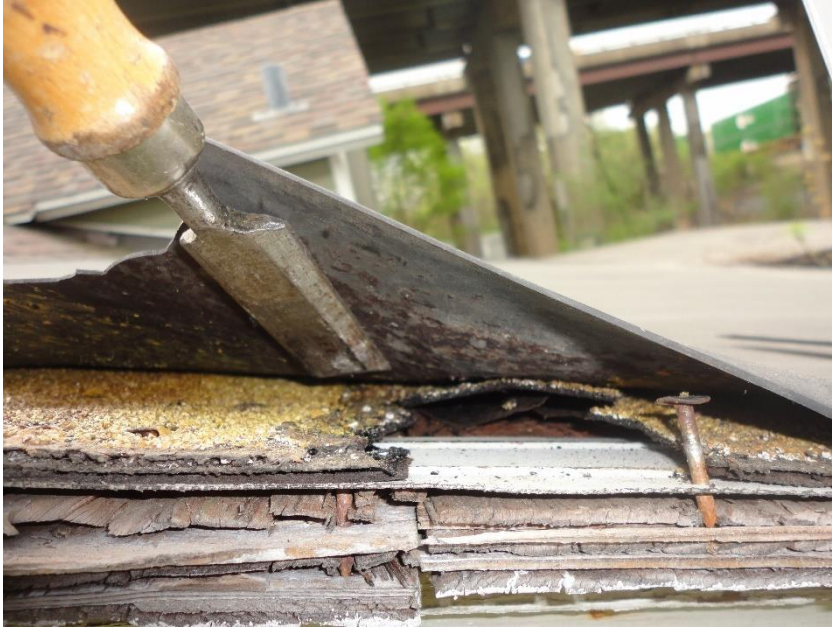
Photo Location:
House Roof - West

Material Description:
Suspect ACM Roof – Rubber Membrane, Shingle and Tar Paper

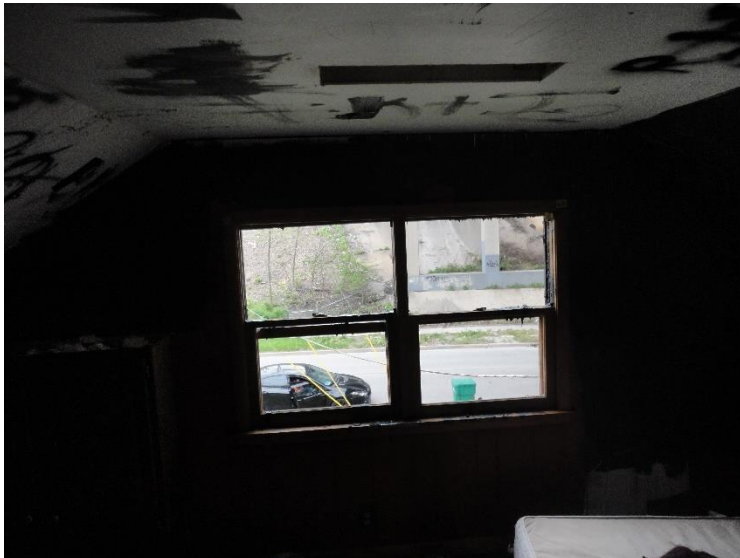
Photo Location:
Interior Window, Second Floor

Material Description:
Suspect ACM Tar Seal
