STATE OF ILLINOIS DEPARTMENT OF TRANSPORTATION

Contract Number: 60B16

BEAM STRAIGHTENING DETAILS GLENWOOD-LANSING RD / IL 394 COOK COUNTY SN 016-0918

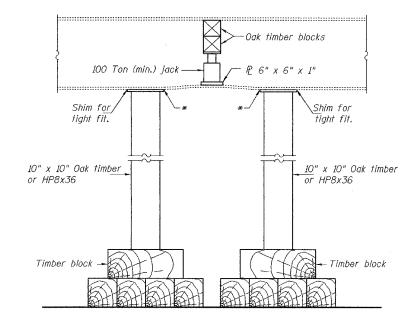
SUGGESTED VERTICAL STRAIGHTENING DETAIL

(To correct localized vertical flange deformations.)

EXISTING DEFORMATION TO BE STRAIGHTENED

(Approximate max. deflections) Deflected length of beam to be straightened is approximately 5'-0".

Braces and jack assembly shall be placed on same side of web. Bent bottom flange shall be straightened before starting any horizontal straightening operations.
