# DRAINAGE STRUCTURE IMPROVEMENT DETAIL

## LOCATION #6 STA. 123+20.00

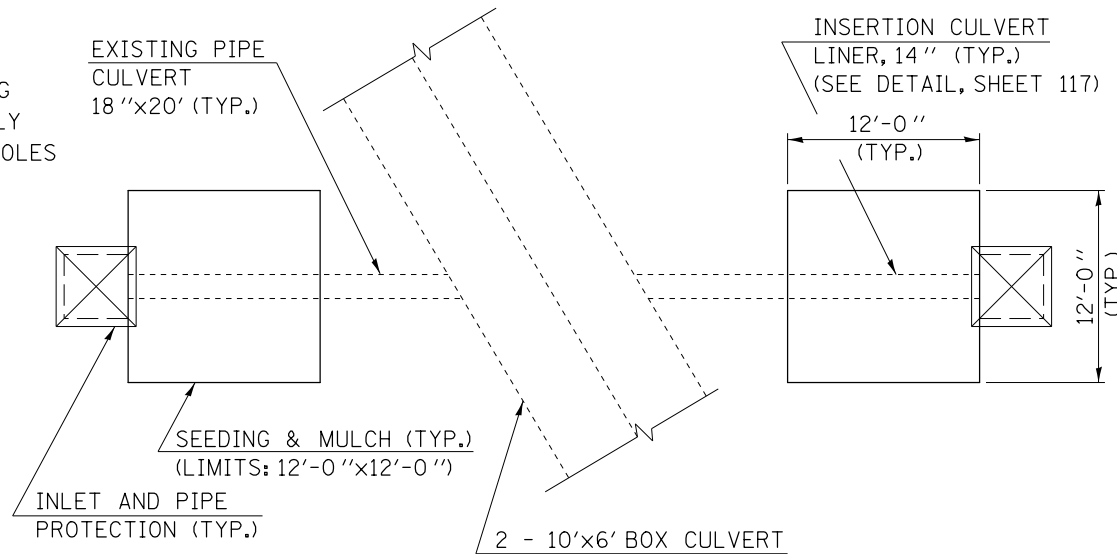
PLAN  
DETAIL "A"

THE EXISTING STRUCTURE AT STATION 123+20.00 CONSISTS OF DUAL MEDIAN INLET BOXES WITH 18" CMP CULVERTS THAT DRAIN INTO A DOUBLE 10' X 6' CONCRETE BOX CULVERT. THE 18" CMP CONNECTING THE OFFSET MEDIAN INLETS TO THE CONCRETE BOX CULVERT IS HEAVILY RUSTED AND IS BEGINNING TO FAIL. THIS FAILURE IS CAUSING SINK HOLES AND DRAINAGE ISSUES AROUND THE MEDIAN INLET BOXES.

THE PROPOSED SCOPE OF WORK IS TO INSERT A CULVERT LINER INTO THE EXISTING CMP TO REMOVE THE CULVERT DEFICIENCY AND TO IMPROVE DRAINAGE. ALL SINK HOLES AROUND THE STRUCTURE SHALL BE FILLED TO FINISH GRADE AND WILL BE PAID FOR SEPARATELY AS FURNISHED EXCAVATION.

OTHER PROPOSED IMPROVEMENTS INCLUDE THE REMOVAL OF ALL TREES AND BRUSH AT THE DOWNSTREAM (SOUTH) END AND TO REPLACE THE EXISTING FENCE WITH WOVEN WIRE FENCE, 4 FT.
