STATE OF ILLINOIS  
DEPARTMENT OF TRANSPORTATION

EXISTING BOX CULVERT REPAIR DETAILS  
STRUCTURE NUMBER 042-2473

SHEET NO. 4 OF 4 SHEETS

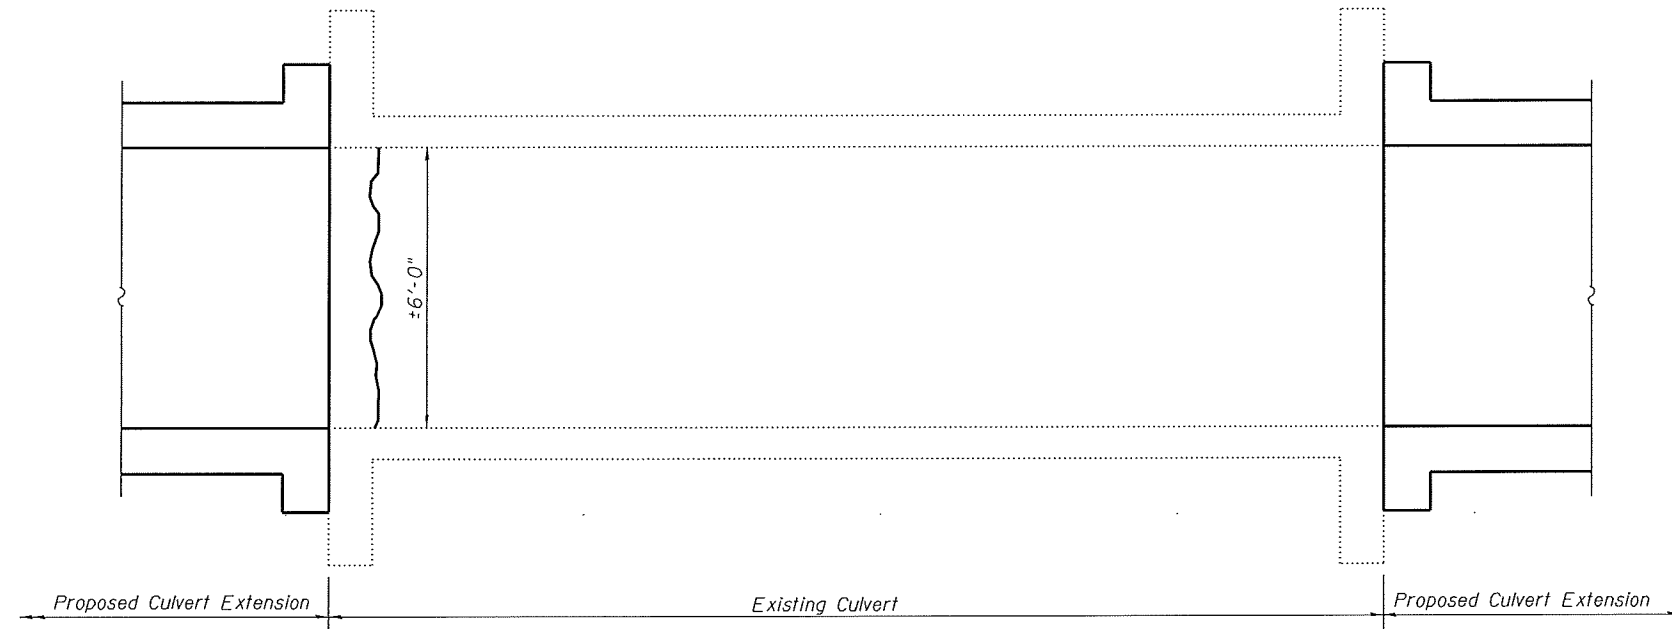
**ELEVATION**  
(Showing Inside Face of East Wall)

~~~~~ Indicates Epoxy Crack Injection Required

*Note:*  
The limits of Epoxy Crack Injection shown are approximate. The limits of Epoxy Crack Injection may vary in the field. Changes in the quantity of Epoxy Crack Injection shall be approved by the Engineer.
