SUPERSTRUCTURE
EAST BOUND LANES
STRUCTURE NO. 081-0022 (E.B.)
FAI ROUTE 280 Section D2 Br Wear Surf I-280
Rock Island County
Sta. 254+98.87

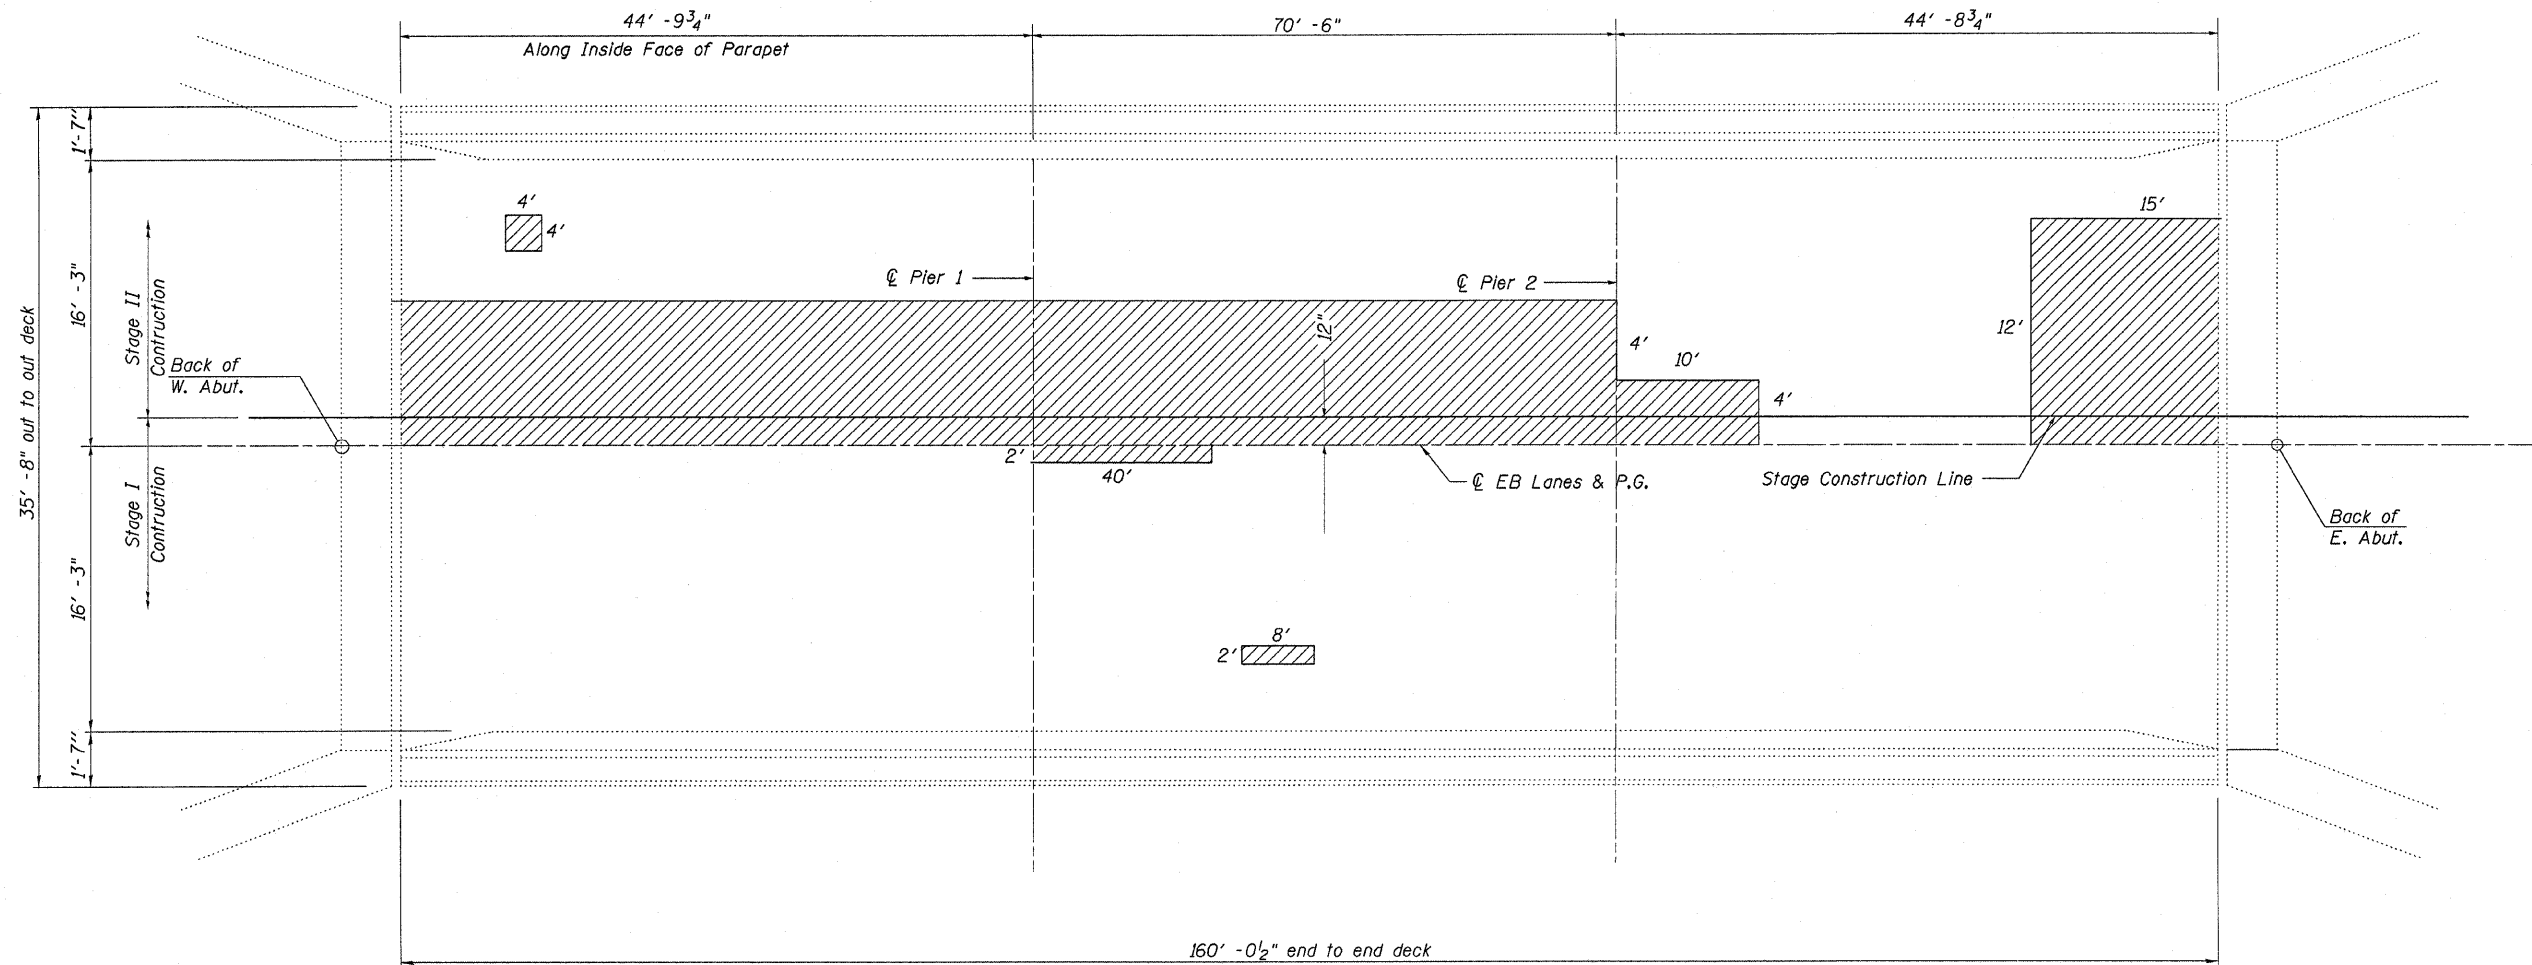
Legend
 Potential Deck Slab Repair (Partial)
 Date of Survey 10/2009

PLAN
 Areas shown for repair are potential areas of deck slab repair. Actual locations and quantities to be determined in the field. Resident Engineer to contact District Bridge Office for assistance with locating patches.
