ROUTE NO.	SECTION	COUNTY	TOTAL SHEETS	SHEET NO.
FAP 681	116BR-1	FORD	37	22
STA.	TO STA.			
FED. ROAD DIST. NO.	ILLINOIS	FED. AID PROJECT-		
DWG. NO. 10 OF 15

CONTRACT NO. 66561

**EAST ABUTMENT**  
IL 116 OVER KELLY CREEK  
FAP ROUTE 681 - SECTION 116BR-1  
FORD COUNTY  
STATION 60+53.00  
STRUCTURE NO. 027-0044

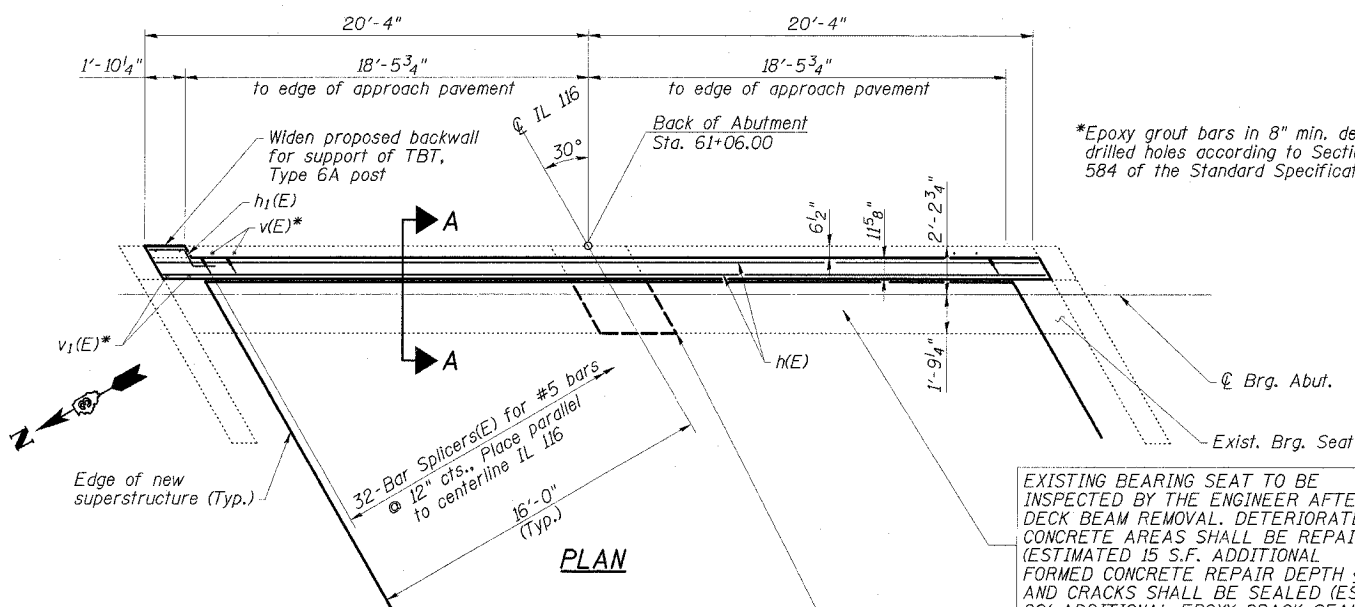
**PLAN**

EXISTING BEARING SEAT TO BE INSPECTED BY THE ENGINEER AFTER DECK BEAM REMOVAL. DETERIORATED CONCRETE AREAS SHALL BE REPAIRED (ESTIMATED 15 S.F. ADDITIONAL FORMED CONCRETE REPAIR DEPTH < 5") AND CRACKS SHALL BE SEALED (ESTIMATED 20' ADDITIONAL EPOXY CRACK SEALING) IF FOUND. BRIDGE SEAT SEALER SHALL BE APPLIED TO FORMED CONCRETE REPAIR AREAS.

\*Epoxy grout bars in 8" min. depth drilled holes according to Section 584 of the Standard Specifications.

8.7 S.F. Formed Concrete Repair to be used to slope existing level portion of abutment seat to provide uniform bearing area for proposed beams
