ROUTE NO.	SECTION	COUNTY	TOTAL SHEETS	SHEET NO.
FAP 681	116BR-1	FORD	37	24
STA.	TO STA.			
FED. ROAD DIST. NO.	ILLINOIS	FED. AID PROJECT-		
DWG. NO. 12 OF 15

CONTRACT NO. 66561

PIER 1
IL 116 OVER KELLY CREEK
FAP ROUTE 681 - SECTION 116BR-1
FORD COUNTY
STATION 60+53.00
STRUCTURE NO. 027-0044

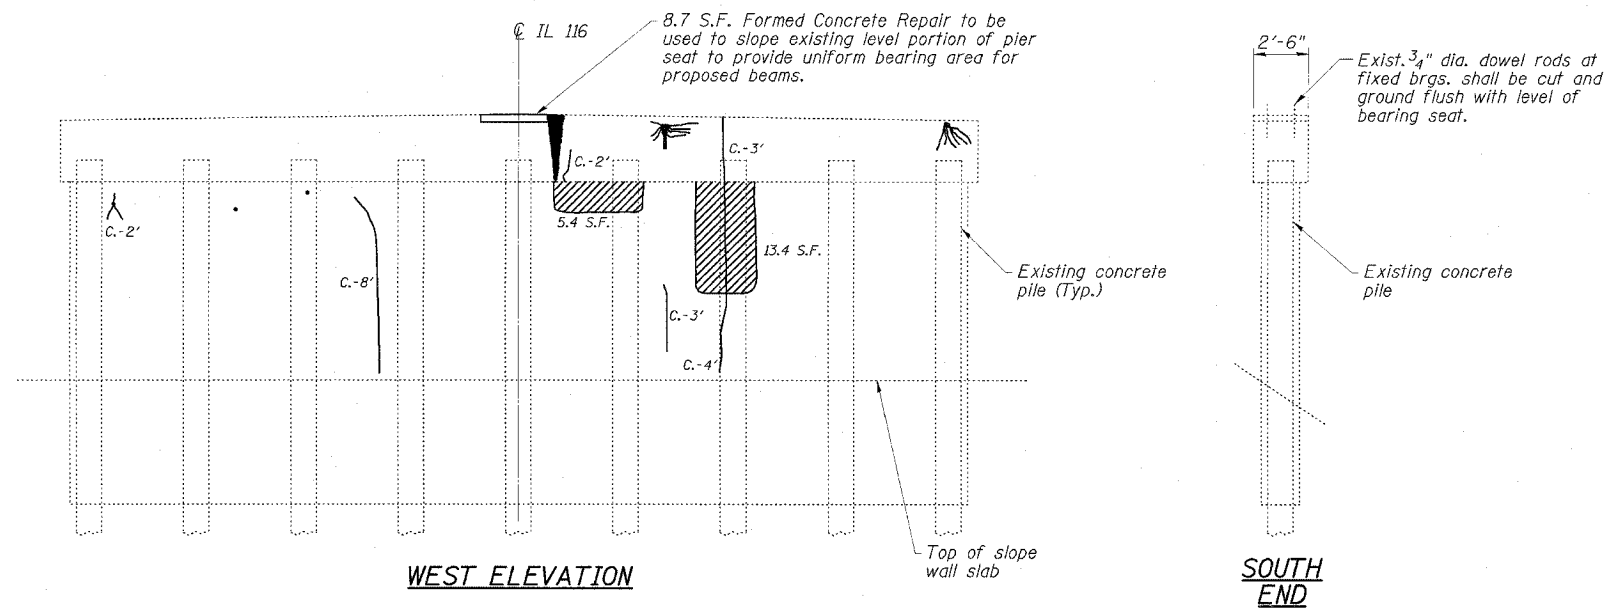
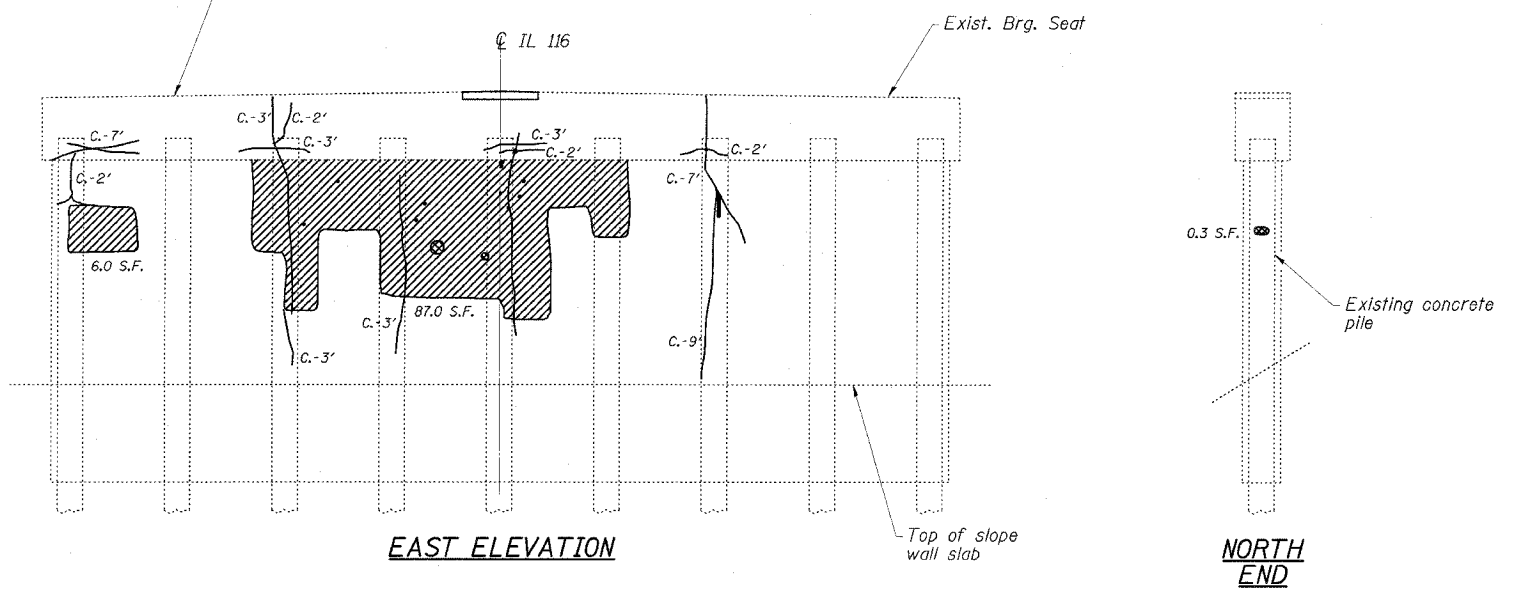
PIER 1
BILL OF MATERIAL

EXISTING BEARING SEAT TO BE INSPECTED BY THE ENGINEER AFTER DECK BEAM REMOVAL. DETERIORATED CONCRETE AREAS SHALL BE REPAIRED (ESTIMATED 15 S.F. ADDITIONAL FORMED CONCRETE REPAIR DEPTH < 5") AND CRACKS SHALL BE SEALED (ESTIMATED 20' ADDITIONAL EPOXY CRACK SEALING) IF FOUND.

NOTE: PIER CRACK REPAIR LENGTHS AND FORMED CONCRETE REPAIR AREAS ARE ESTIMATED FROM 4-14-05 SURVEY WORK. ACTUAL LOCATIONS AND QUANTITIES OF REPAIRS SHALL BE SHOWN BY THE ENGINEER ON THE AS-BUILT PLANS FOR THIS SECTION.
