STATE OF ILLINOIS
DEPARTMENT OF TRANSPORTATION

ROUTE NO.	SECTION	COUNTY	TOTAL SHEETS	SHEET NO.
FAP 681	116BR-1	FORD	37	25
STA.	TO STA.			
FED. ROAD DIST. NO.	ILLINOIS	FED. AID PROJECT-		
DWG. NO. 13 OF 15

PIER 2
IL 116 OVER KELLY CREEK
FAP ROUTE 681 - SECTION 116BR-1
FORD COUNTY
STATION 60+53.00
STRUCTURE NO. 027-0044

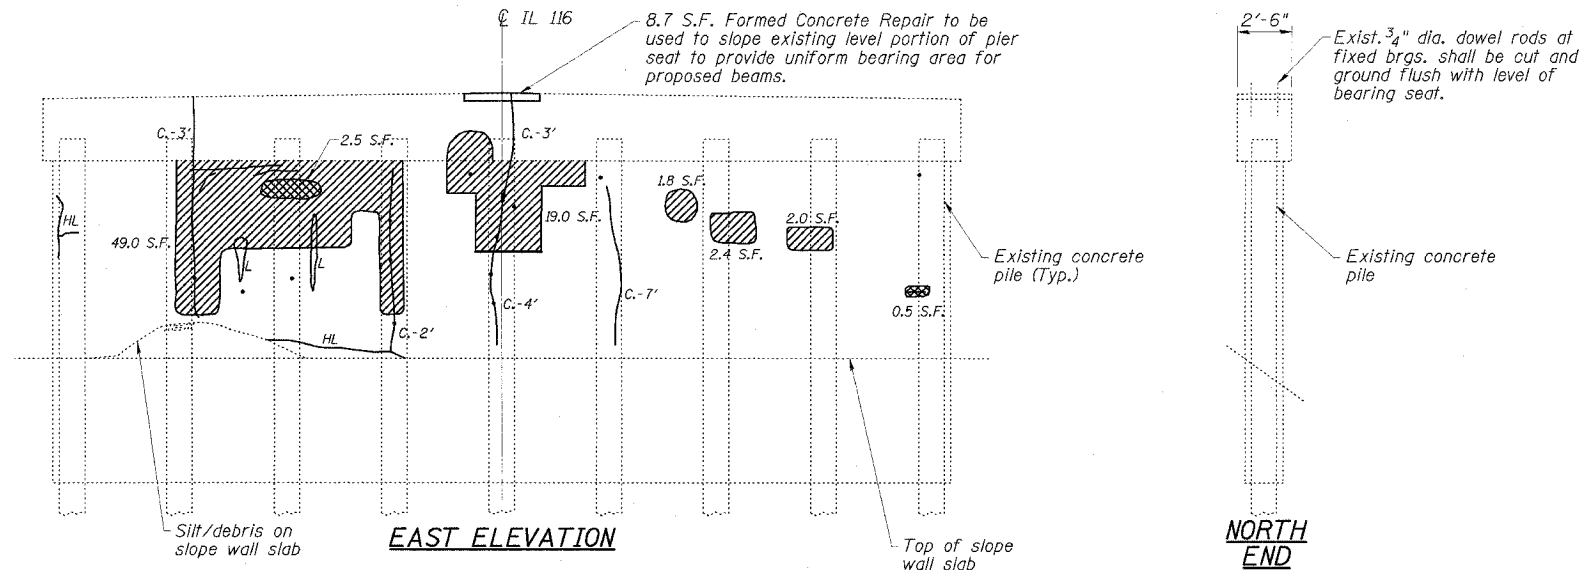
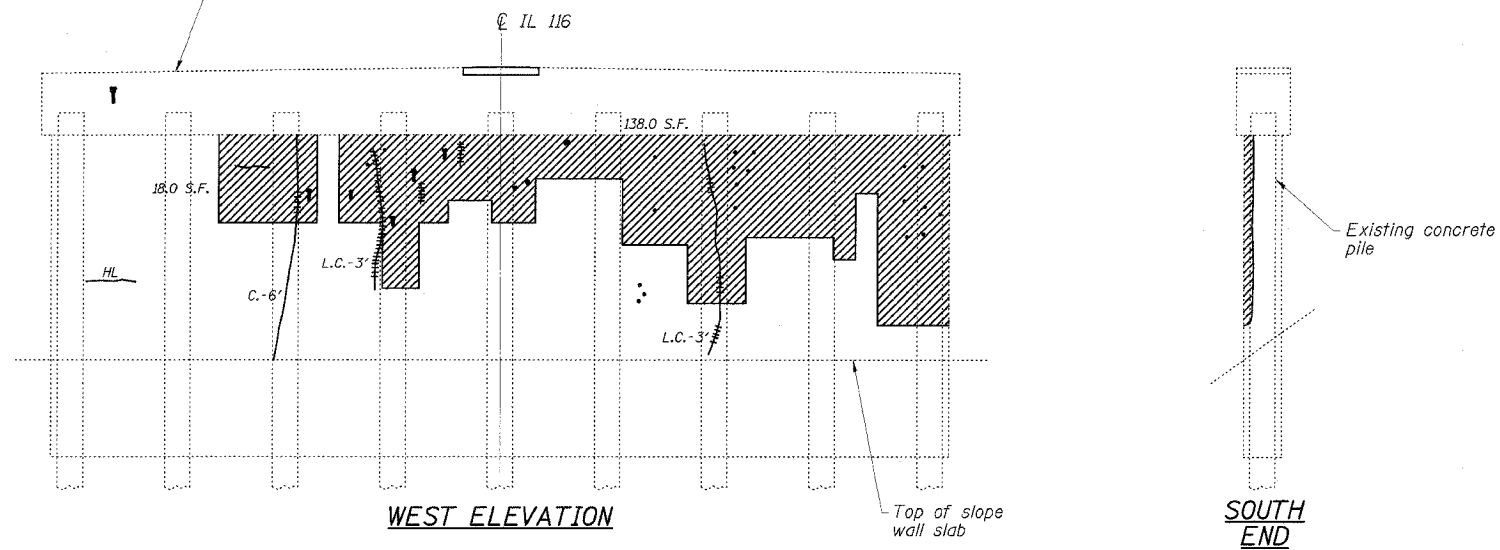
PIER 2
BILL OF MATERIAL

NOTE: PIER CRACK REPAIR LENGTHS AND FORMED CONCRETE REPAIR AREAS ARE ESTIMATED FROM 4-14-05 SURVEY WORK. ACTUAL LOCATIONS AND QUANTITIES OF REPAIRS SHALL BE SHOWN BY THE ENGINEER ON THE AS-BUILT PLANS FOR THIS SECTION.

EXISTING BEARING SEAT TO BE INSPECTED BY THE ENGINEER AFTER DECK BEAM REMOVAL. DETERIORATED CONCRETE AREAS SHALL BE REPAIRED (ESTIMATED 15 S.F. ADDITIONAL FORMED CONCRETE REPAIR DEPTH \leq 5") AND CRACKS SHALL BE SEALED (ESTIMATED 20" ADDITIONAL EPOXY CRACK SEALING) IF FOUND.
