MISSOURI APPROACH - PLATE GIRDER REPAIR SCHEDULE

BRIDGE NO. 1
STRUCTURE 002-0005
FOR INFORMATION ONLY

MISSOURI APPROACH - SPANS
GIRDER REPAIR SCHEDULE
F.A.U.S. Rte. 9811 (U.S. 60 & 62)
S.B.I. 150 SECTION 138 D-BR
ALEXANDER CO., IL. MISSISSIPPI CO., MO.
STATION 28+13.08

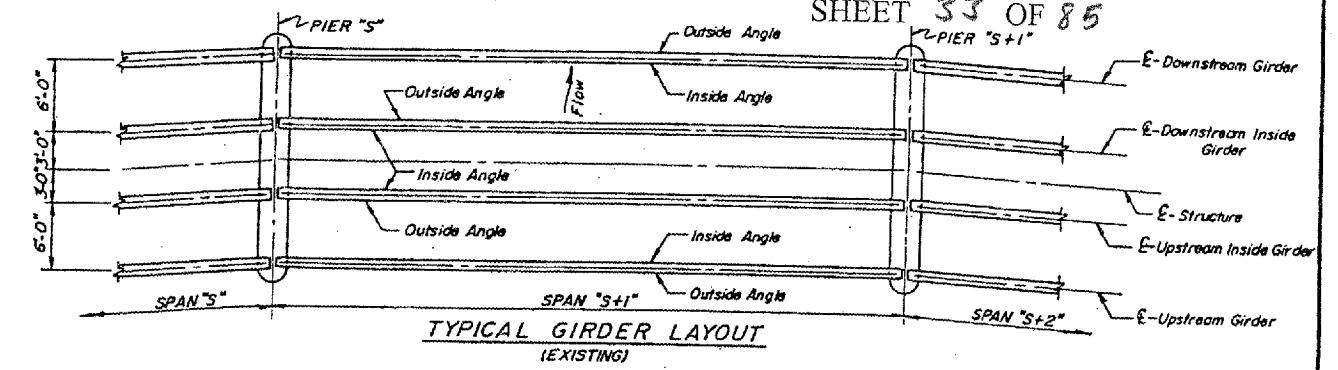
SPAN NUMBER	PIER NUMBER	GIRDER LOCATION				REMARKS
		UPSTREAM	DOWNSTREAM	UPSTREAM-INSIDE	DOWNSTREAM-INSIDE	
12S (CONT.)	11S TO 12S	Inside face of the web has 3/16" loss near the bottom between stiff. #15 and the end. See Note "3", This Sheet.	Inside/bottom flange angle has 3/16" loss at top and bottom b/wn stiff. #15 and the end. (27)	Inside and outside faces of the web have 3/16" loss near the bott. between stiffener #15 and the end. Use A = 26 1/4", B = 15 1/2", n = 8 and n1 = 3. (25)	Inside and outside faces of the web have 3/16" loss and a hole near the bottom between stiffener #15 and the end. Use A = 16 1/2", B = 12", n = 5 and n1 = 2. (25)	Downstream Girder: A = 16 1/2" for Detail "6" N = 2
		Inside face of the web has 3/16" loss near the bottom between stiffener #1 and the end. See Note "3", This Sheet.	Outside stiffener #6 has 80% loss of section at bottom. See Note "3", This Sheet.

13S	12S TO S.ABUT.	Sole plate and inside and outside bottom flange angles have 1/8" to 1/4" pack rust in between them at Pier 12S. See Note "2", This Sheet.	Sole plate and inside and outside bottom flange angles have light pack rust in between them at S. Abut. See Note "1", This Sheet.	Sole plate and inside and outside bottom flange angles have 1/8" to 1/4" pack rust in between them at Pier 12S. See Note "2", This Sheet.	Sole plate and outside bott. flange angle have light pack rust in b/wn them at South Abutment. See Note "1", This Sheet.	
		Outside bottom flange angle has 1/4" loss at bottom adjacent to sole plate at South Abutment. See Note "1", This Sheet.	Sole plate and inside and outside bottom flange angles have 1/8" pack rust in between them at Pier 12S. See Note "2", This Sheet.	Sole plate and inside and outside bottom flange angles have 1/8" pack rust in between them at S. Abut. See Note "1", This Sheet.	Sole plate and inside and outside bottom flange angles have 1/8" to 1/4" pack rust in between them at Pier 12S. See Note "2", This Sheet.

Outside bottom flange angle has 1/8" loss at bottom between stiff. #1 and the end. See Note "3", This Sheet.	Inside bottom flange angle has 1/8" loss at top and bottom b/wn stiffener #1 and the end. See Note "3", This Sheet.	Outside bottom flange angle has 1/8" loss at top between stiff. #1 and the end. See Note "3", This Sheet.	Outside bottom flange angle has 3/16" loss at top between stiffener #1 and the end. See Note "3", This Sheet.	
		Inside bottom flange angle has 1/8" loss at bottom between stiff. #15 and the end. See Note "3", This Sheet.	Outside face of the web has 1/4" loss near the bottom between stiffener #1 and the end. See Note "3", This Sheet.	Inside bottom flange angle has lost 2" of its outer edge b/wn stiff. 1-End. (26)	Inside bottom flange angle has lost 3" of its outer edge between stiff. #1-End. (26)	
		Inside bottom flange angle has 1/8" total loss at top and bottom between stiffener #1 and the end. See Note "3", This Sheet.

Outside face of the web has 3/16" to 1/4" loss near the bottom b/wn stiffener #1 and the end. Use A = 17 1/4", B = 15 1/2", n = 5 and n1 = 3. (25)

1. Clean girder end and remove all rust, foreign material and old paint down to the bare metal. Seal bearing using Fixed Bearing Repair Details, Sheet 31.
2. Clean girder end and remove all rust, foreign material and old paint down to the bare metal. Expansion bearing is being replaced. See Bearing Repair Schedule, Sheets 28-30, and Expansion Bearing Replacement Details, Sheet 32.
3. Clean and remove all rust, foreign material and old paint down to the bare metal. Cost incidental to "Cleaning and Painting."
