ABUTMENT BEARING REPLACEMENT DETAILS

BRIDGE NO. 1
STRUCTURE 002-0005
FOR INFORMATION ONLY

APPROACH SPANS - GIRDERS
FIXED BEARING REHABILITATION
F.A.U.S. Rte. 9811 (U.S. 60 & 62)
S.B.I. 150 SECTION 138D-BR
ALEXANDER CO., IL. MISSISSIPPI CO., MO.
STATION 28+13.08

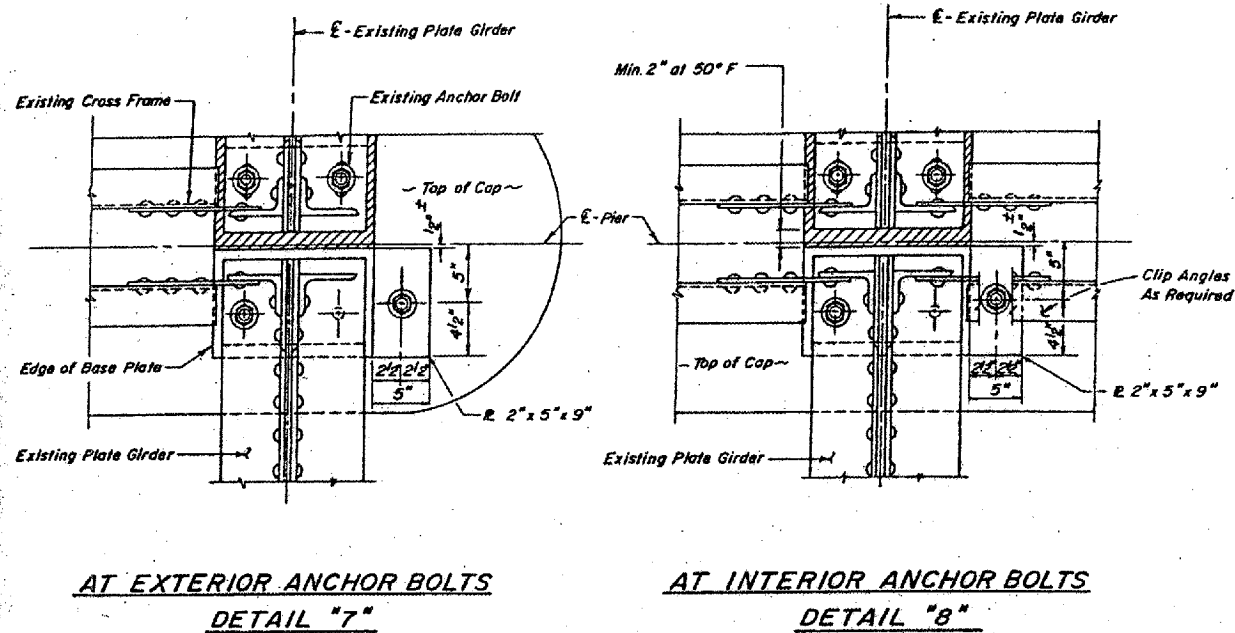
AT EXTERIOR ANCHOR BOLTS
DETAIL "7"

AT INTERIOR ANCHOR BOLTS
DETAIL "8"

PLAN

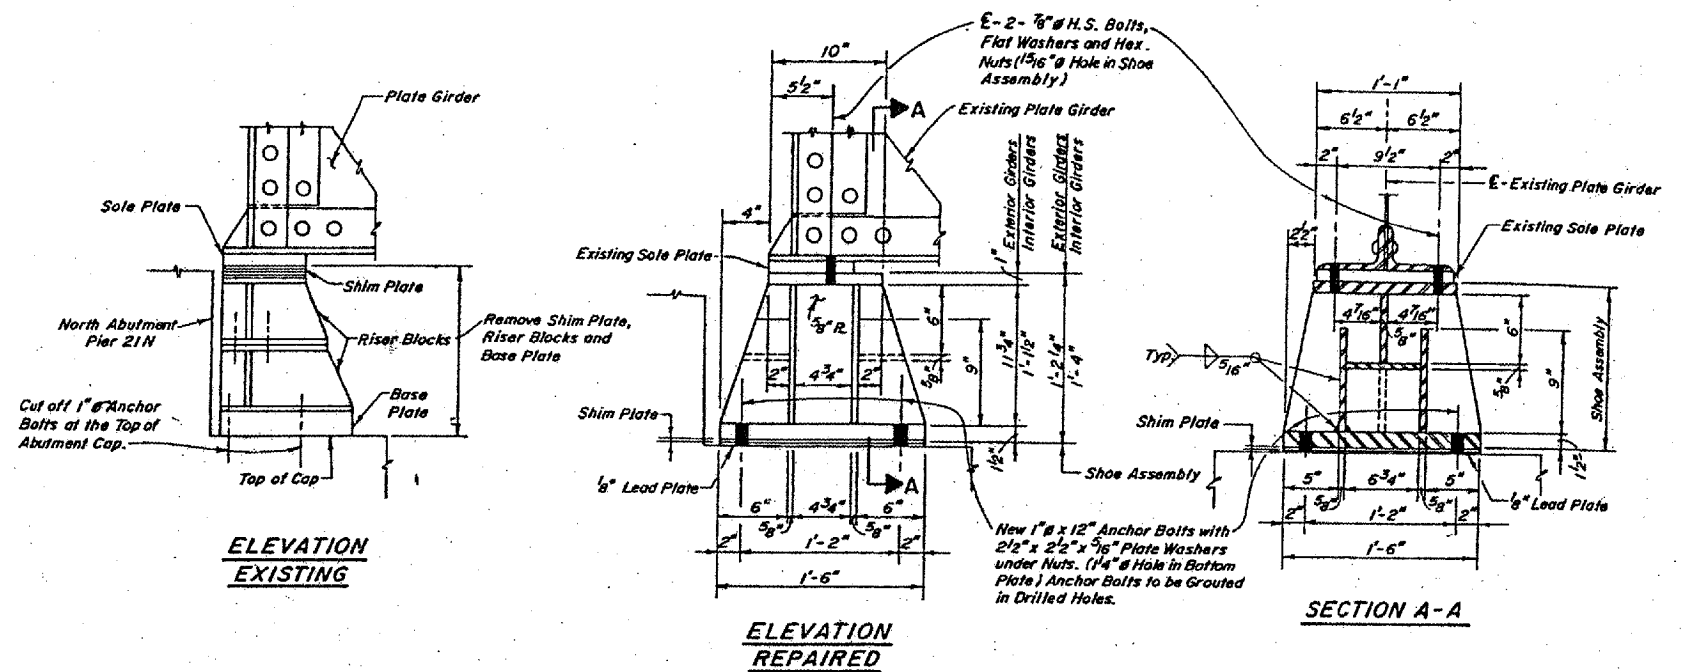
ELEVATION
EXISTING

ELEVATION
REPAIRED

SECTION A-A

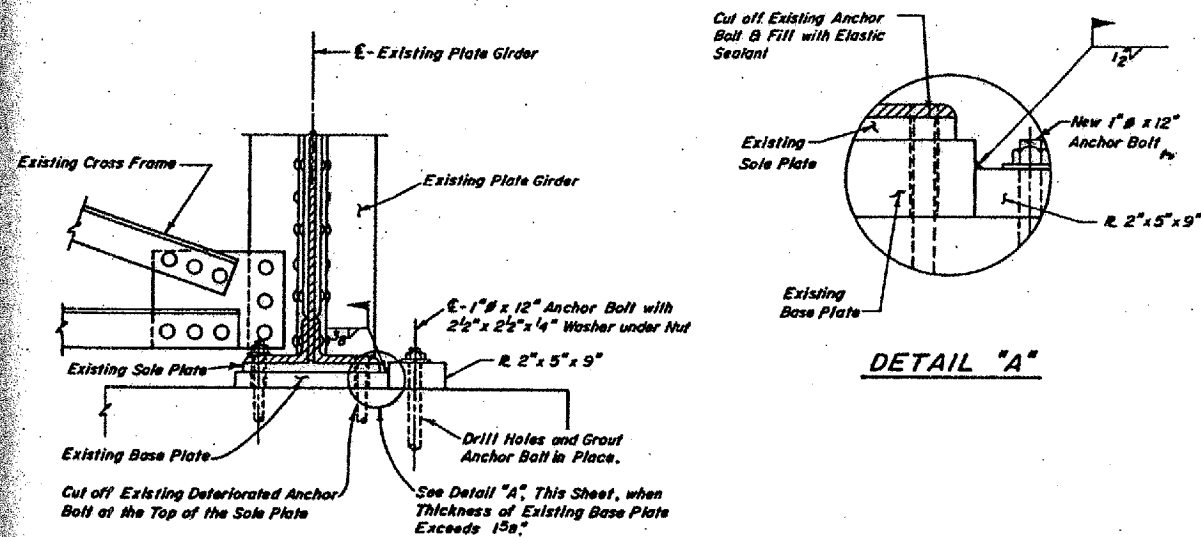
ANCHOR BOLT REPLACEMENT DETAILS "7" AND "8"
(AT FIXED BEARING)

TYPICAL ELEVATION
(SHOWN AT EXTERIOR ANCHOR BOLT,
INTERIOR ANCHOR BOLT SIMILAR.)
